Walney Island

PHASE 2 CONSERVATION STATEMENT

Issue 3

June 2016

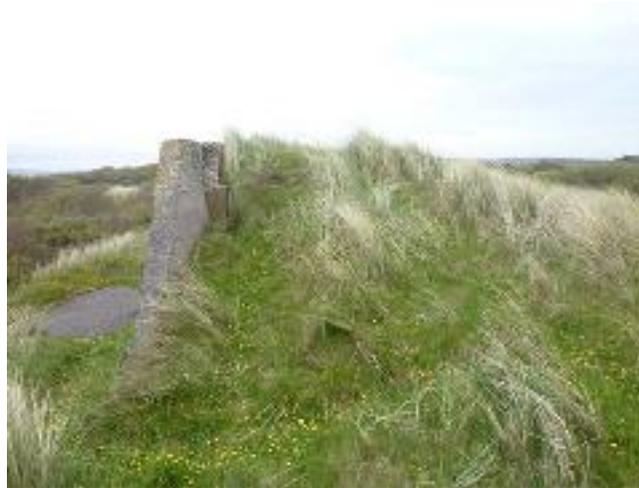
Subsiding wall rear view

It is recommended that a structural assessment should be completed and the wall pinned back into the existing grass dune as required.

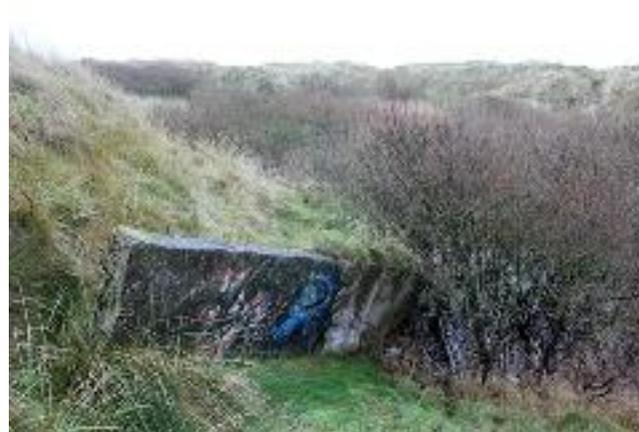
The site at present consists of little more than concrete platforms and concrete remnants set in the dunes. The concrete has decayed and exposed corroded reinforcements are present. The exposed reinforcement ends pose a potential health and safety hazard.

Concrete remnants at Air Gunner's Range with exposed reinforcements

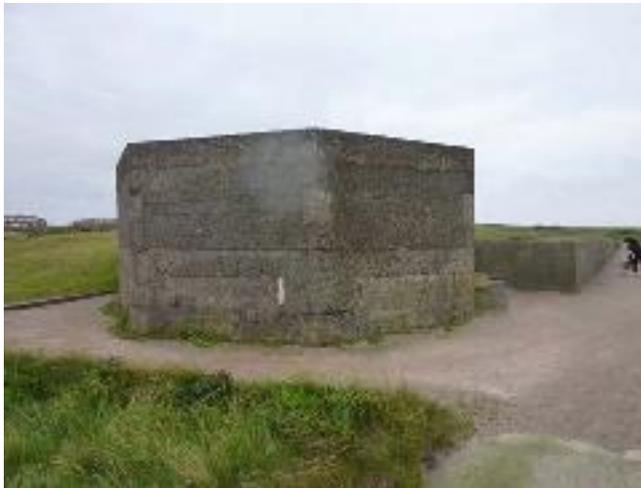
Pill-box on approach to Golf Course

The pill-box is a simple cast in-situ concrete structure with an irregular hexagonal plan form. All apertures have been infilled with brickwork and concrete, therefore the internal condition is unknown.

The weathering of the infills indicate that they have not been recently installed. No roof covering is present however it appears in reasonable condition.

The structure externally is in good condition with no evidence of failure or spalling to the concrete. Day joints in the construction of the pill-box are clearly visible.

It may be beneficial to remove concrete and brick in-fill to ventilate the structure and allow interior inspection. Discreet grilles may be provided for security.

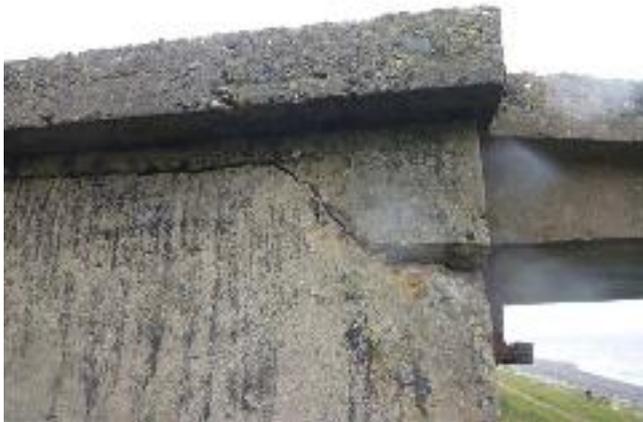
The steel I-beams supporting the roof internally are heavily corroded with significant loss of fabric to the web and it would be beneficial for these to be replaced.

Concrete jacking due to corroded steelwork

It is advised that the corroded steel should be removed and a new I-beam fabricated and installed to support the roof.

The cracking caused by the jacking of the roof should be repaired on completion of the I-beam replacement.

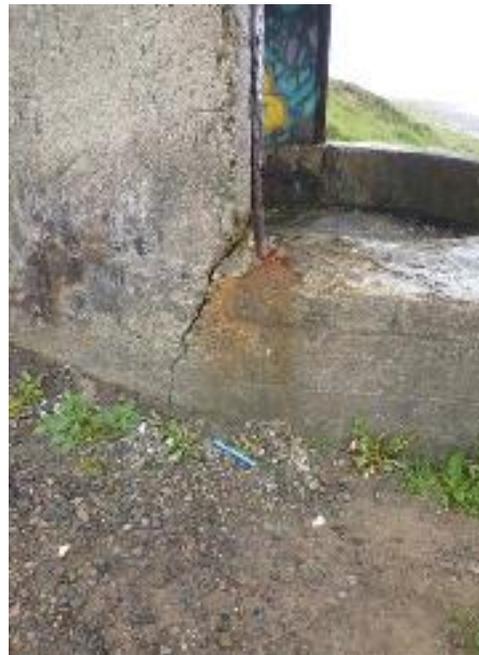
Cracking due to subsidence

To facilitate the long term stability of the structure it is recommend that the slab should be underpinned and concrete repairs undertaken at the junction of the knee and main walls.

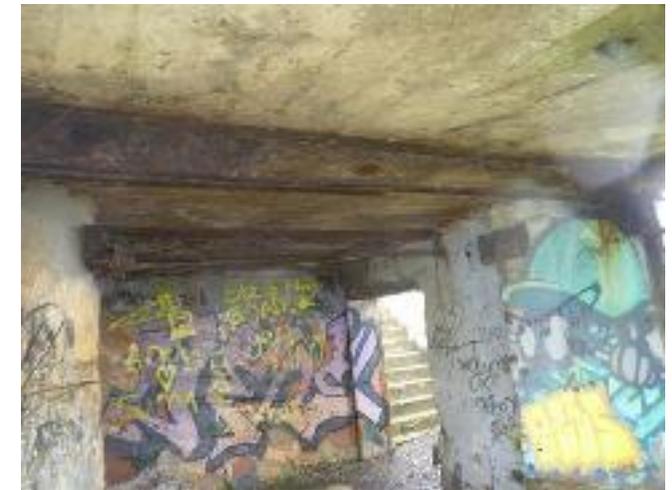
Deteriorated girders and graffiti.

It is imperative that the structure is fenced off, temporarily supported and relevant signage installed as soon as possible, pending a full structural appraisal and consideration of recommendations presented for remedial works..

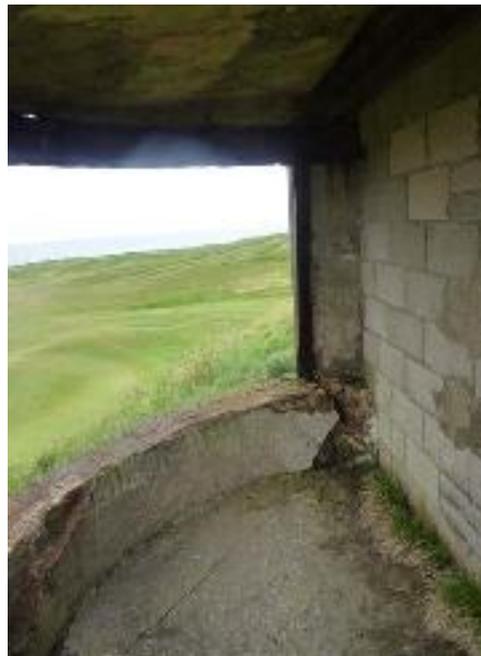
Subsidence cracking

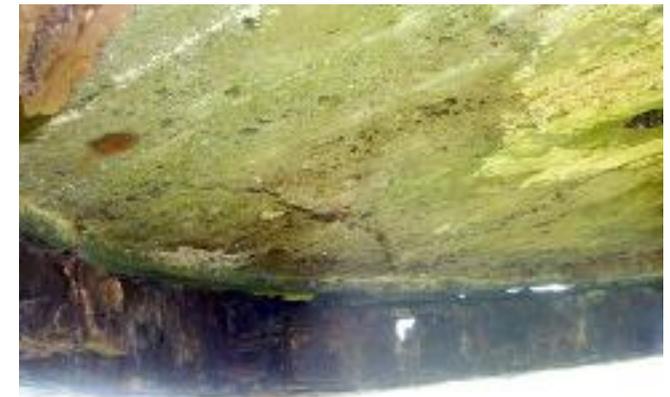
Crack on soffit

It would be beneficial for the concrete cover be removed, reinforcements treated or provided with cathodic protection as necessary and concrete repairs completed.

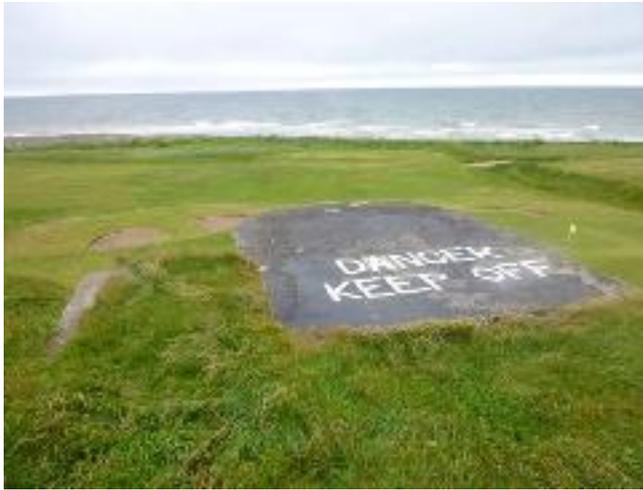
Roof of Emplacement with backfilled stair

It would be beneficial to provide balustrading to restrict access to the roof.

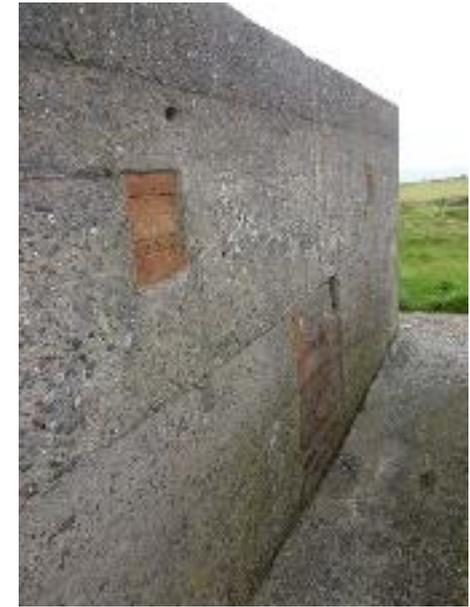
Brick up entrance to pill-box

It may be beneficial to remove concrete and brick in-fill to ventilate the structure and allow further interior inspection. Discreet grilles may be provided for security.

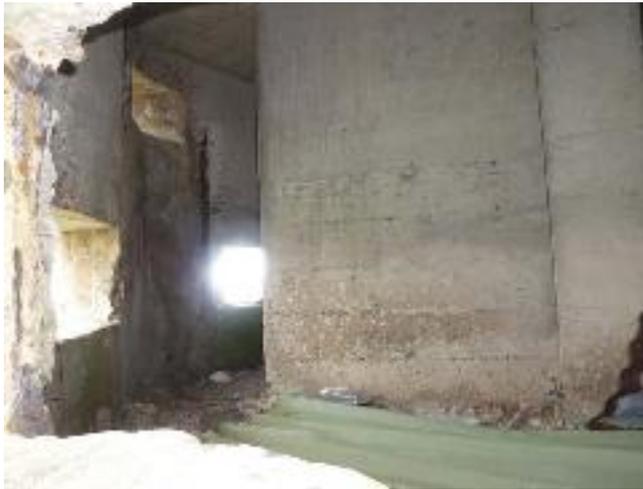
Interior of pill-box

There are signs of unauthorised access. The interior should be cleared of debris.

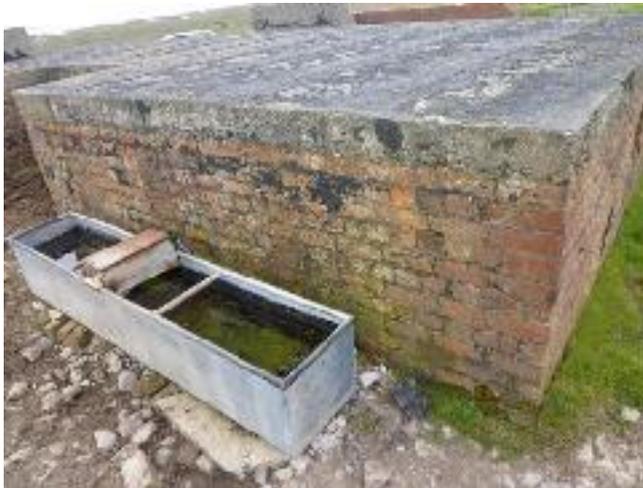
Structurally the building is stable, however there is severe spalling to the brickwork, most likely due to the high water table and rubbing of livestock who shelter around the building.

Spalling brickwork near water trough

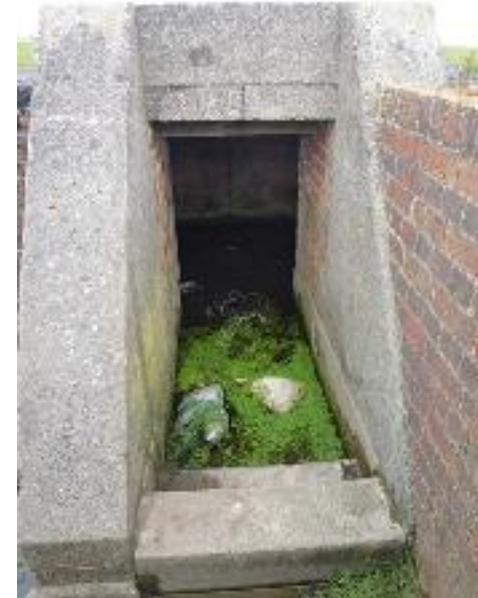
Flooded interior:

Provision could be made for archaeological investigations to explore the extents of the decoy installation in the surrounding area.

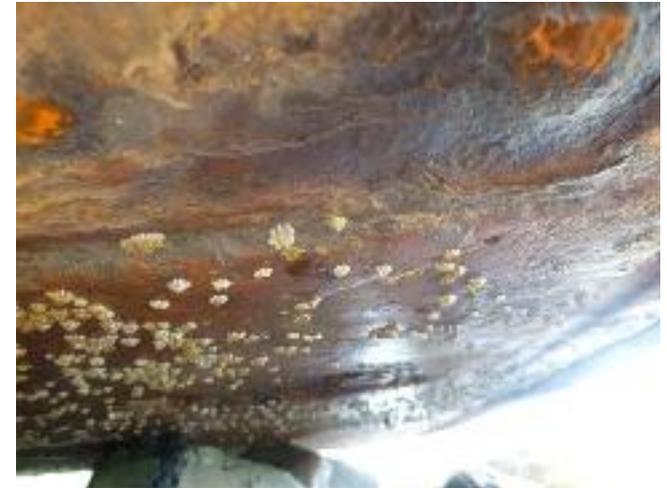
Corrosion to tray

It is recommended that the slabs are recorded and consideration given to relocating them.

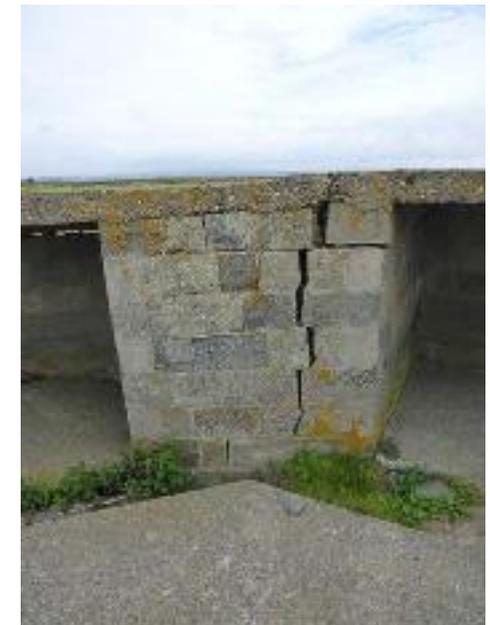
Large structural crack in wall

Due to the extremely poor build quality and current condition of the battery, we recommend that works to record and make the building safe are completed and it is the view of the conservation architect that, following full consultation with the landowner, stakeholders and advisory bodies that consideration should be given to managed decline.

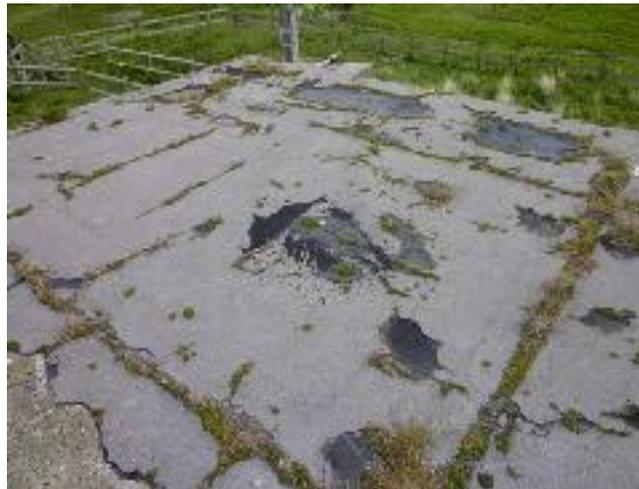
Asphalt roof

There are remnants of a steel framework on top of the roof slab, indicating that historically a roof mounted structure or mast was present. It is recommended that these should be recorded and removed.

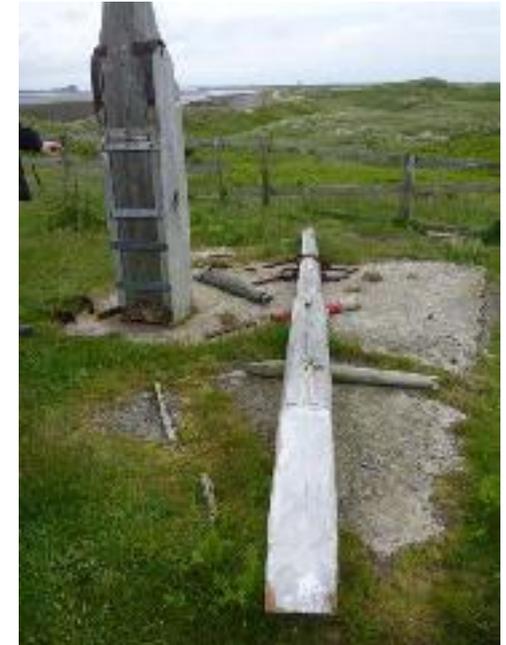
Adjacent to the pill-box is a flag pole, the top half of which has been taken down and is lying on the ground. The pole requires full repair if reinstatement is intended.

Flag pole

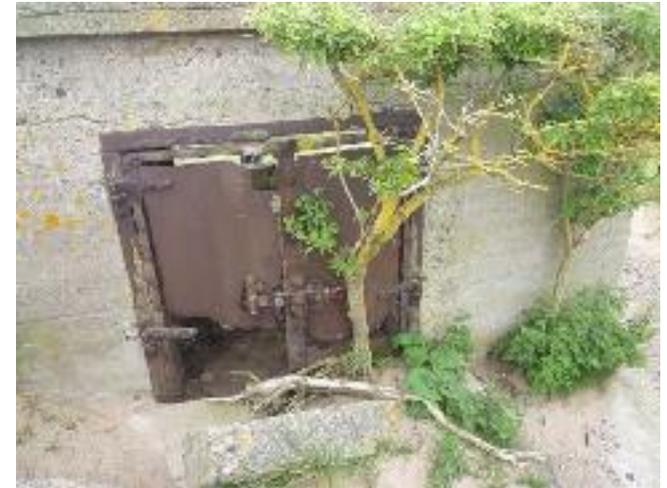
Corrosion to the doors

Reinforcement to the roof slab should be treated or provided with cathodic protection and concrete repairs undertaken.

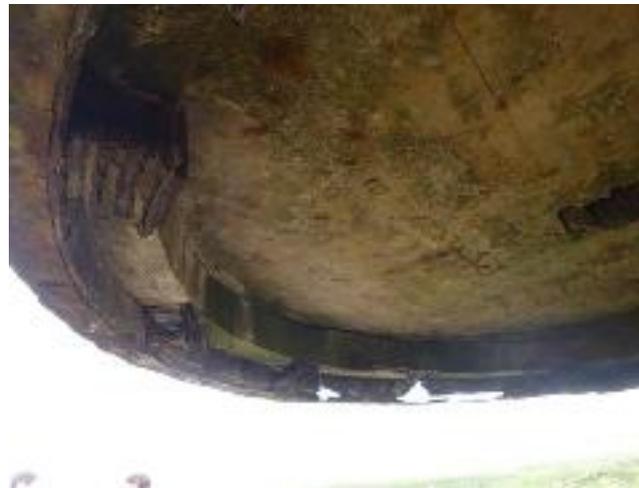
Corrosion to cantilever I-beam

It is advised that the concrete down-stand should be investigated by a structural engineer and removed or repaired as necessary.

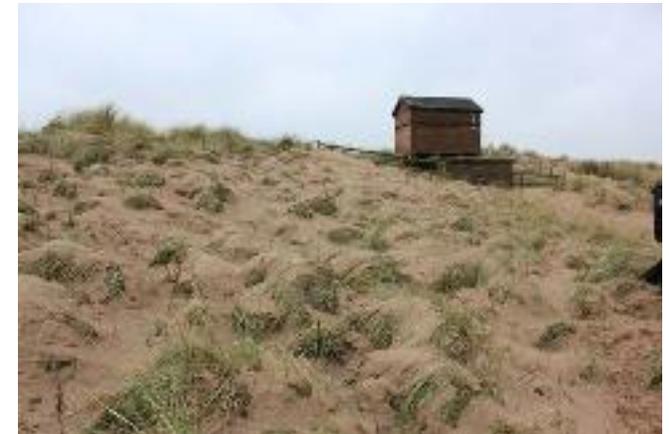
Emplacement

Shifting dunes have caused the battery to have become largely buried meaning that most of the exterior could not be inspected. This may have protected the structure and although corrosion is present this is not as advanced as the northern emplacement.

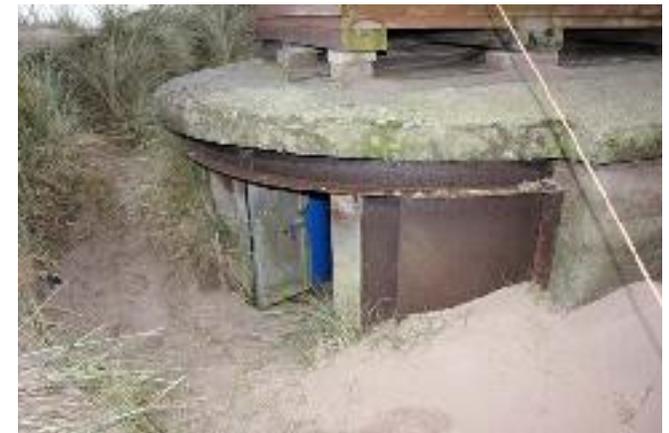
The emplacement at present is used as a storage facility with a lockable door giving access to the interior. Similar to the previous sites, reinforcement to the concrete roof slab is exposed and it is advised that these undergo treatment or cathodic protection prior to completion of minor concrete repairs.

Entrance and roof

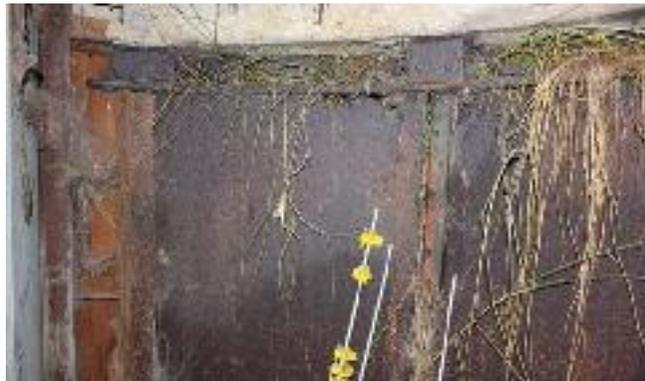
Original Metal Shutters

It is recommended that the doors should be cleaned back and treated with a corrosion inhibitor.
