# Hampsfell Hospice PHASE I CONSERVATION STATEMENT

I<sup>II</sup> Issue 4 PURCELL October 2015

This report will cover Hampsfell Hospice and its setting at the top of Hampsfell in Cumbria. As a phase I report, it will provide a summary understanding of the building, will discuss the setting in order to put the structure into its physical and historical context and will include an initial assessment of suitability with a commentary on condition and potential future uses. This will inform the conclusion as to whether it is appropriate to take the site forward to the full conservation statement stage.

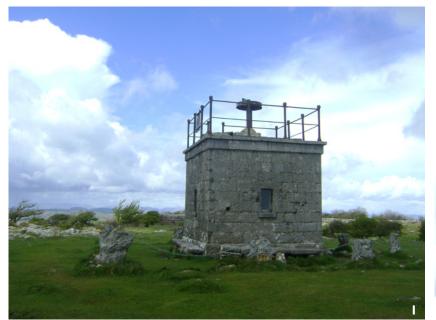
Hampsfell Hospice is a single storey square structure with even proportions. It is constructed of dressed limestone and has deteriorating stone benches around its base. Twelve limestone blocks support an iron chain fence surrounding the building. The entrance to the Hospice is in the east elevation and has an iron gate with freize above, containing the Greek lettering, "RODODAKTYLOS EOS" (Rosy-fingered Dawn; a quotation from Homer). The north, south and west elevations each have a small rectangular window. Stone steps with a handrail project from the north elevation. These steps lead to the flat roof, which is surrounded by iron railings. At its centre is a turntable which indicates landmarks visible from the Hospice (a board attached to the western railings provides a key). An iron pipe projects through the south west corner and appears to be connected to the fireplace below.

- I South and west elevations
- 2 View from the Hospice
- 3 North elevation

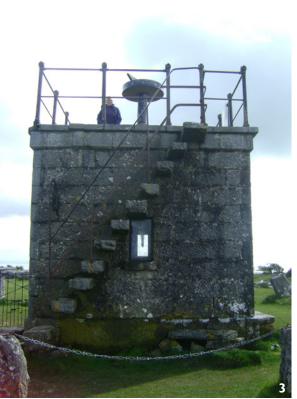
The external walls are in good condition. However, due to prevailing weather algal growth is present to the north and west elevations. The stone benches to the base have either failed or are deteriorating. A small section of iron pipe projects through the wall to aid the chimney to draw. The modern iron gate at the hostel entrance is in fair condition, but consideration could be given to redecoration.

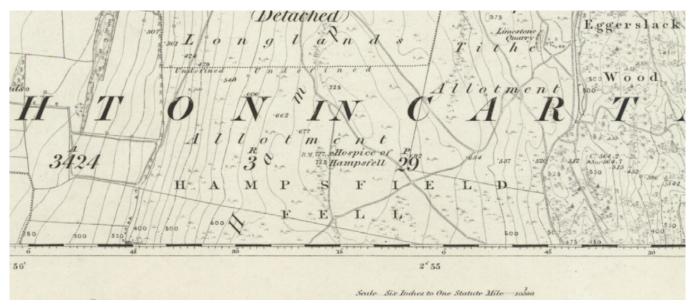
1851 Ordnance Survey

The Hospice (Lake District HER No 16137) was constructed between 1835-46 for Rev T. Remington, as a shelter for walkers on the fell. It is apparent on the First Edition Ordnance Survey, published in 1851 and is marked as 'Hospice of Hampsfell'. Several photographs exist from the Victorian and Edwardian eras, which although all undated, underline the importance of the Hospice as a popular stopping off point for those taking walks in the area. The photos show a subject posing on the roof or steps of the Hospice and the structure itself is very similar to how it stands today. The differences are that the turntable on the roof is not visible in any of the available historic photographs, suggesting that it was added in the twentieth century, perhaps at the same time that repairs were carried out to the roof. The other change is that the current gate at the entrance to the Hospice is a modern addition, replacing the one standing in the historic photos.

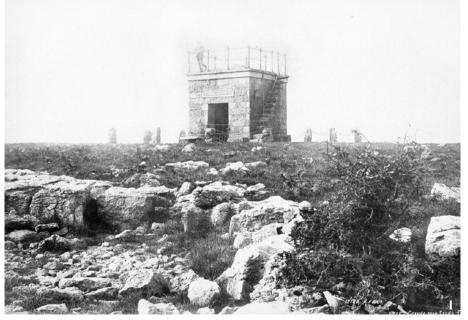
Historic photographs of the Hospice, dates unknown
