Hampsfell Hospice

PHASE 2 CONSERVATION STATEMENT

Issue 2

June 2016

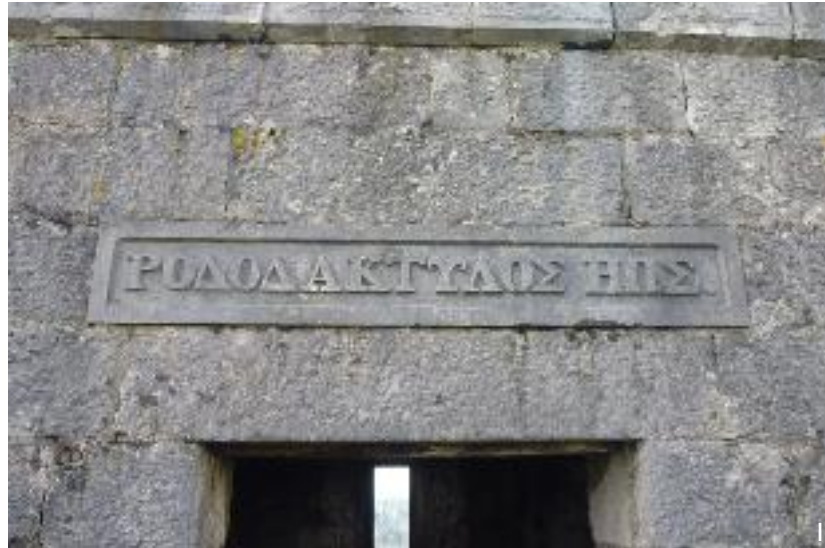
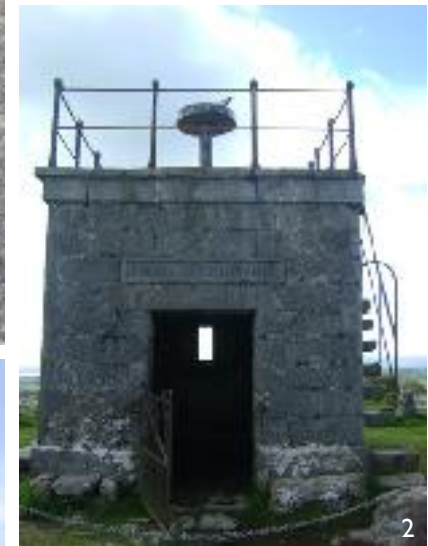
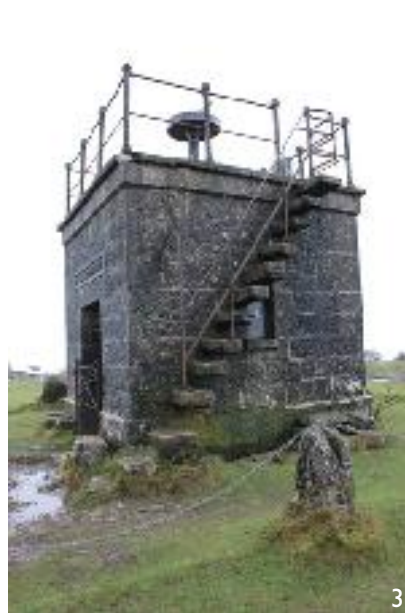
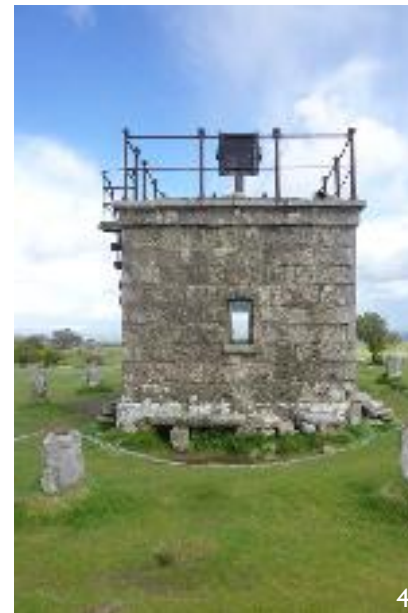
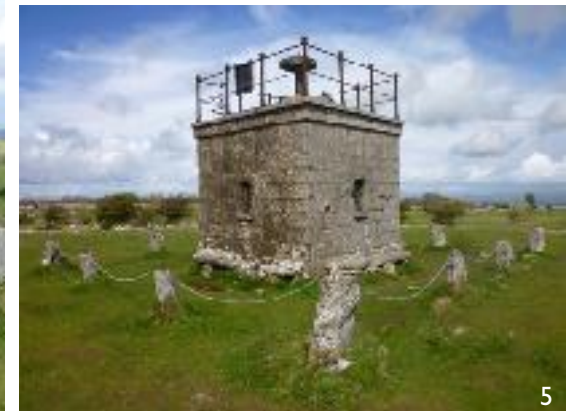
EXTERIOR

Hampsfell Hospice is a single storey square structure with even proportions. It is constructed of dressed limestone and has deteriorating stone benches around its base. Twelve limestone blocks support an iron chain fence surrounding the building. The entrance to the Hospice is in the east elevation and has an iron gate with frieze above, containing the Greek lettering, "RODODAKTYLOS EOS" (Rosy-fingered Dawn; a quotation from Homer). The north, south and west elevations each have a small rectangular windows with single light casements covered in polycarbonate sheeting. Cantilevered stone steps with a handrail project from the north elevation. These steps lead to the flat roof, which is surrounded by iron railings with Gothic detailing. At its centre, mounted on a limestone block, is a turntable which indicates landmarks visible from the Hospice (a board attached to the western railings provides a key). An iron pipe projects through the south west corner and appears to be associated with the chimney.

The entrance door in the eastern elevation has an iron gate, possibly to keep out unwanted sheep or cattle. Internally, there is a single room with the fireplace located in a canted angle in the south west corner and a recess in the corresponding canted angle in the north west corner. Black boards with white lettering to all sides have a notice and three poems. Three are relatively modern replacements introduced by the Lake District National Park. The fourth appears to be older and is held up by rusting iron brackets. Small limestone benches run around the walls on the north, south and west sides. The walls are of limestone blocks, but a smooth concrete render has been applied to the lower half of the walls. The windows have slate sills and lintels in stone, timber and concrete (the timber and concrete are more recent replacement). The door has a timber lintel in poor condition. There are signs of graffiti around the walls. The floor is concrete.

- 1 Greek inscription above door
- 2 Entrance
- 3 North and east elevations
- 4 West elevation
- 5 Window with polycarbonate sheeting
- 6 South and west elevations

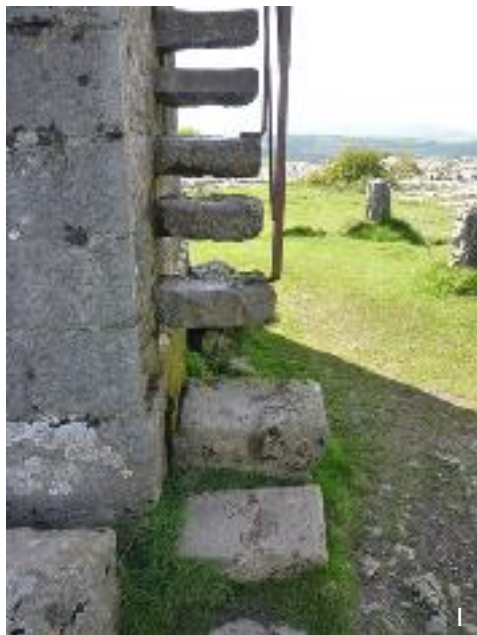
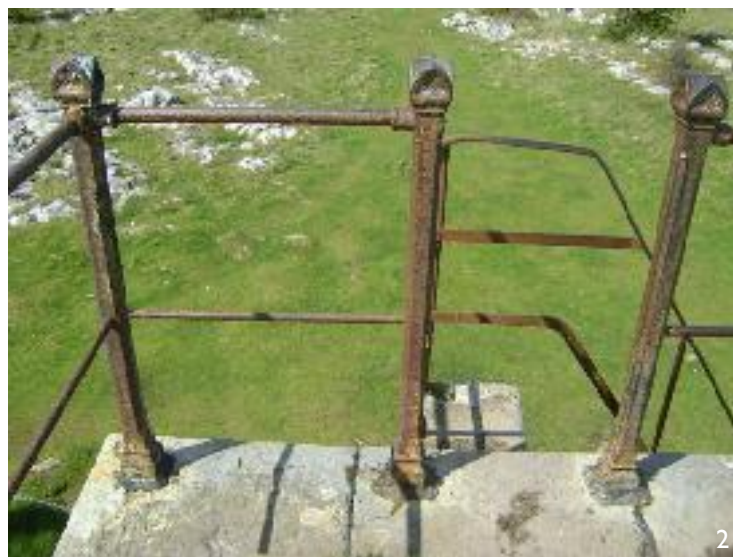
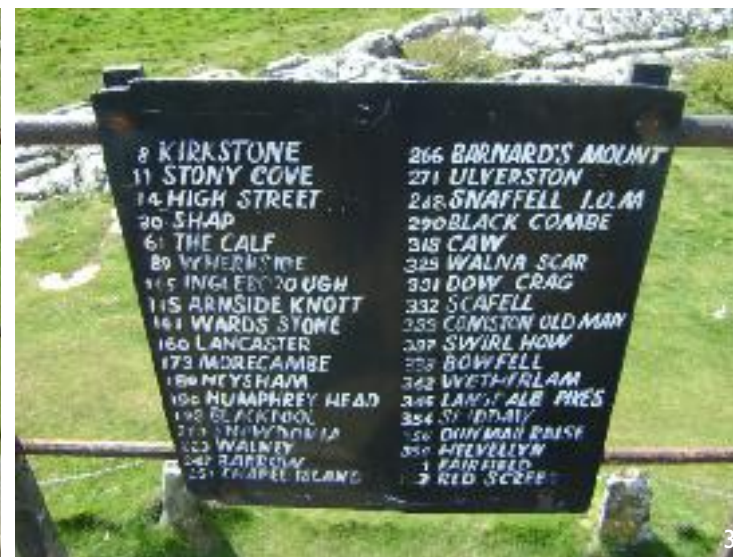
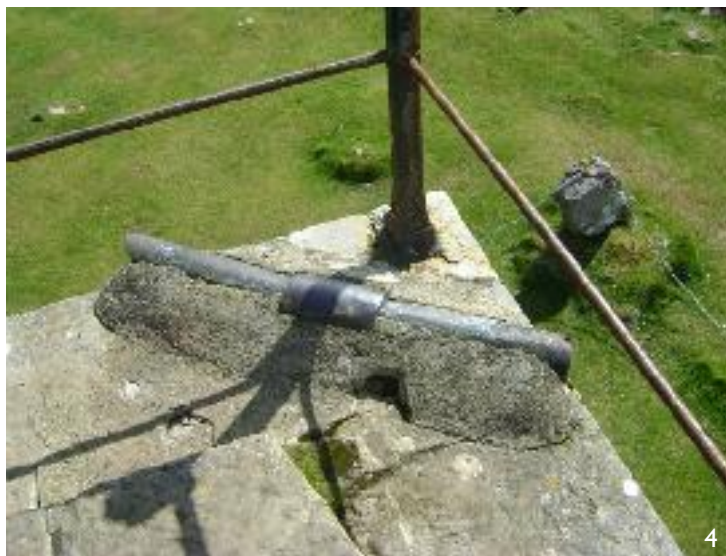
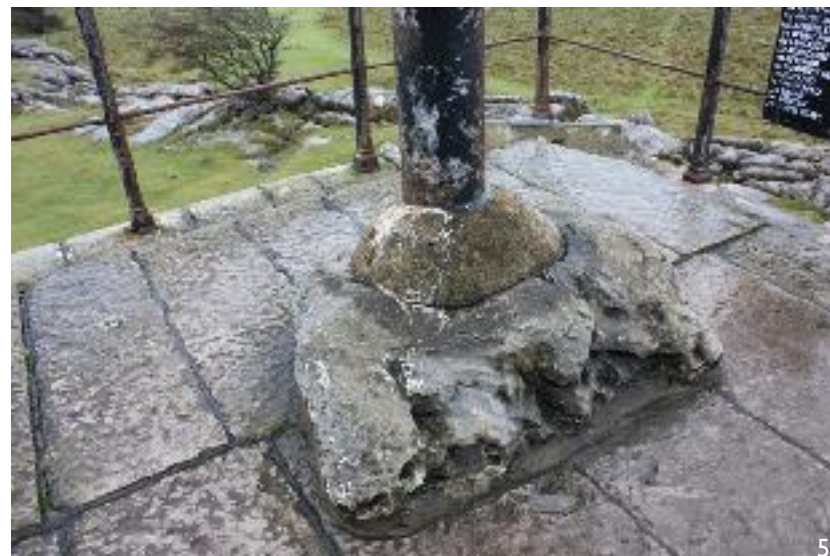
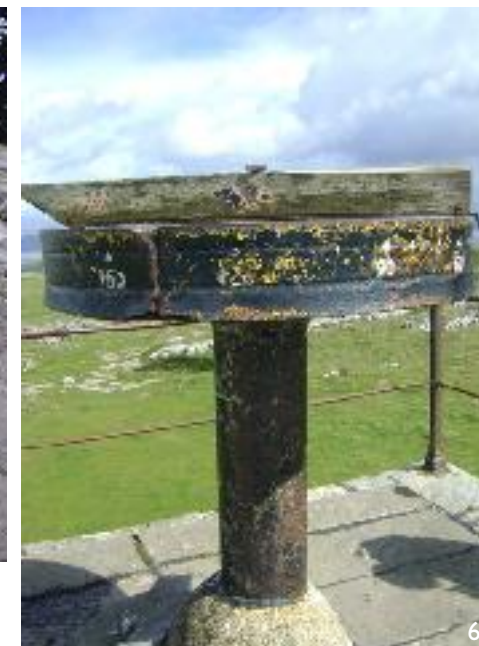
| 1 Cantilever steps | 4 The chimney |
| 3 Information board | 6 Direction Indicator |

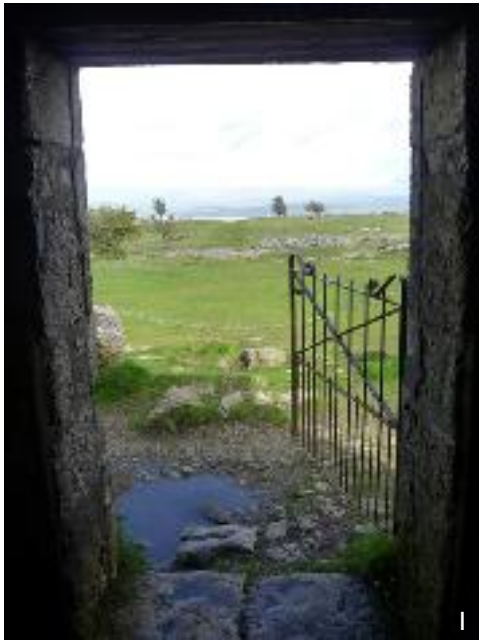
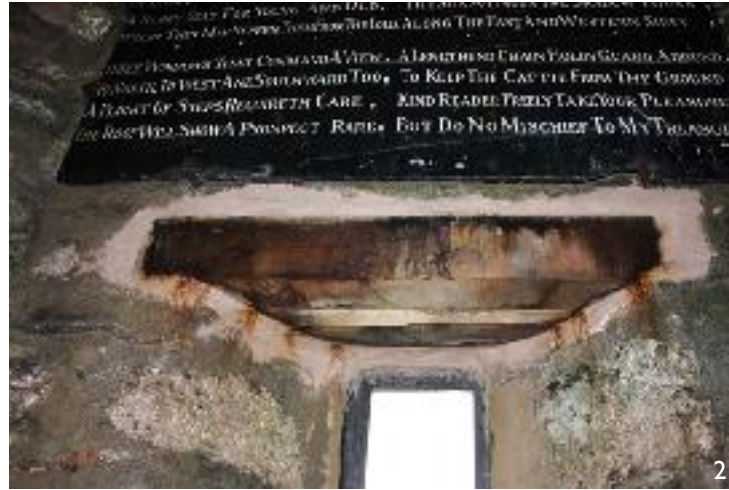
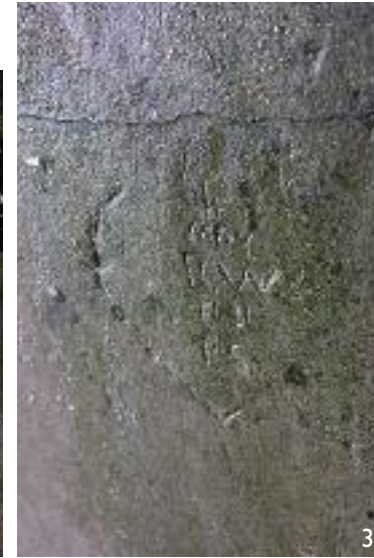
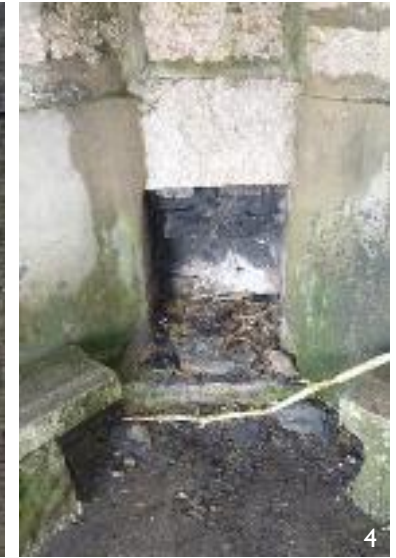
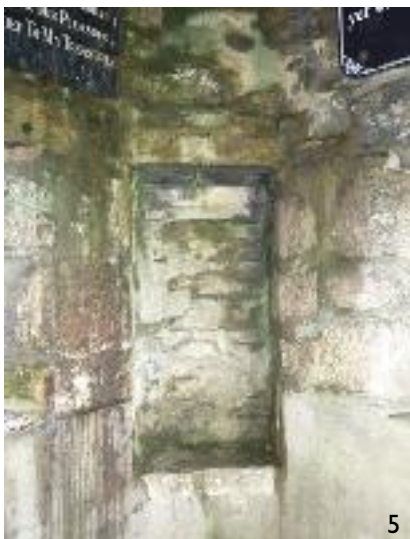
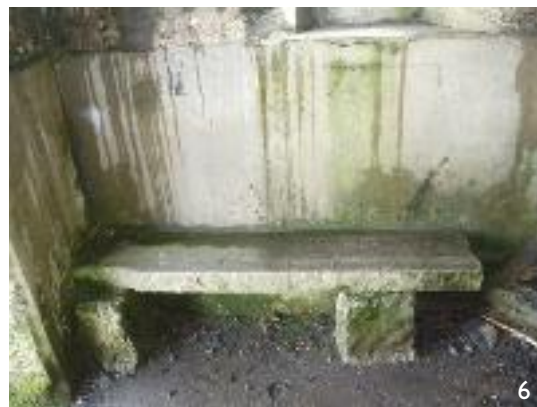
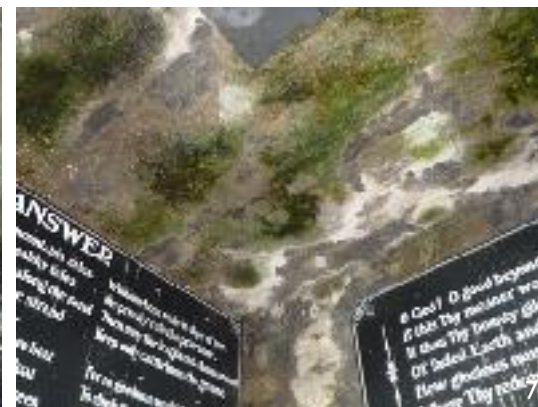
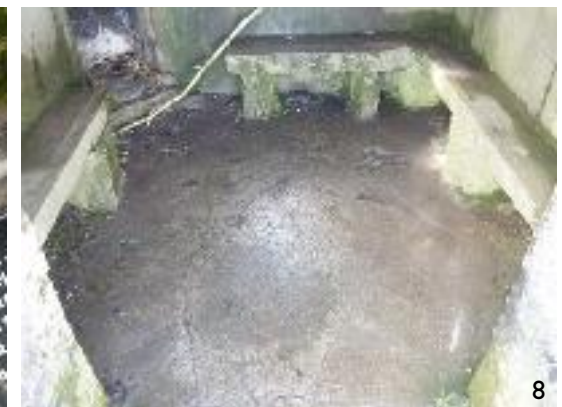
INTERIOR

1 View eastwards from the Hospice

2 New timber lintel

More recently, two window lintels have been replaced and stonework has been repointed.

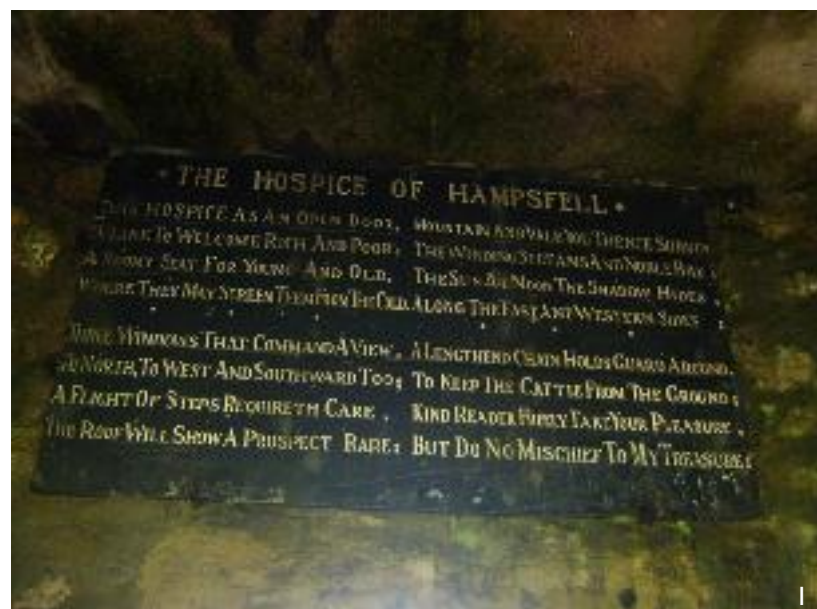
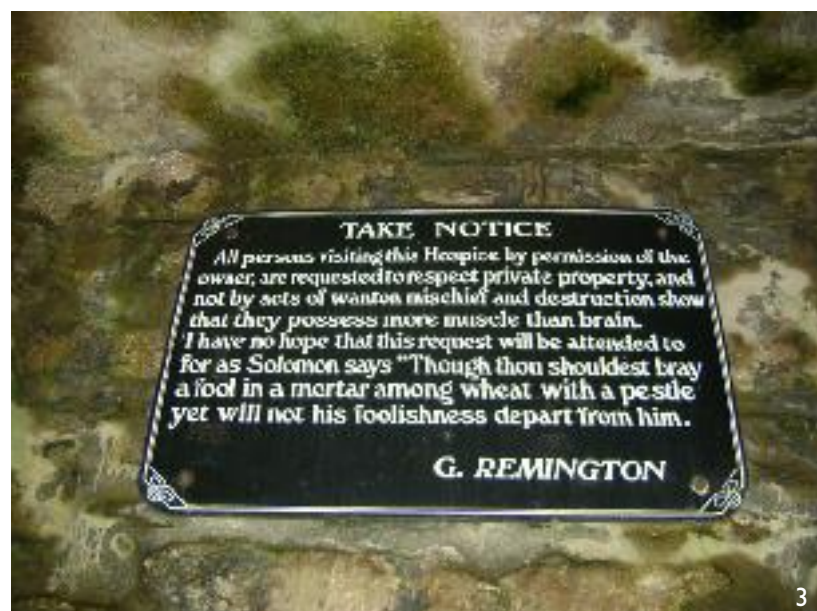
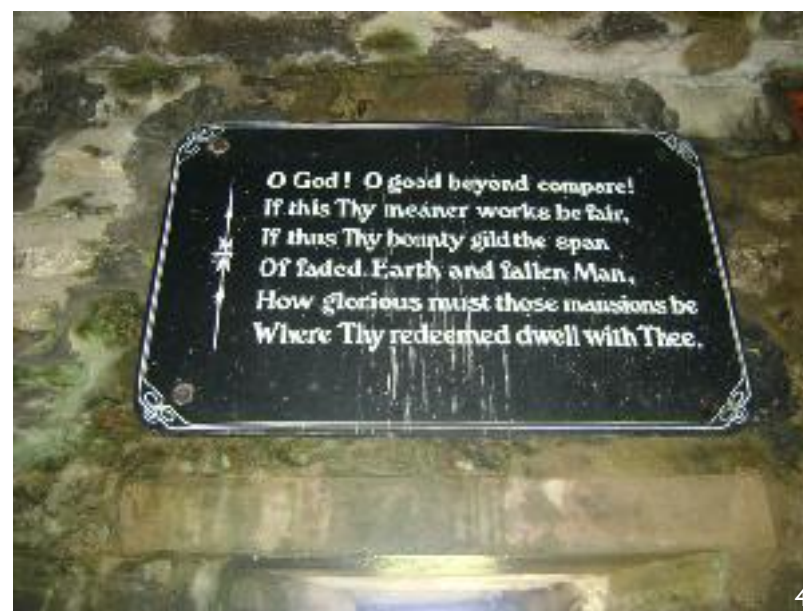
THE NOTICE BOARDS

- 1 The Hospice of Hampsfell (west wall)
- 2 The Answer (east wall)
- 3 Take Notice (north wall)
- 4 The Hymn (south wall)

Despite its limited size, all four walls have notice boards positioned high on each wall. Whilst 3 boards appear to have been replaced in modern times, the fourth appears to be of some age. It is thought that these notices have, at various times been added by the owners of the Hospice.

The '*Hospice of Hampsfell*' also tells us that the chain was installed around the Hospice to keep the cattle out – and is a very early arrangement. The style of script and condition of the board also indicates that the notice may be original, or at least an historic copy. The poem is not dated.

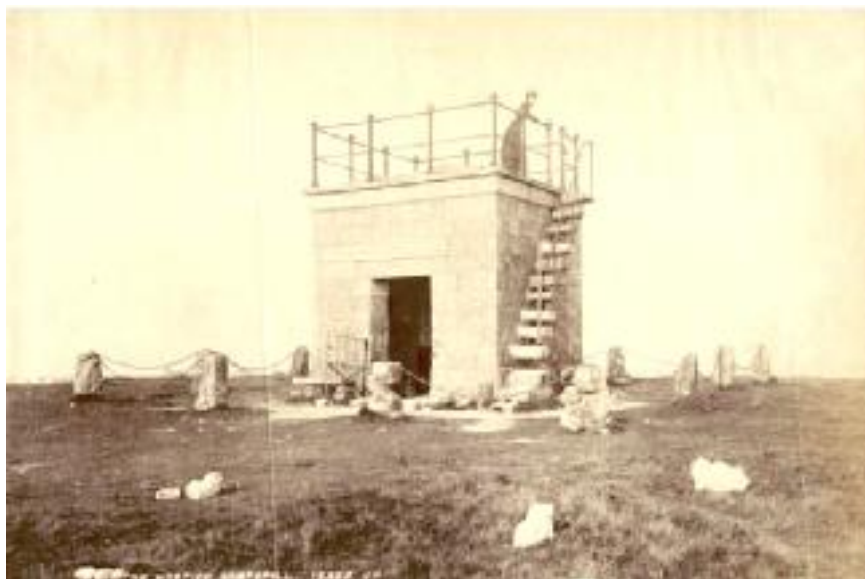
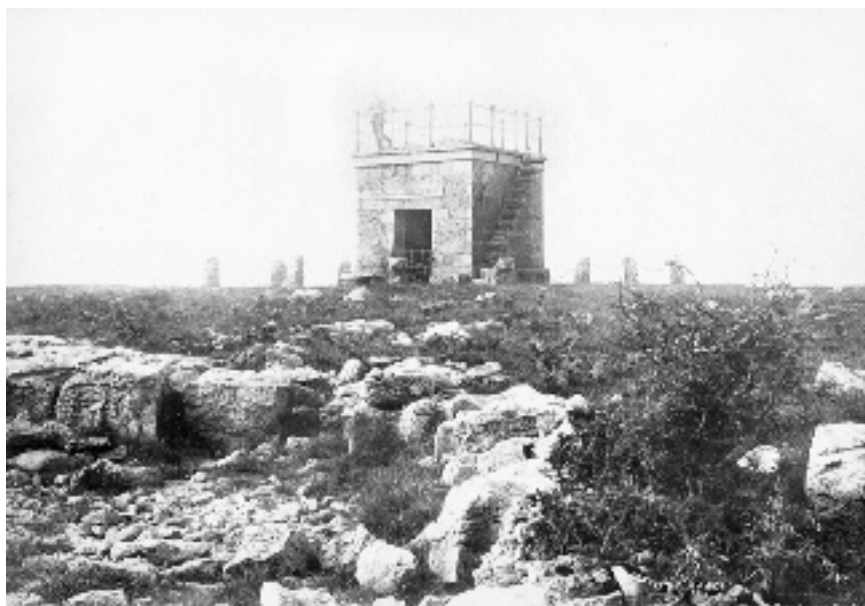
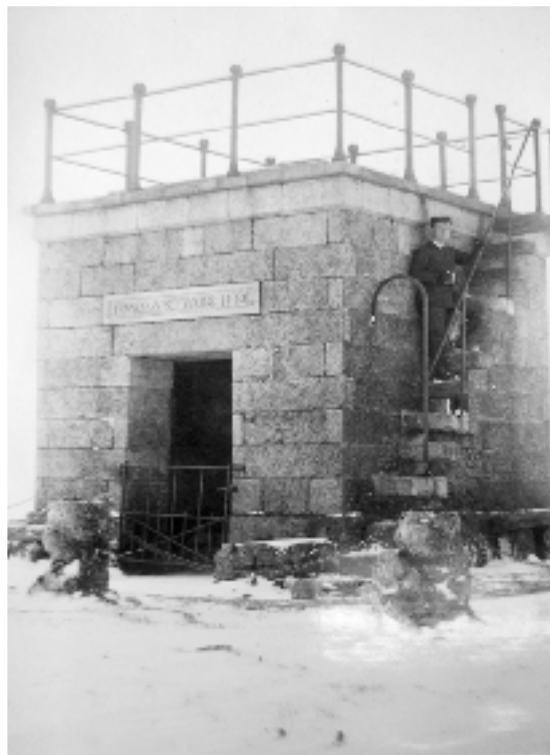
Historic photographs of the Hospice, dates unknown

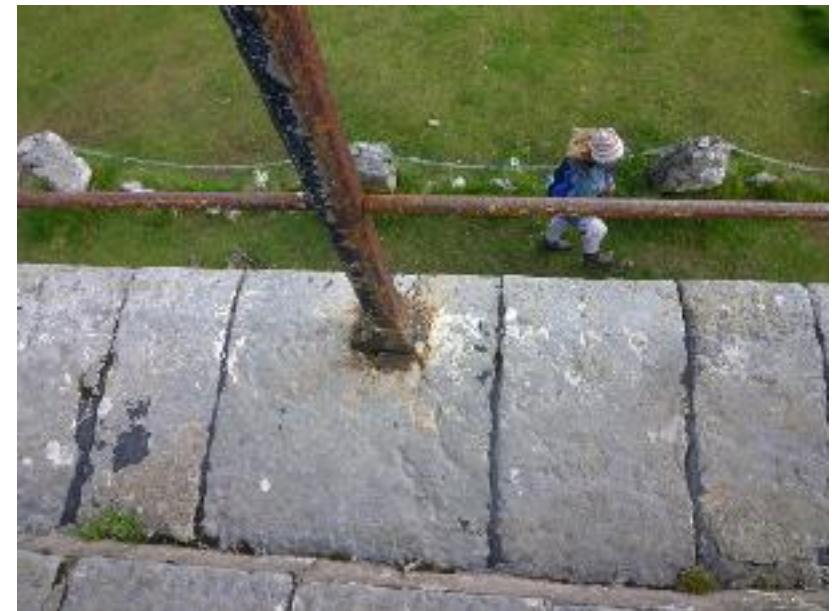
The roof consists of dressed limestone slabs jointed with bitumen, supported on what appears to be a modern concrete slab internally. The slabs to the perimeter of the roof over-hang the external walls, which sit on a flat band with chamfered bottom edge, giving the appearance of a simplified entablature to the structure beneath and acting as a plinth to the railing above. These limestones slabs appear to be in relatively good condition with minor wear apparent. Moss growth is prevalent at the joints due to water run-off and sitting water. A number of slabs have had cementitious mortar repairs to cracked slabs.

The roof leaks at present due to failure of the bitumen jointing. A comprehensive solution would be to lift the slabs and re-bed on a new membrane. Given the building's occasional use, it may be sufficient to rake out and renew the joints between the slabs in molten lead.

Existing failed bitumen joints.

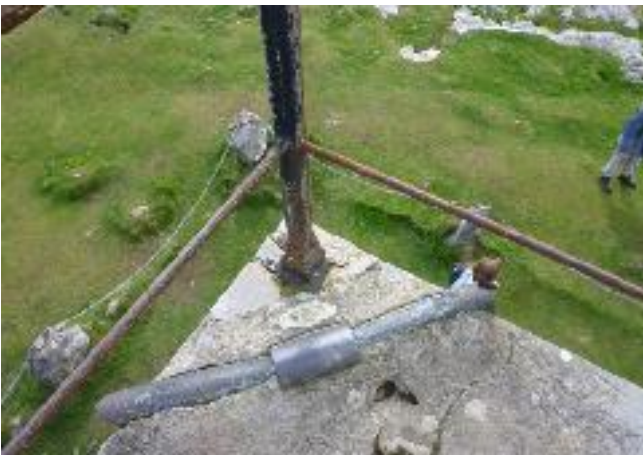
There is minor corrosion at the base of the stanchions, while not impacting on the stability of the railing itself this has caused spalling and fracturing to the limestone slabs beneath. It is recommended that the joints between the stanchions and slabs should be raked out and the corrosion treated. The joints would then be filled using molten lead and the cracked stones pinned with minimum 316 graded stainless steel pins.

Cracked limestone slab below railing stanchion and iron chimney flue.

The Gothic detailed railings on the top of the building are stable and in fair condition with only minor iron oxide present on the surfaces. Consideration should be given to cleaning down the railings and redecorating with a red oxide metal primer and additional coats of a hard wearing metal paint.

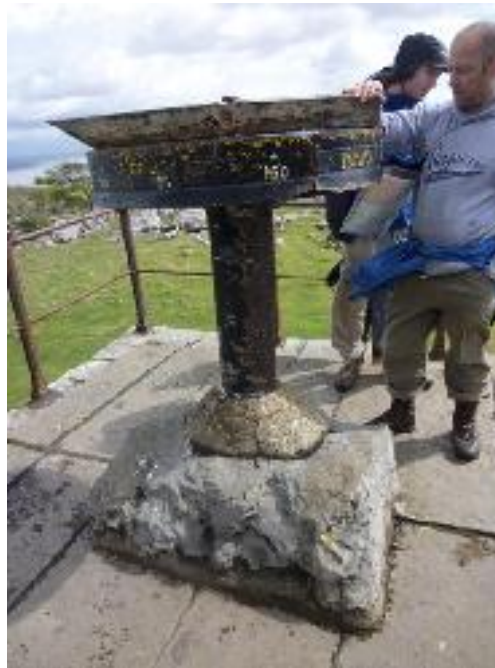
The direction indicator in the centre of the roof appears to be in fair condition. Consideration should be given to redecoration of the iron table.

The cement flaunching to the bottom of the base column appears to be in good condition with only hairline cracks.

The timber needle also appears to be in good condition with no apparent sign of rot. However, it is recommended that adequate protection is applied as soon as possible with a moisture permeable paint to minimise deterioration of the timber.

Direction Indicator

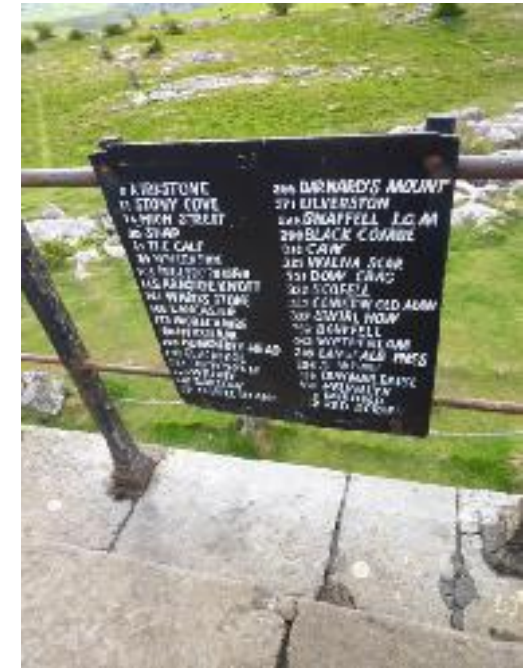
The direction indicator key affixed to the balustrade is in good condition but may require minimal decoration.

Direction indicator key sign requiring new fixings.

The fixings require attention as they are suffering from corrosion. An appropriate matching 316 graded stainless steel fixing is recommended to replace the existing.

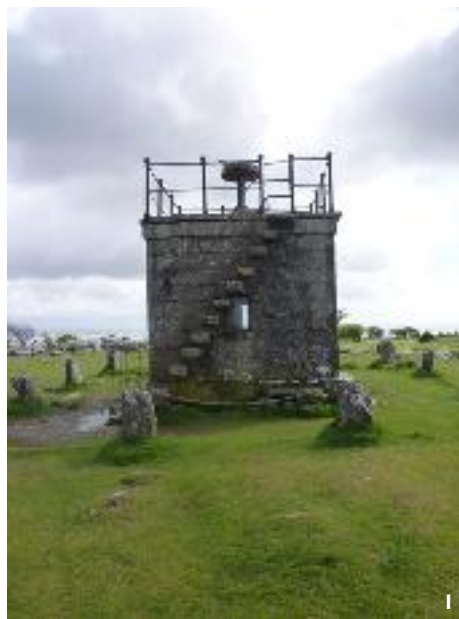
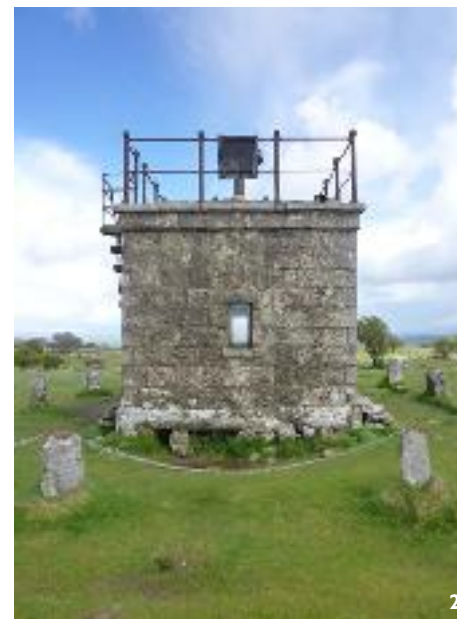
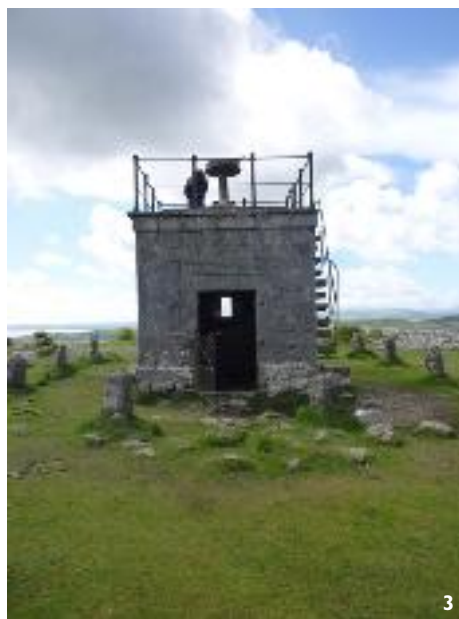
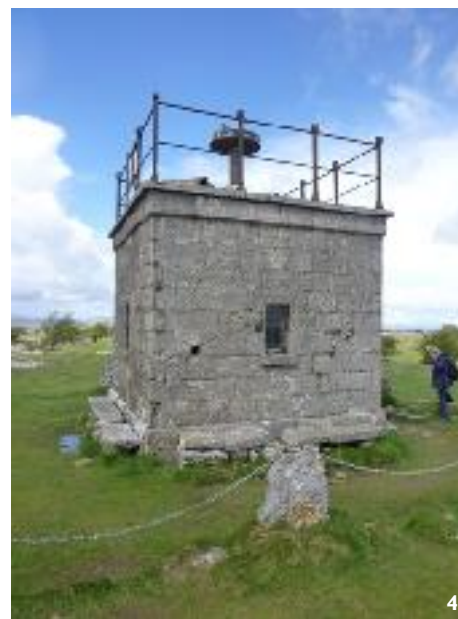
The external walls are in good condition with only a number of joints missing mortar. However, the existing cementitious pointing is advised to be raked out and replaced with a natural hydraulic lime mortar to allow the building to naturally dry out.

Run-off staining mars the north and east elevation and a gentle steam-clean is recommended.

The external benches have deteriorated and some slabs are already broken. It is recommended that existing bench tops are pinned with stainless steel pins.

The cantilevered stone steps to the north elevation are in fair condition. Iron oxide staining appears on a number of treads from rainwater run-off the spindles.

- 1 North Elevation
- 2 West Elevation
- 3 East Elevation
- 4 South Elevation

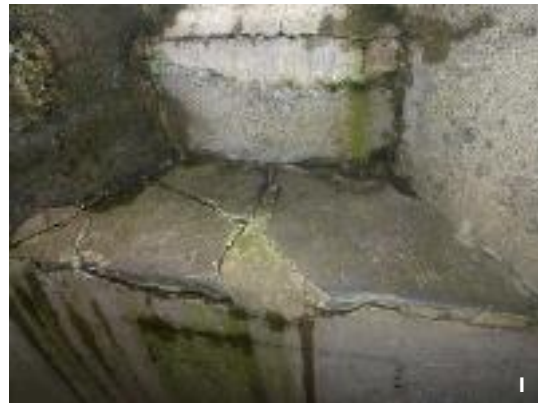
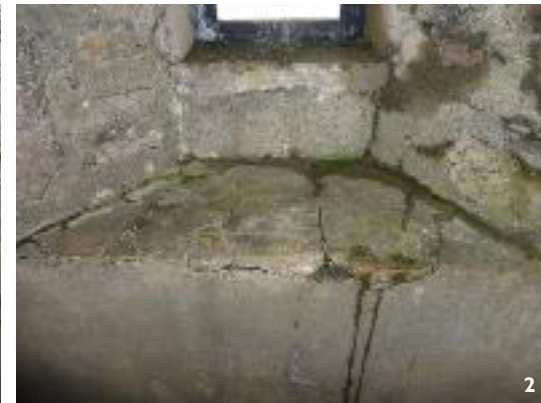
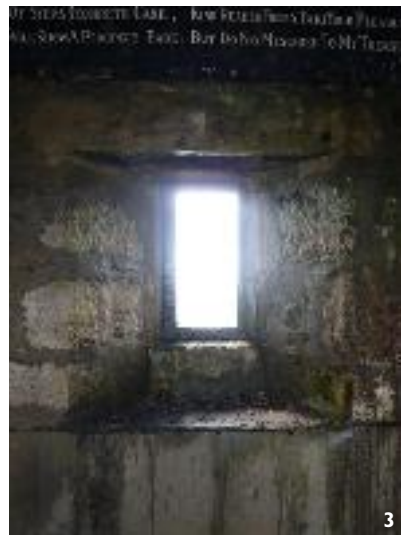
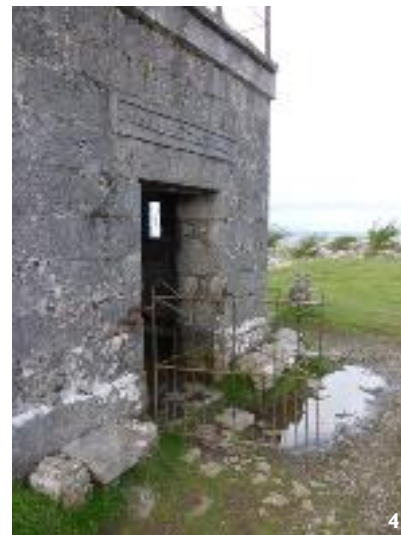
The existing stone sill has a number of cracks and a cementitious mortar repair. Their replacement is recommended.

The cement render sill could be removed and replaced with a stone sill to match the existing profile of other window sills.

The natural stone sill appears to be in good condition. It is recommended that debris is removed and the sill steam cleaned to remove algae growth. The existing timber lintel is completely decayed and could be replaced with a stone lintel to ensure ease of maintenance in future.

The timber lintel above the door opening has some decay and one of the three window lintels has failed. It is likely that the remaining rendered lintels have also failed and could be replaced in stone.

The modern iron gate at the hostel entrance is in fair condition, but consideration could be given to redecoration.

- 1 South Window Sill
- 2 North Window Sill
- 3 West Elevation Window
- 4 Entrance Gate

The existing timber lintel is coated in cementitious render and is likely to have decayed like the West Window lintel. It is advised to remove the timber lintel and replace with stone to minimise on-going maintenance.

The timber framed polycarbonate sheet to the window opening could be thoughtfully replaced in a sympathetic design to allow cross ventilation.

The existing timber lintel is coated in cementitious render and is likely to have decayed like the West Window lintel. It is advised to remove the timber lintel and replace with a stone lintel to ensure ease of maintenance in the future. The timber framed polycarbonate sheet to the window opening could be thoughtfully replaced in a sympathetic design to allow cross ventilation.
