Gleaston Castle, Gleaston, Cumbria

Results of Aerial Survey and Conservation Statement

Helen Evans and Daniel Elsworth
April 2016

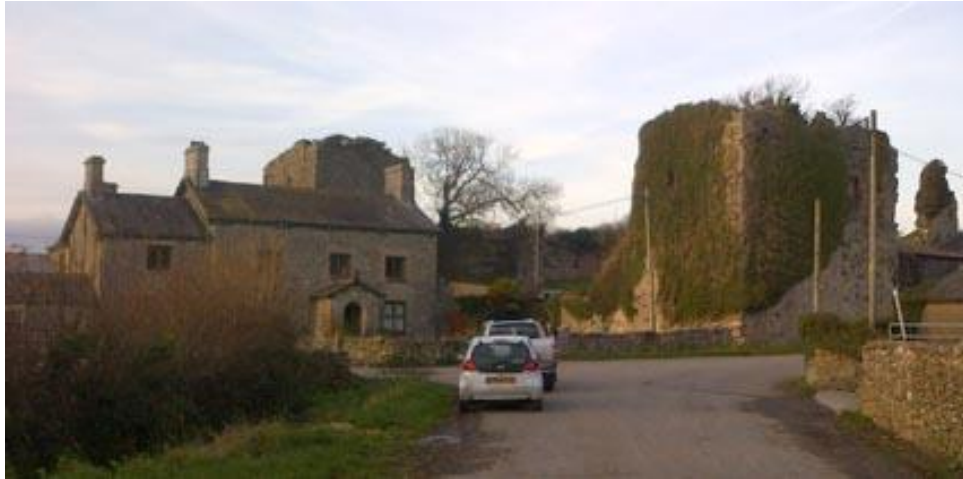
Plate 1: Gleaston Castle (south east tower in foreground) and farmhouse

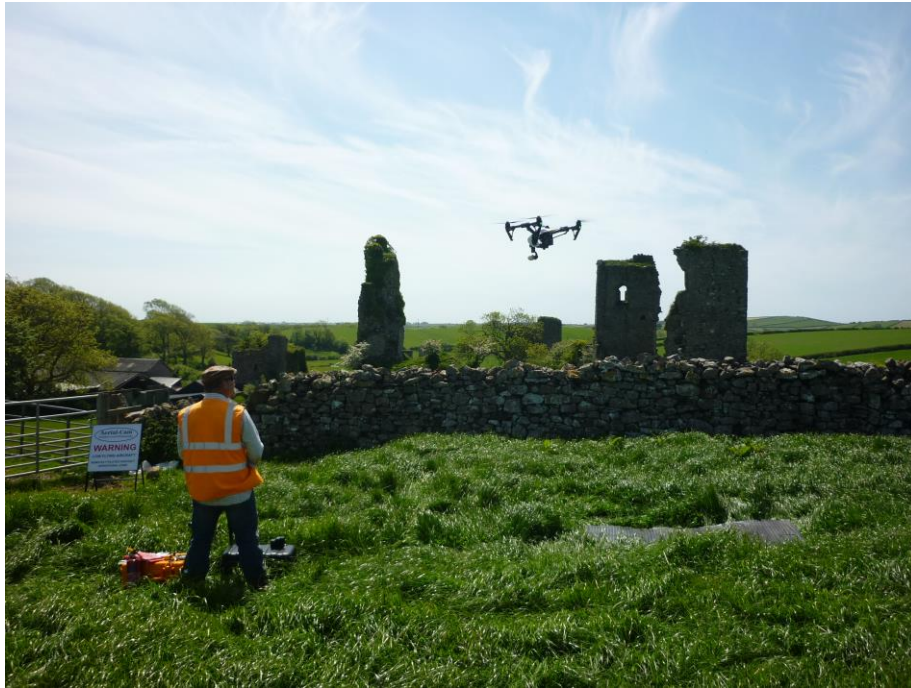
Plate 2: UAV survey being undertaken by Aerial-Cam

- 1.2.3 This survey enabled recording of standing remains of Gleaston Castle to be carried out using an Unmanned Aerial Vehicle (UAV, Plate 2) and other remote photographic survey techniques, as well as more traditional total station survey of the earthworks and plan of the standing elements of the castle. This work was carried out in 2015 by Aerial-Cam and Greenlane Archaeology and has enabled the production of a full 3D model of the entire structure and rectified images of the principal elevations (see Plates 3 to 5).

comprised the use of an unmanned aerial vehicle (UAV; Plate 2) but also a high-level telescopic pole and more traditional ground-based photography. This was accompanied by an earthwork survey completed by Greenlane Archaeology using a total station (Plate 3).

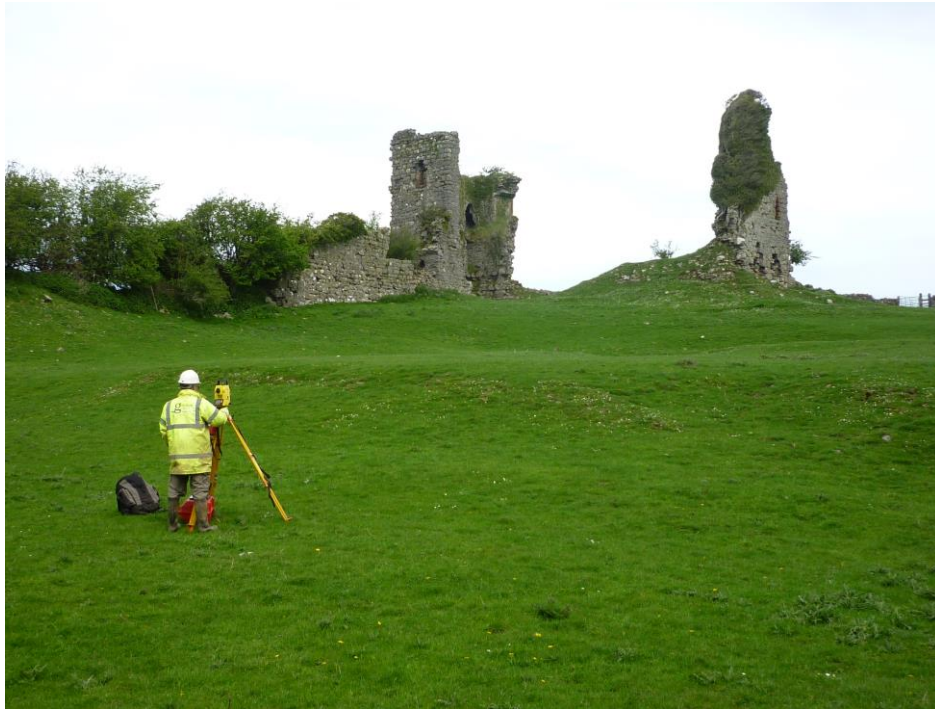
Plate 3: Total station survey being undertaken by Greenlane Archaeology

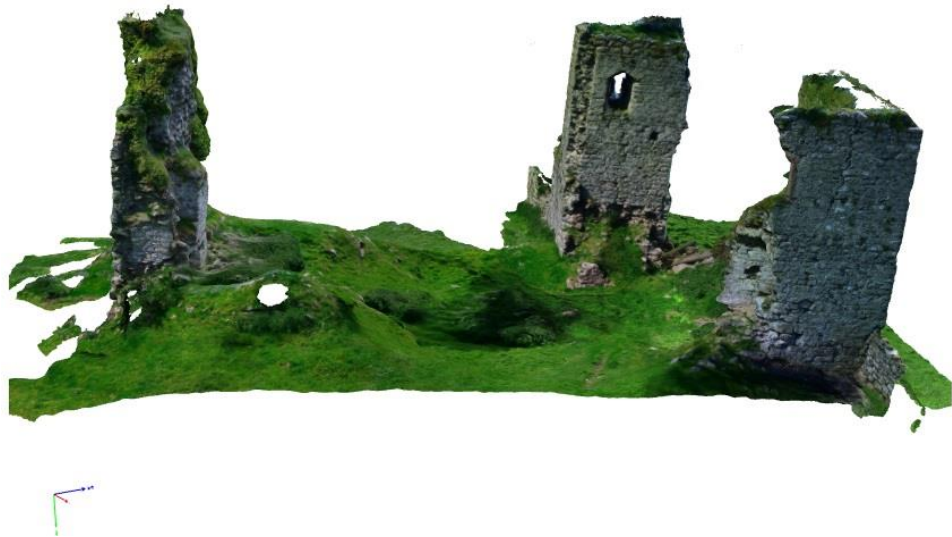
Plate 4: 3D view of the remains of the north tower

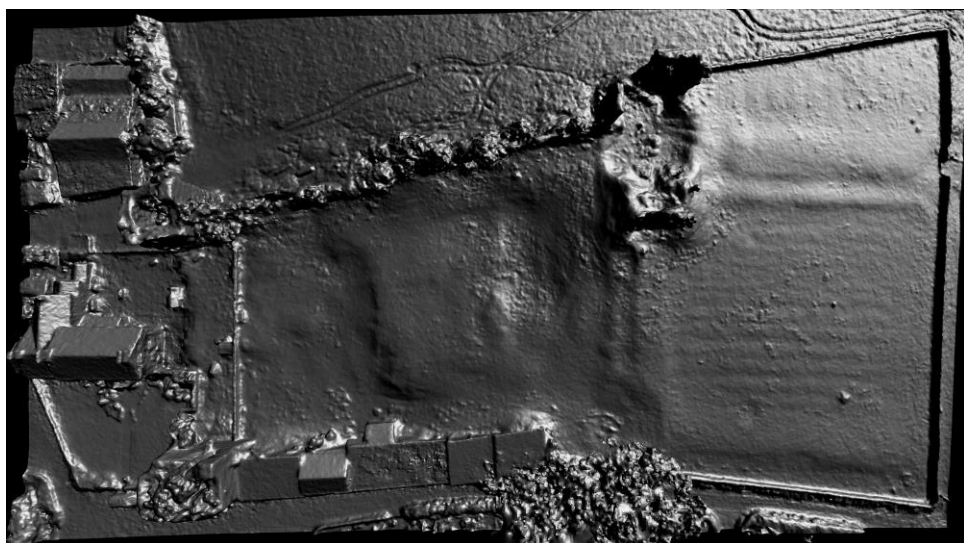
- 1.5.3 The data captured has also been shaded to show details of the earthworks (Plate 4). The data collected during the survey will be archived with the Archaeological Data Service (ADS).

Plate 5: Shaded view showing the earthworks across the site

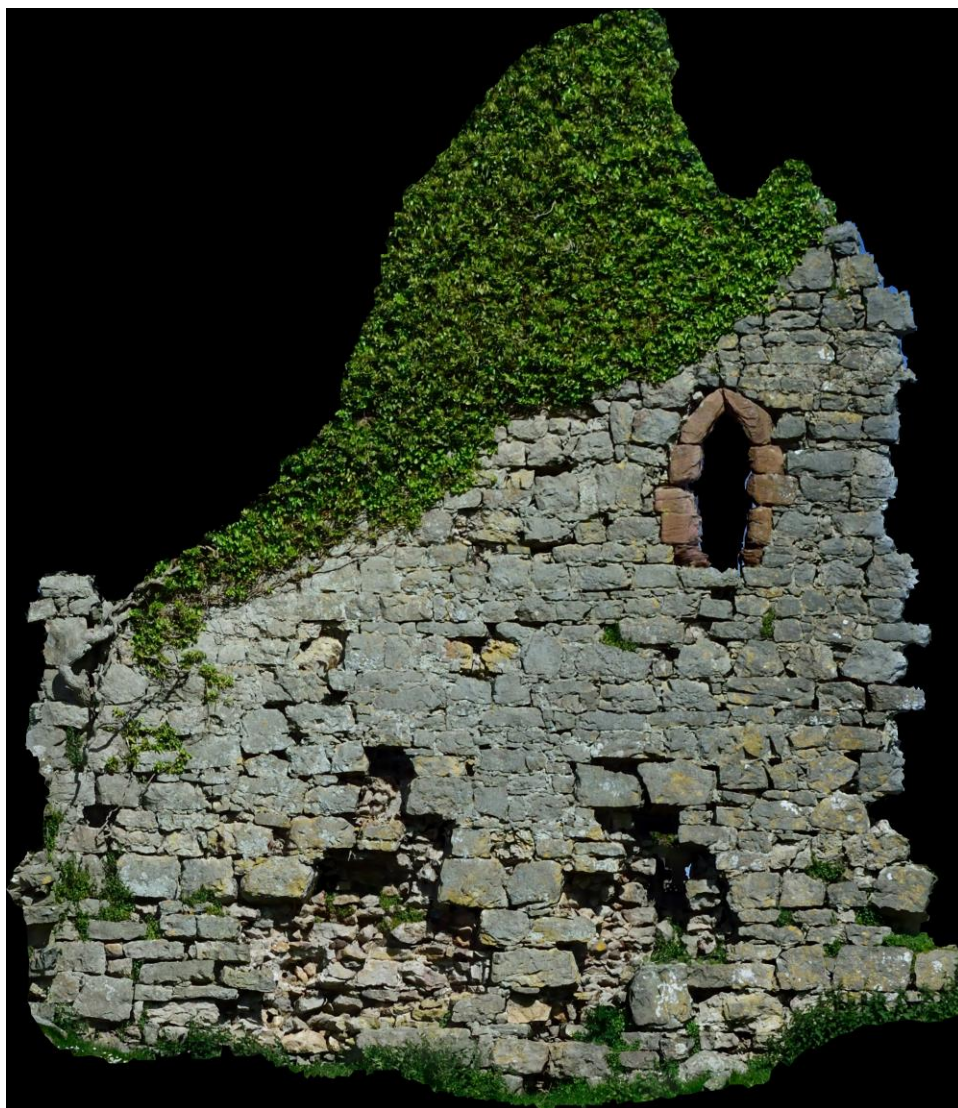
Plate 6: Rectified view of part of the north tower

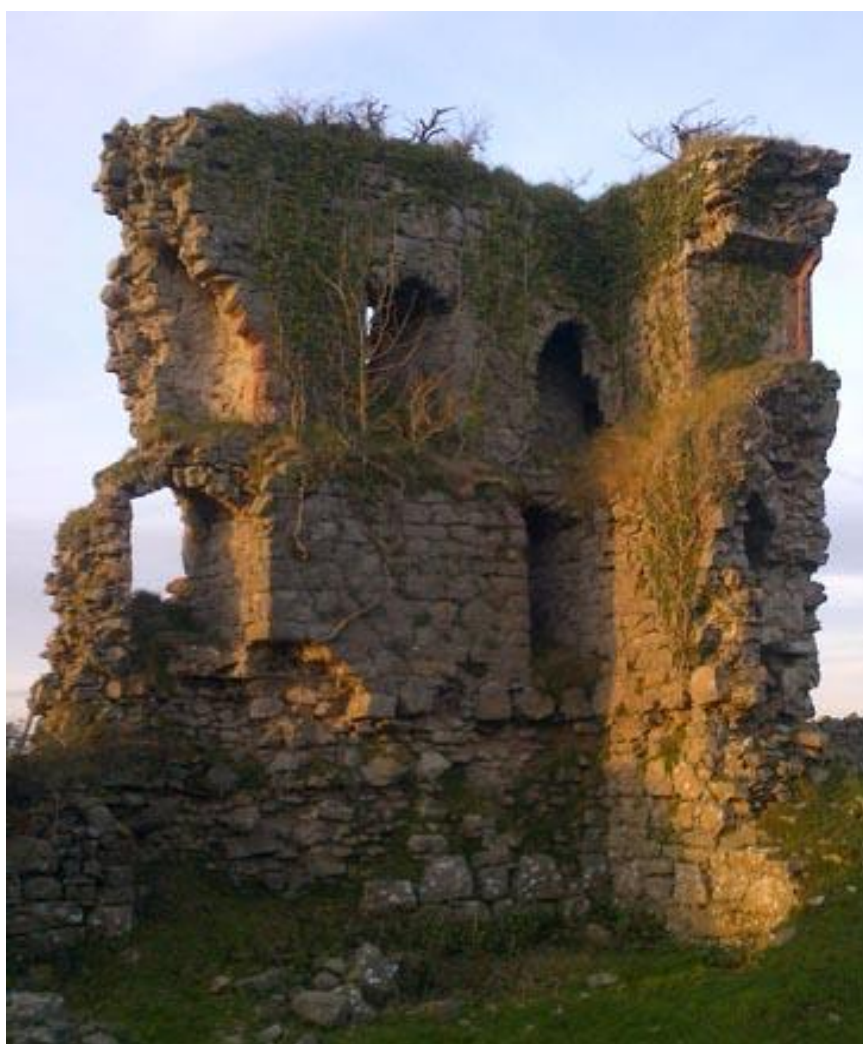
Plate 8: Corner section of the north west hall

- 2.1.1 The site incorporates two square corner towers at its southern extent with a third much larger structure, the manor or hall house, at the north west (Plates 7 and 8). The north eastern tower is identifiable as an earthwork. The buildings were set in a rough quadrangle surrounding an open central area and were connected, but not surrounded, by substantial curtain walls (Figure 4).

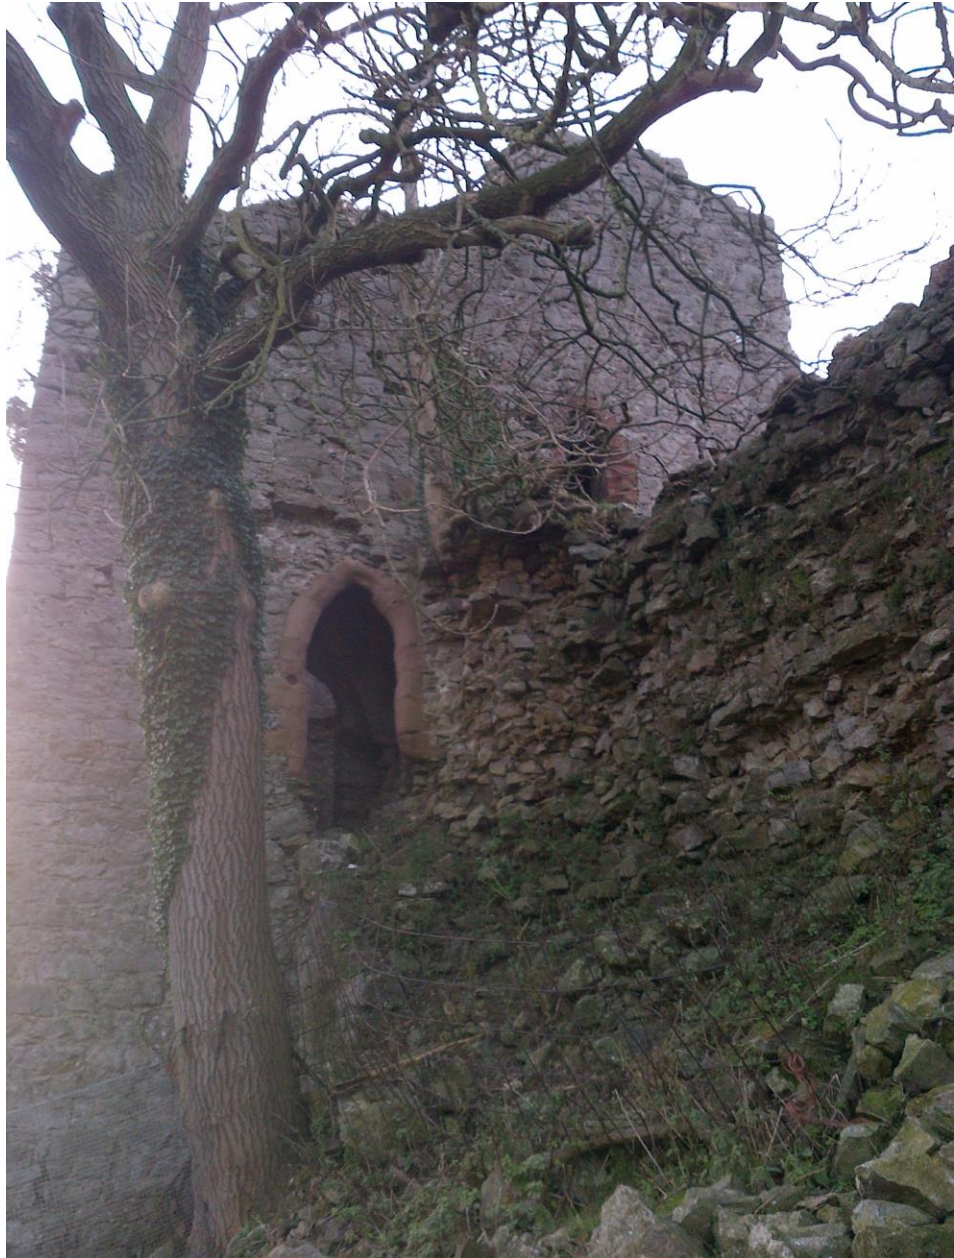
Plate 9: South west tower and western curtain wall

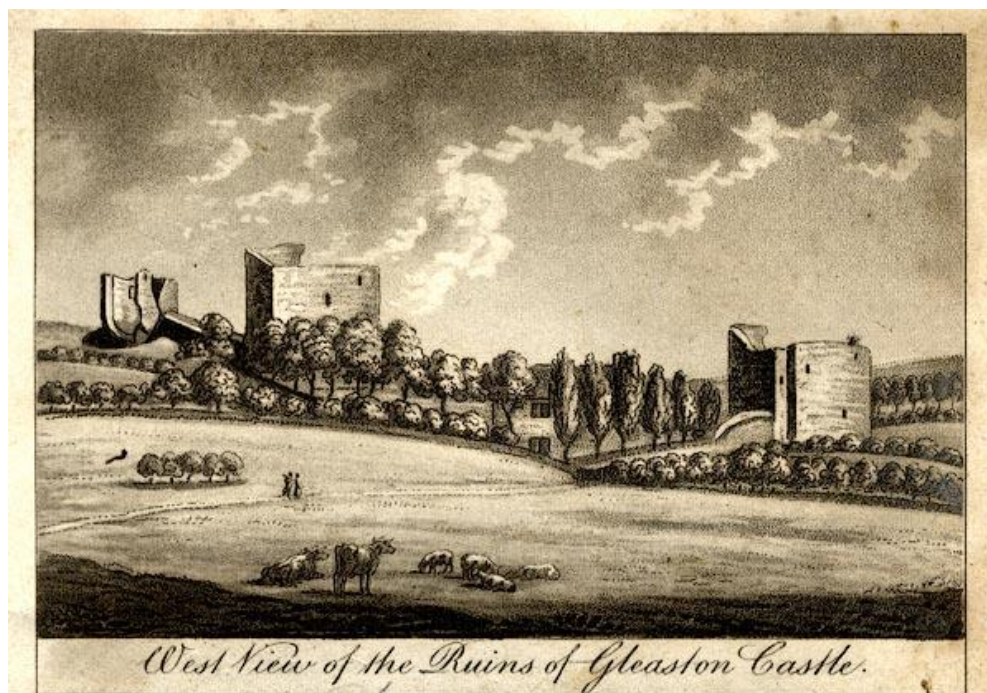
Plate 11: View of Gleaston Castle by William Close (West 1805)

2.6.2 Subsequent illustrations produced in the early 19th Century by the local antiquarian William Close (Close in West 1805) and artist William Green (see Burkett and Sloss 1984) also exist and show a similar state of decay (Plate 11 to Plate 13). An engraving published in 1860 (Waugh 1860)

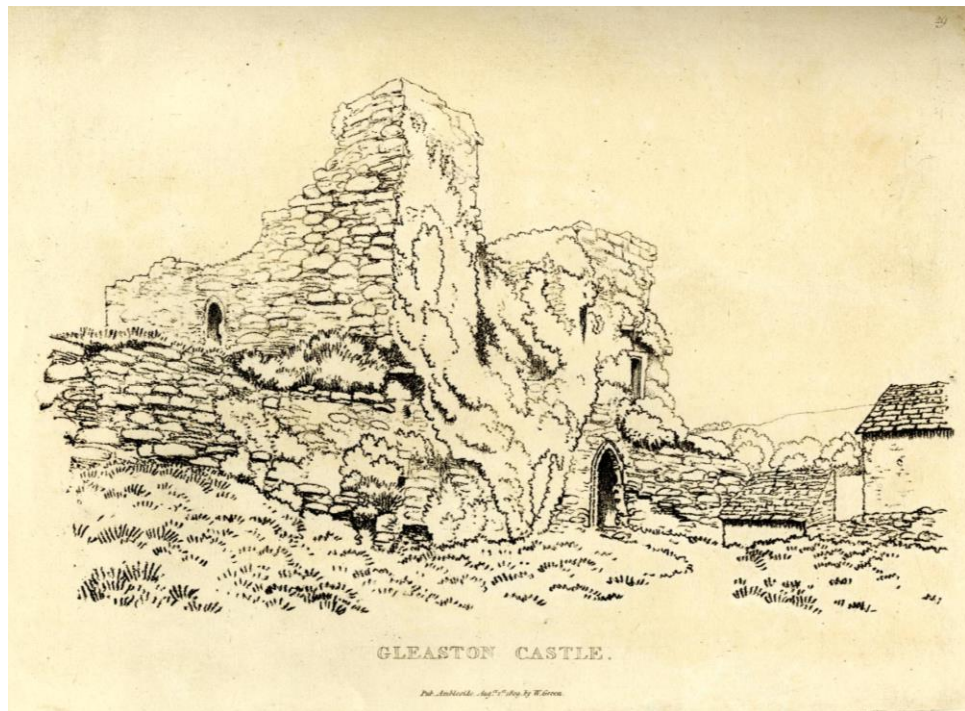
Plate 13: View of Gleaston Castle by William Green, dated 1809 (Green 1809)

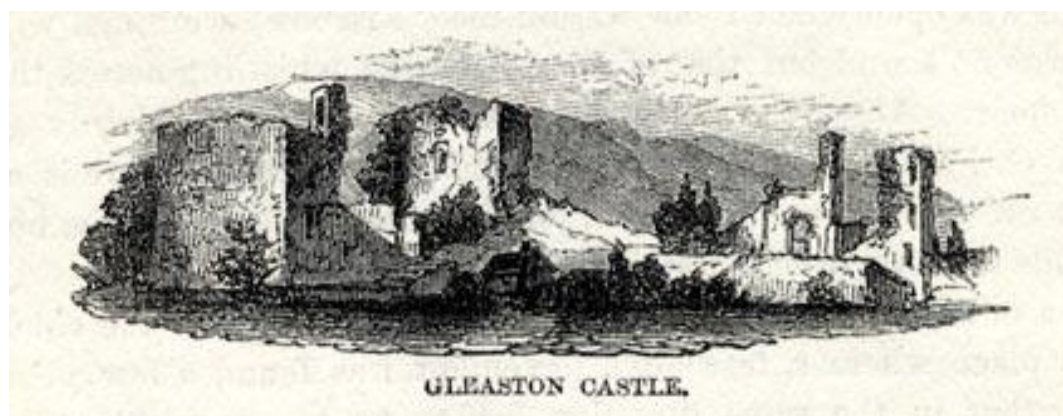
Plate 14: View of Gleaston Castle dated 1860 (Waugh 1860)

shows it in much the same condition as it appears today (Plate 14). This engraving is from the east, it does not include the present farmhouse (with a date stone of 1830), but clearly illustrates the eastern wall and gateway before the addition of farm buildings.

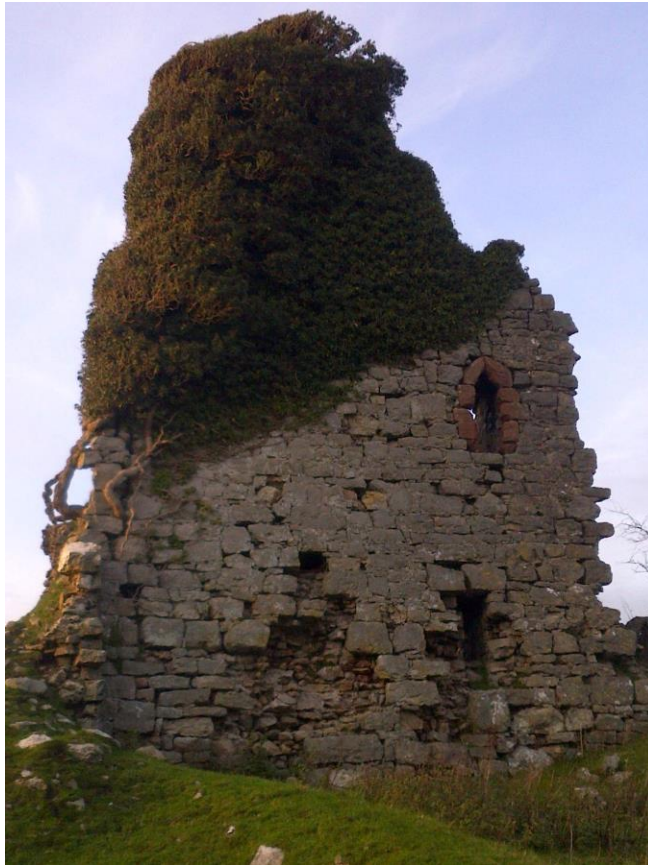
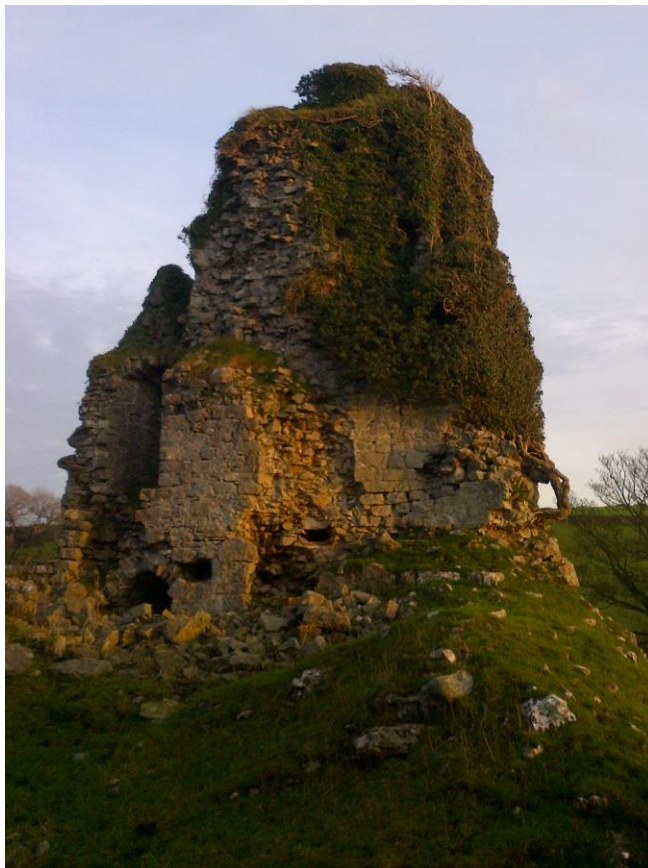
Eastern Gable (Plates 15a-d)

- 3.2.2 The easternmost of the three areas of masonry defining the hall is the remains of a gable wall containing embrasures/window pockets and a chimney. In its west face, an arched fireplace/oven and flue are identifiable at ground floor level, above which much of the chimney has collapsed. The remains of the stack are covered with ivy with the stonework beneath not discernible. In the corner of the east and north walls is a passage or doorway that served a privy, lit by a narrow arched sandstone window visible in the gable (Kendal 1906). The east-facing wall has lost some of its facing stones at ground floor level, one section apparently where a window pocket has collapsed. What appear to be the remains of the northern curtain wall, one or two stones in length, stand to a height of c. 2 m at the south east corner of the structure. Adjacent to the east gable, the north and south walls of the hall are represented by a turf covered mounds of rubble.

Plate 15a. The Hall: East facing eastern gable wall

Plate 15b. The Hall: West facing eastern gable wall

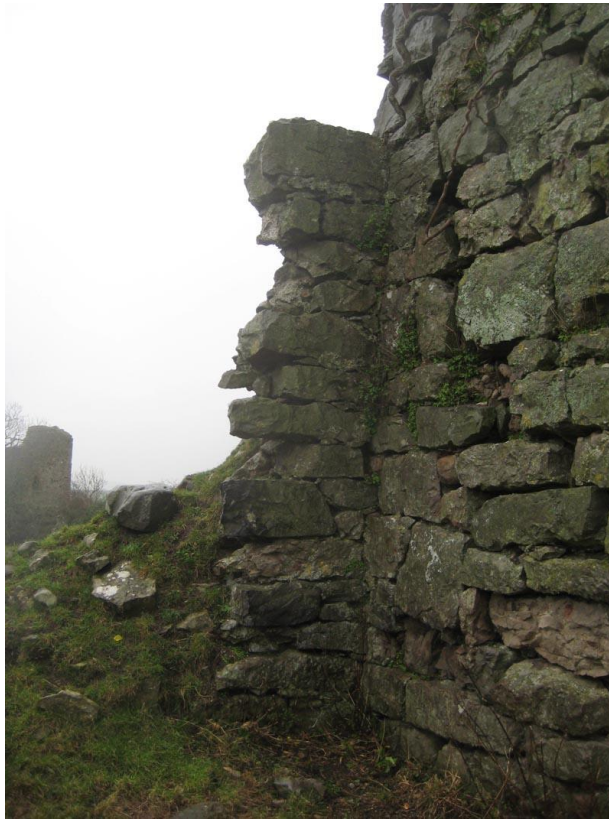
Plate 15c. Remains of northern curtain wall attached to eastern gable

- 3.8.2 The northern curtain wall, running between the hall and the north east tower, is largely represented by an earthwork. Despite interpretations that the northern wall was never completed beyond footing height (e.g. Kendal 1906), it is discernible (although poorly defined) to c.2m in height at the south east corner of the hall (Plate 15c).

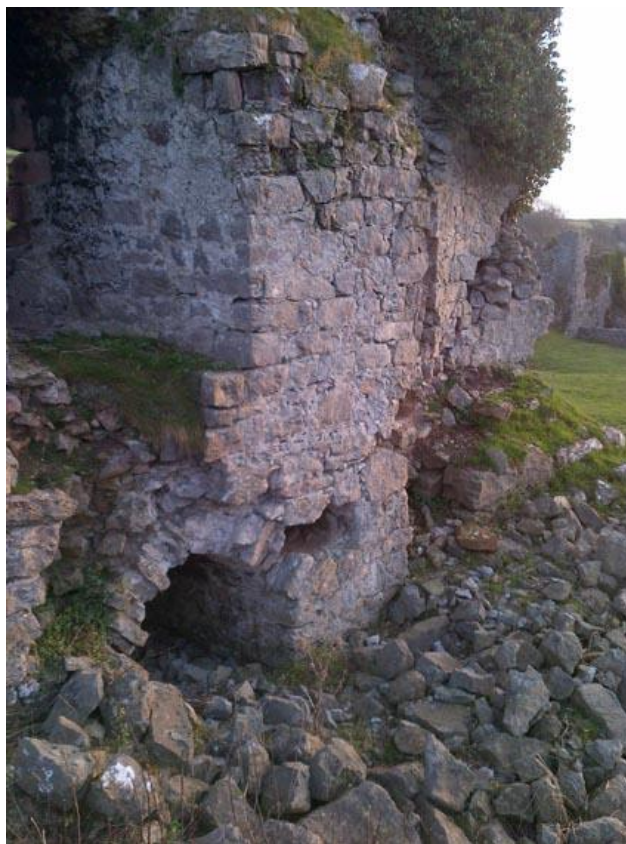
Plate 15d. The Hall: Close up of fireplace/oven and flue

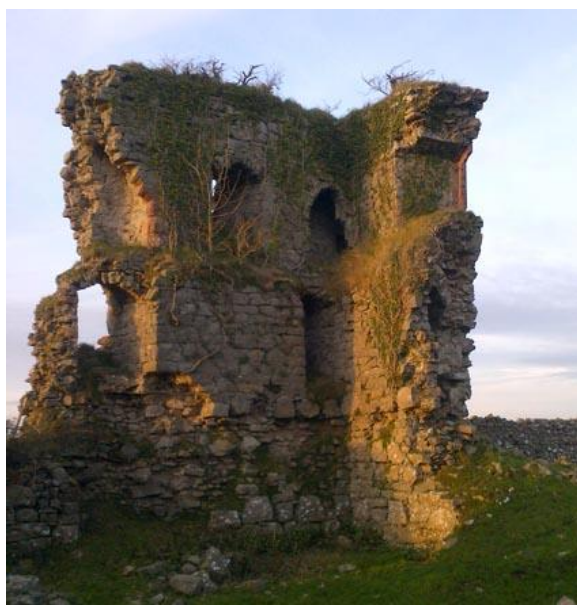
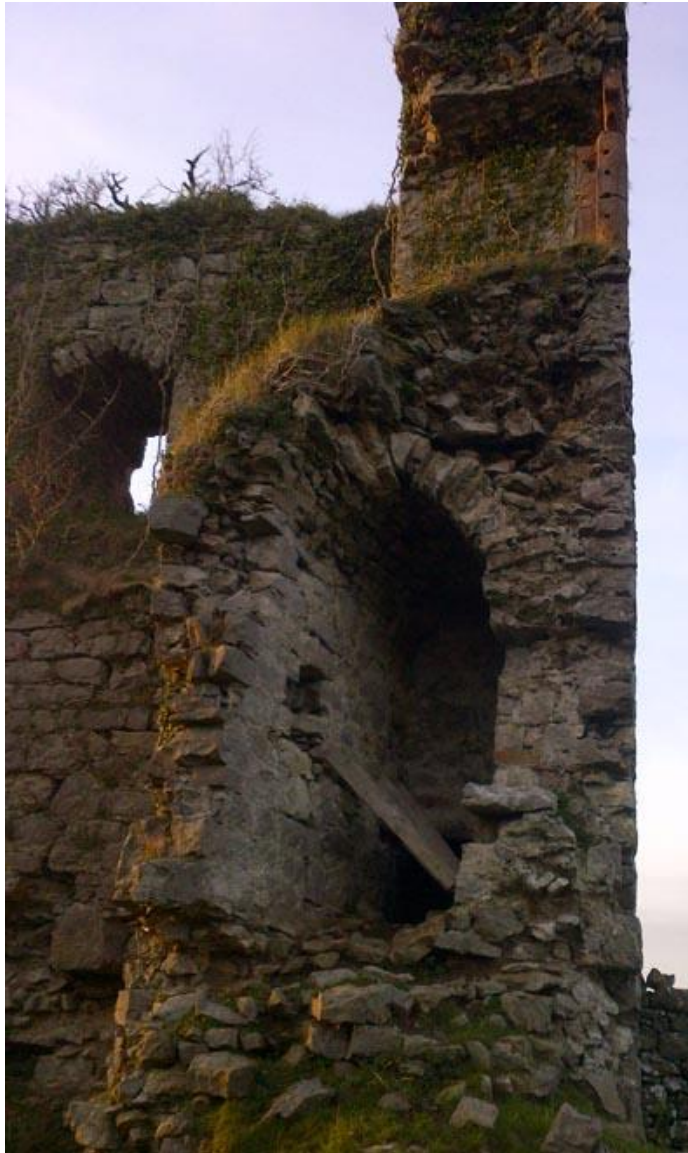
West End Corner Section (Plates 15 e-f)

3.2.3 The north western element is represented by a corner section incorporating the west facing end wall and a small section of the building's north frontage. Due in part to the loss of face work, there are no internal features visible at ground floor level apart from corbelled stones to support the floor above. At first floor height an arched opening at the south end of the west wall is in precarious condition and may threaten the collapse of masonry above. The second floor incorporates three arched openings, a window, a doorway into a privy in the angle of the north and west walls and a possible fireplace at the south. Above the second floor the stonework appears loose and unconsolidated and the wall tops are covered with grass and shrubs. A vertical crack visible on the north end of the external elevation rises the full height of the wall and suggests its movement away from the north wall.

3.2.4 The north wall also incorporates an arched intramural passageway leading to a privy at first floor level, again the angle of the north and west walls. The passageway supports the stonework above, which is characterised by the partial remains of a large wide window with sandstone detailing.

Plate 15e The Hall: East facing corner section

Plate 15f. The Hall: Arched passageway in north wall

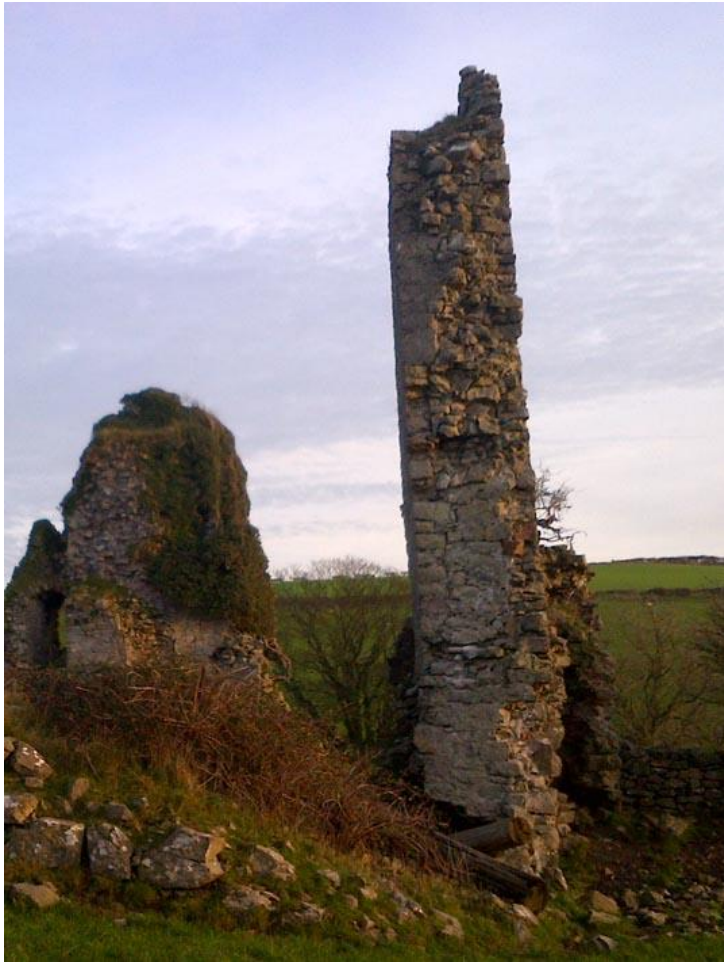
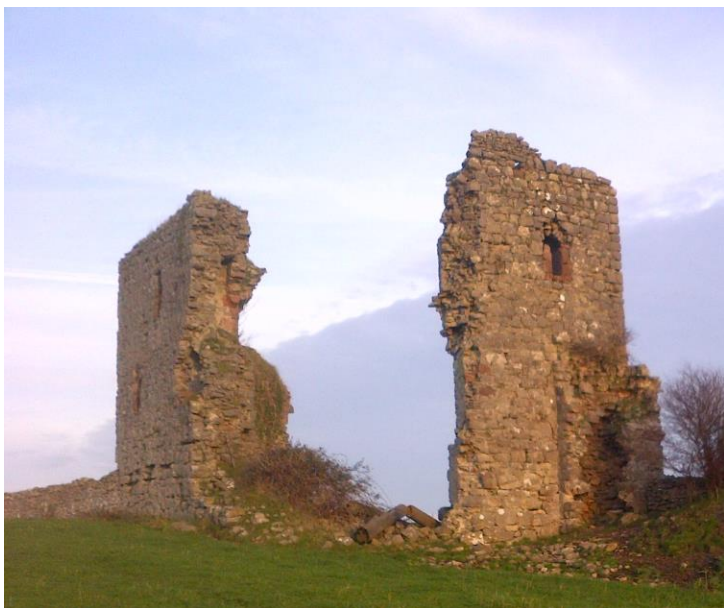
South section (Plates 15 g-h)

- 3.2.5 The southern section of the hall is characterised by a high narrow pier of stonework illustrating a substantial lean to the north. Externally, the wall appears to be buttressed by the remains of a gateway through the western curtain wall, which is now blocked. There is an arched window at second floor height, the top of which has eroded and may pose a threat to the unconsolidated stonework above. The eastern extent of the pier illustrates quoin work, suggesting it formed a corner to the L-shaped hall.

Plate 15g. The Hall: Leaning southern section

Plate 15h. The Hall: West facing corner section and south facing southern section

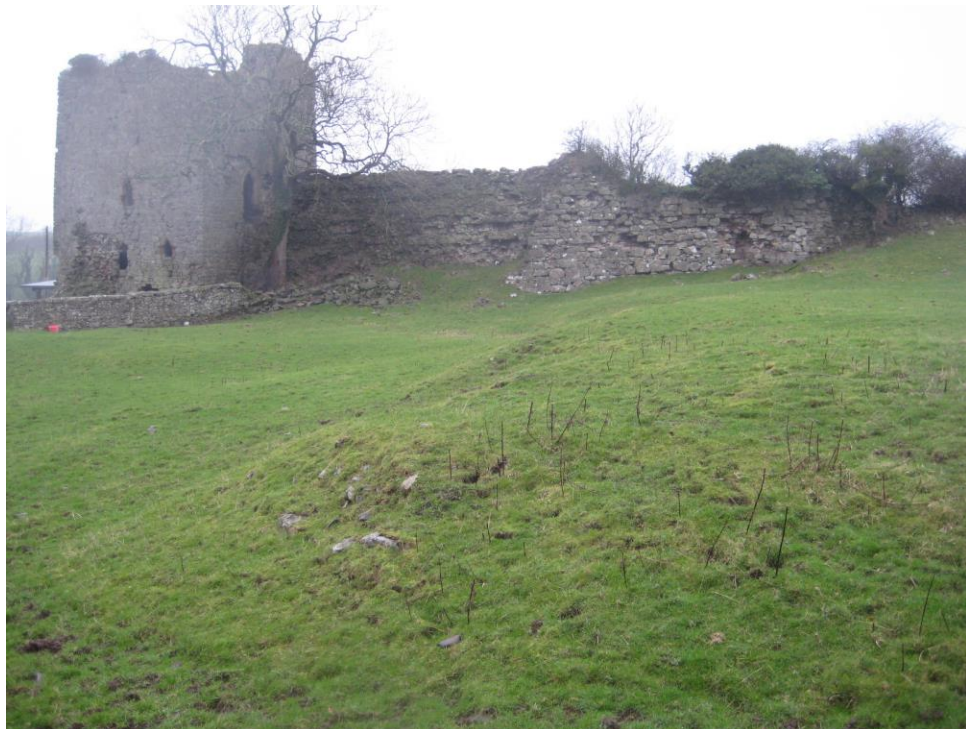
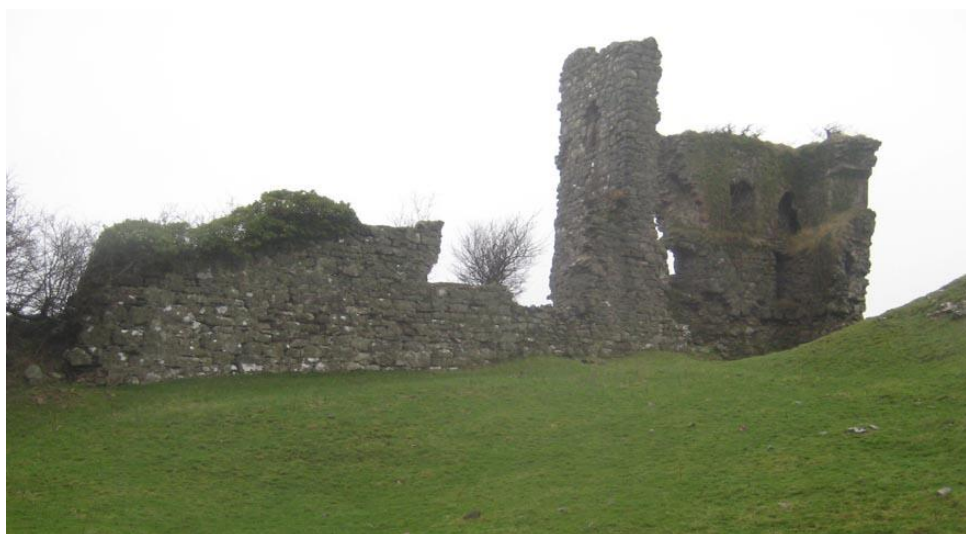
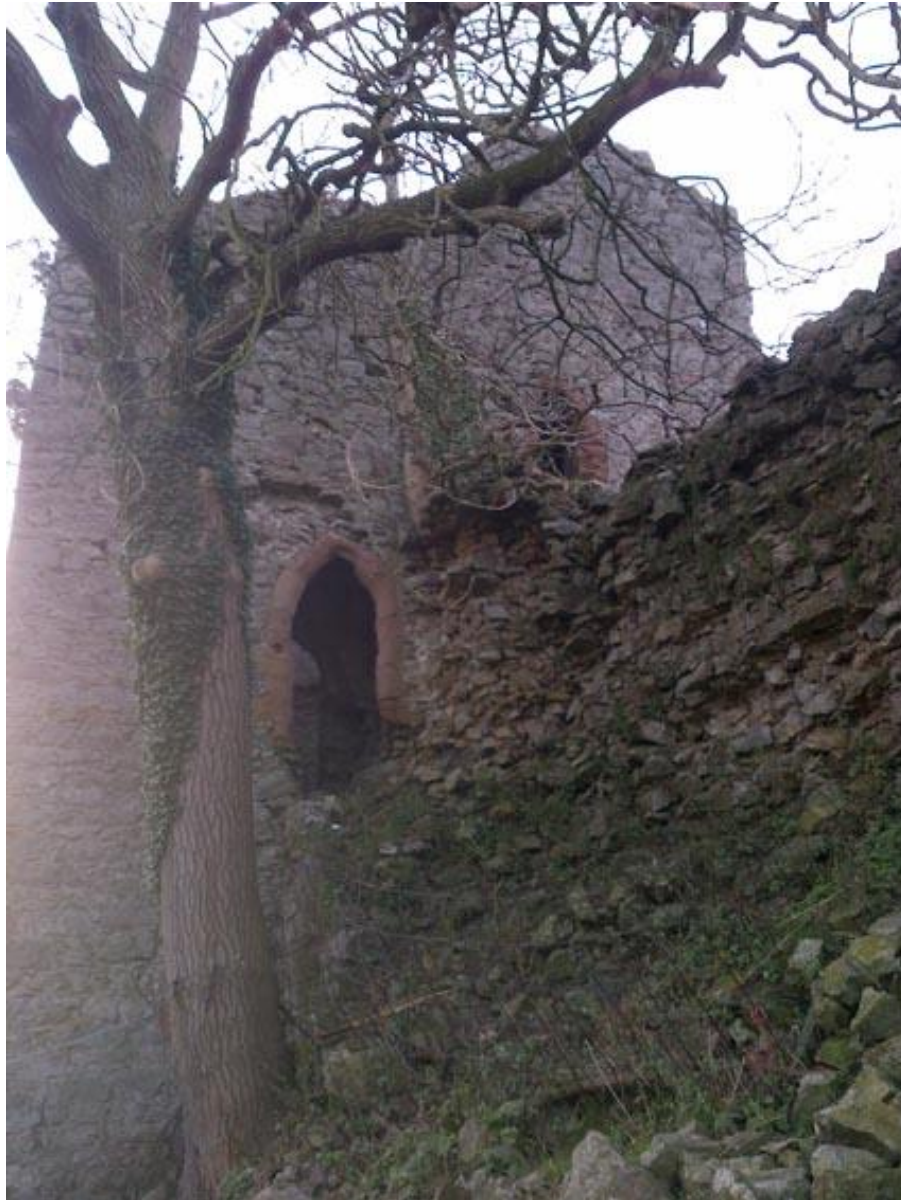
- 3.3.1 The western curtain wall (Plates 16a-e) runs from the southern section and gateway of the main hall to the corner of the south west tower. At its northern extent the arched gateway, recorded in Waugh's sketch of 1860 (Norgate 2014) has now fallen with the entrance blocked by a modern drystone wall. To the south of the gateway the curtain wall stands to a height of c.3m and is in relatively good condition. A set of stone stairs onto the battlements was recorded by Kendal (1906).

Plate 16a. East facing south west tower and western curtain wall (south)

Plate 16b. East facing hall and western curtain wall (north)

Plate 16c. North facing wall of south west tower and east facing section of curtain wall

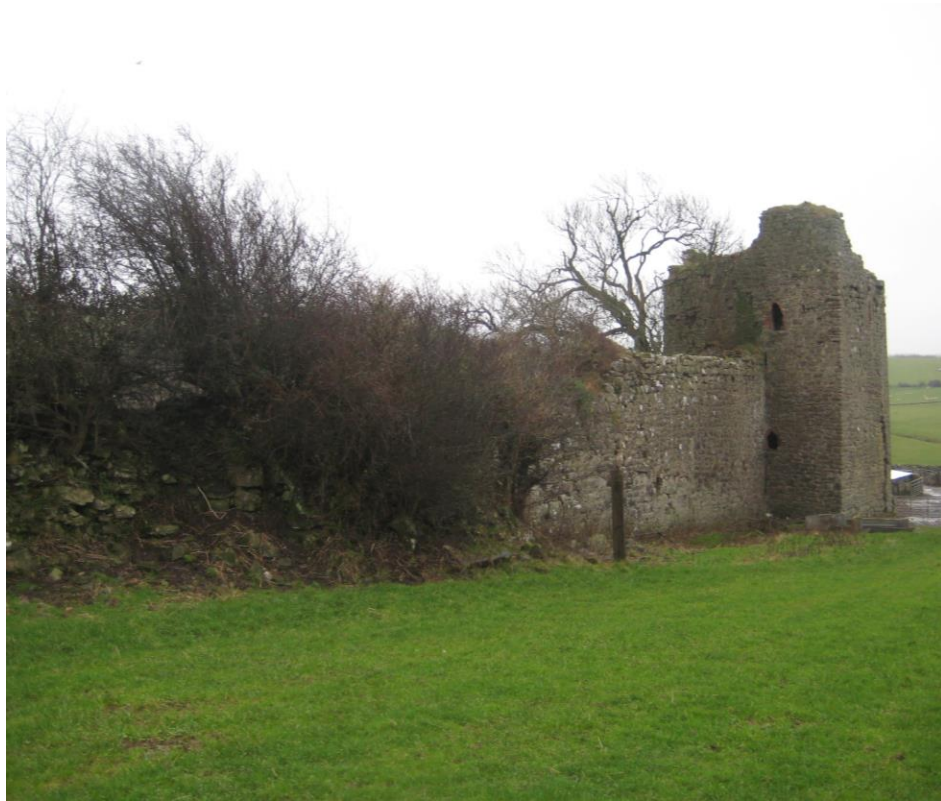
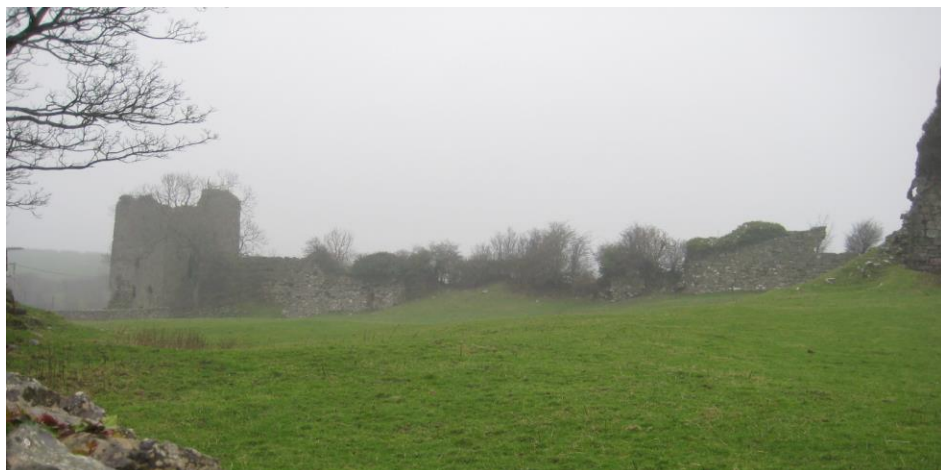
- 3.3.2 Approximately half way along the western curtain wall is a substantial lump of masonry. It is in poor condition and obscured by vegetation. This structure has seen interpretation as a ‘bastion’ or the base of a ruined tower defining a site layout preceding the construction of the hall (e.g. Kendal 1906; Curwen 1912).
- 3.3.3 South of the bastion structure, the curtain wall stands to a height of *c.* 9m and it is *c.* 3m thick where it meets the south west tower. The wall is aligned slightly differently to that to the north of the bastion. Although externally it appears to be in good condition, internal inspection reveals only its outer face remains. Both Curwen (1912) and Kendal (1906)

recorded that this section of wall had a clay core, the erosion of which may account for its ruinous state. Internally, there was access onto the wall and into a doorway at first floor height of the south western tower.

Plate 16d. West facing western curtain wall and south west tower

Plate 16e. Full length of the east facing western curtain wall. Earthwork remains of the northern wall are in the foreground

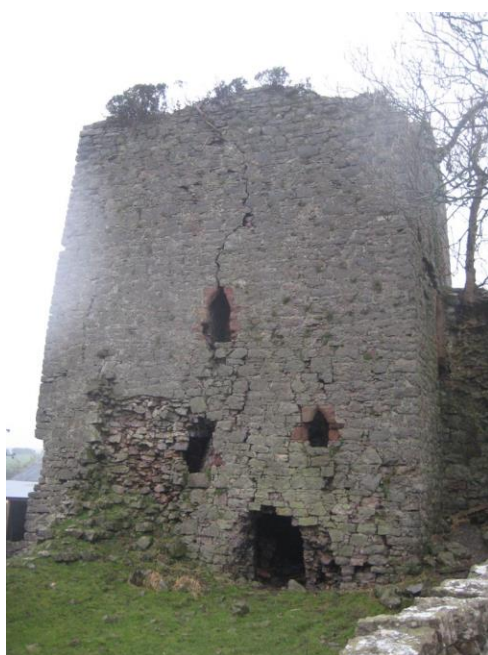
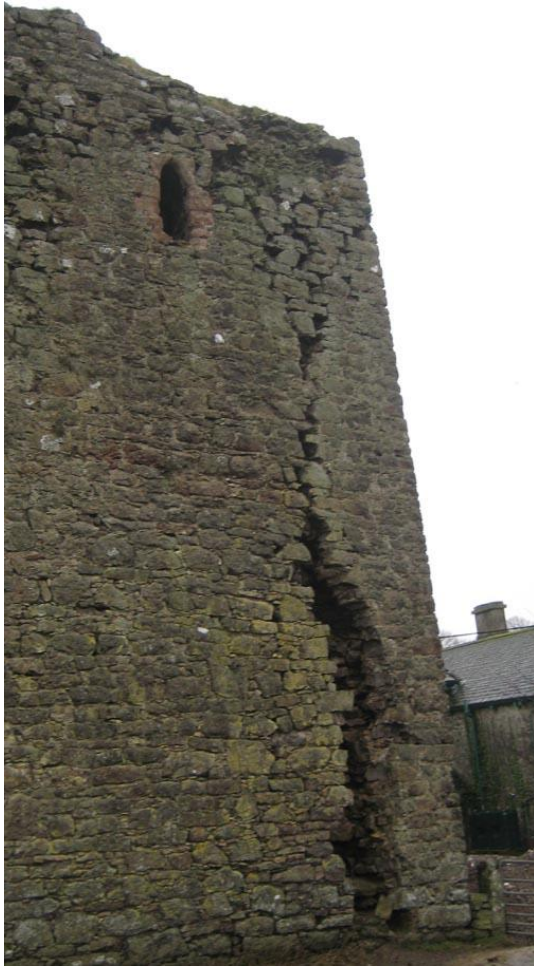
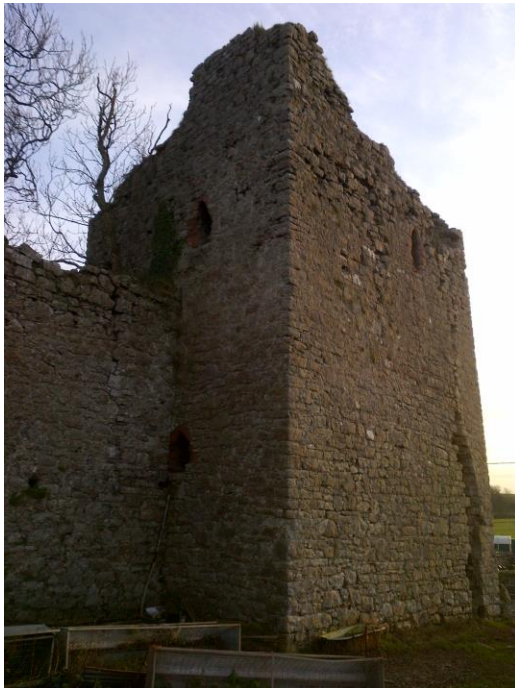
c.19m (LUAU 1998). The interior of the structure is not accessible due to its ruinous condition but it consists of a ground floor store reached from a courtyard doorway, three single-room floors with fireplaces, latrines and small pointed arched sandstone windows (Kendal 1906; Curwen 1913). Battlements with a small watch tower were reached by a winding internal stair.

- 3.4.2 Externally, the west wall of the tower has a massive vertical crack which is c. 0.8m wide at its base at ground level from where it narrows progressively as it reaches the top of the wall. There is a single third floor pointed arched window. The east facing elevation has a denuded ground floor entrance and narrow arched windows at first and second storey height. A narrow crack from the top of the doorway runs upwards through the second storey window and continues to the wall top. A section of facing is missing at ground floor height adjacent to a possible collapsed window pocket and quoin work is missing from the south east corner. The south facing wall incorporates second and third floor windows. The north facing wall has arched windows at first and third storeys. The inner face of the wall, inside the curtain wall, is partly obscured by tumble and a large tree, but it is possible to discern a second floor arched doorway accessible from steps incorporated in the curtain wall.

Plate 17a. East facing wall of south west tower

Plate 17b. West facing wall of south west tower

Plate 17c. North and west facing walls of south west tower

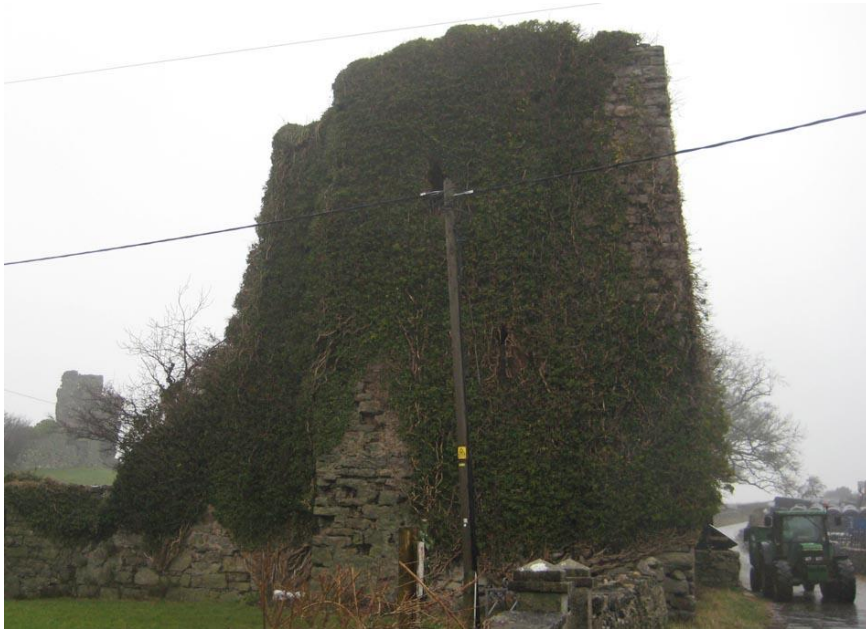
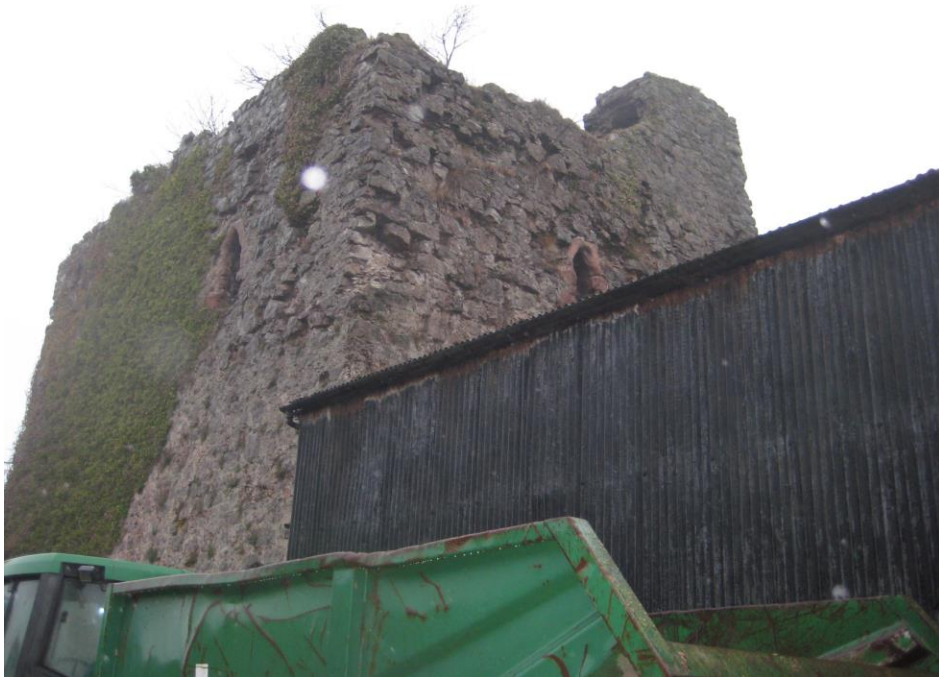
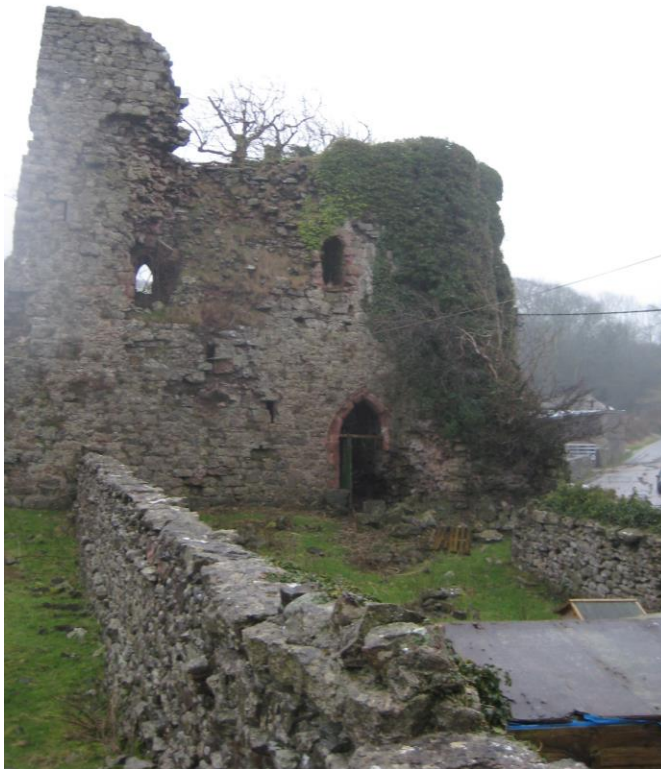
- 3.6.1 The south east tower (Plates 18a-c), situated on low ground adjacent to the road, is of two storeys, measuring c.9.5m by 13m and standing c.12m high (LUAU 1998). As with the south west tower, its dangerous structural condition means it is inaccessible.

- 3.6.3 Most of the external south and east facing elevations are obscured by ivy making their condition impossible to establish. Both walls incorporate a single second storey window. The north facing wall is partly obscured by modern farm buildings, above which there is also a second storey window.

- 3.6.4 The west facing elevation of the south east tower has a ground floor doorway with a pointed red sandstone arch, and two second floor windows. The wall is in a dangerous structural condition with its north west corner exhibiting signs of imminent collapse. Part of the face of the wall has fallen away at second storey height. The precariously wedged voussoir of a badly eroded window threatens the existence of the unconsolidated core work and high battlements above.

- 3.6.5 The south west corner of the tower appears to have been added to at some point. It is covered with ivy and was not accessible for close examination; however Buck's sketch of 1727 (West 1774) shows a building, probably a house, built up against this part of the tower; elements of the low walls remaining form a small enclosure within the garden of the current farmhouse.

Plate 18a. South facing wall of south east tower

Plate 18b. East and north facing walls of south east tower

**Plate 18c. West facing wall of the south east tower,
and wall defining the south of the enclosure**
