Gleaston Castle, Gleaston, Cumbria

Results of Aerial Survey and Conservation Statement

Helen Evans and Daniel Elsworth
April 2016

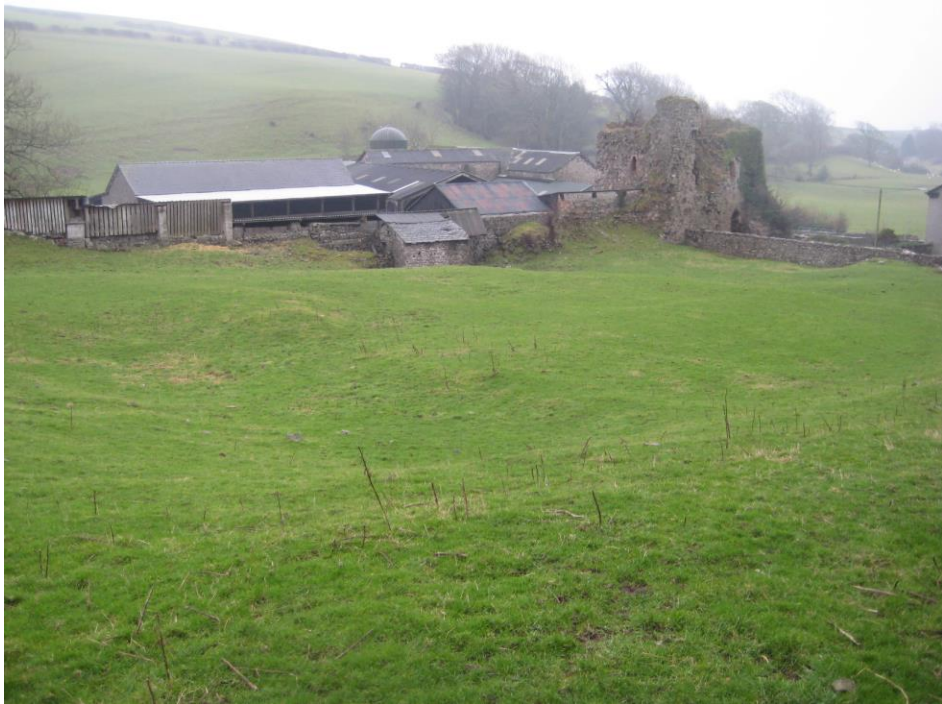
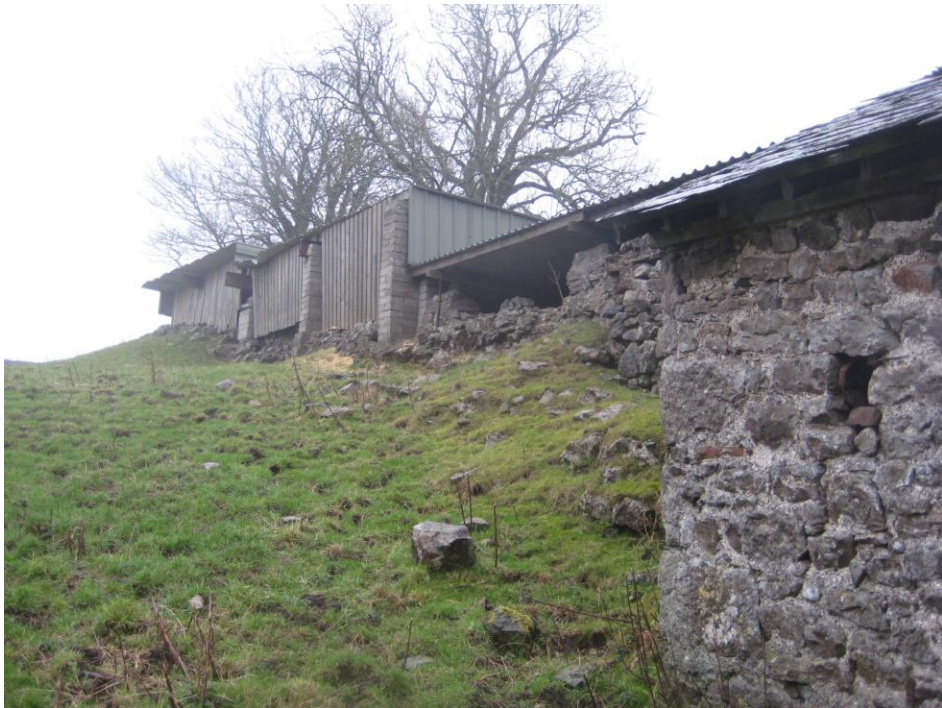
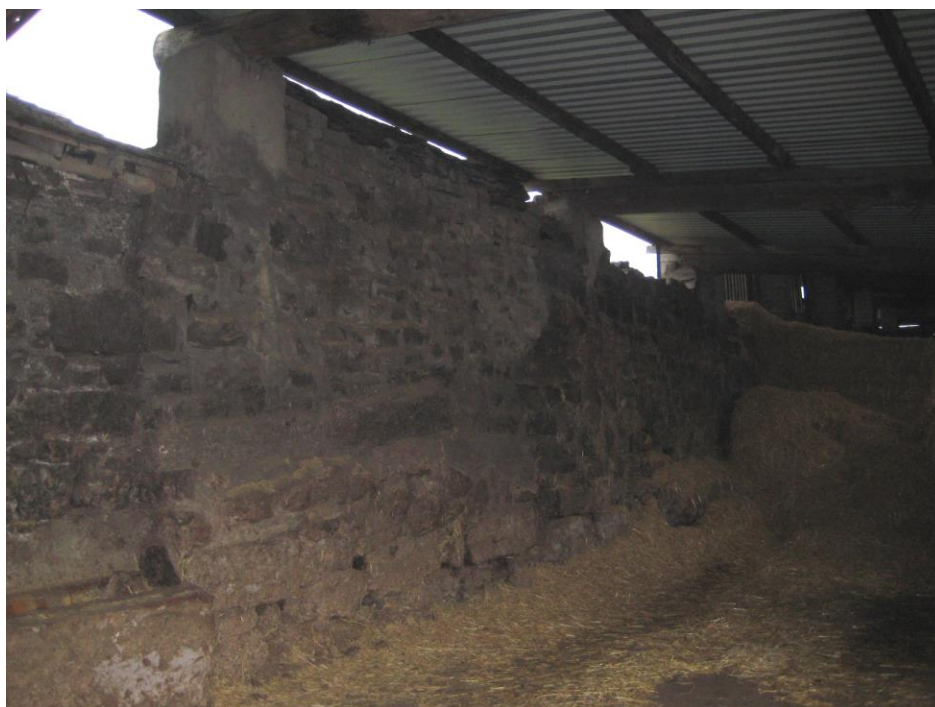
- 3.7.1 The eastern curtain (Plates 19a-c) wall stands *c.*4m high externally where it has been incorporated into modern farm buildings. It survives in relatively good condition where it has been covered in, although the walls have been disturbed by blockwork piers built to support the roofs. Within the enclosure the wall is not visible, its west face being obscured by grassed-over rubble mounds. The original entrance to the enclosure was in the east wall, as illustrated by Waugh's 1860 engraving (Norgate 2014). There is a wide gap in the wall into which a small shed of traditional lime-mortared construction has been inserted (also shown in the engraving). The remainder of the gap is gated and currently acts as the entrance to the enclosure.

Plate 19a. The interior of the enclosure, the remains of the east wall and the south east tower

Plate 19b. West facing eastern curtain wall and farm buildings

Plate 19c. East facing eastern curtain wall inside farm buildings

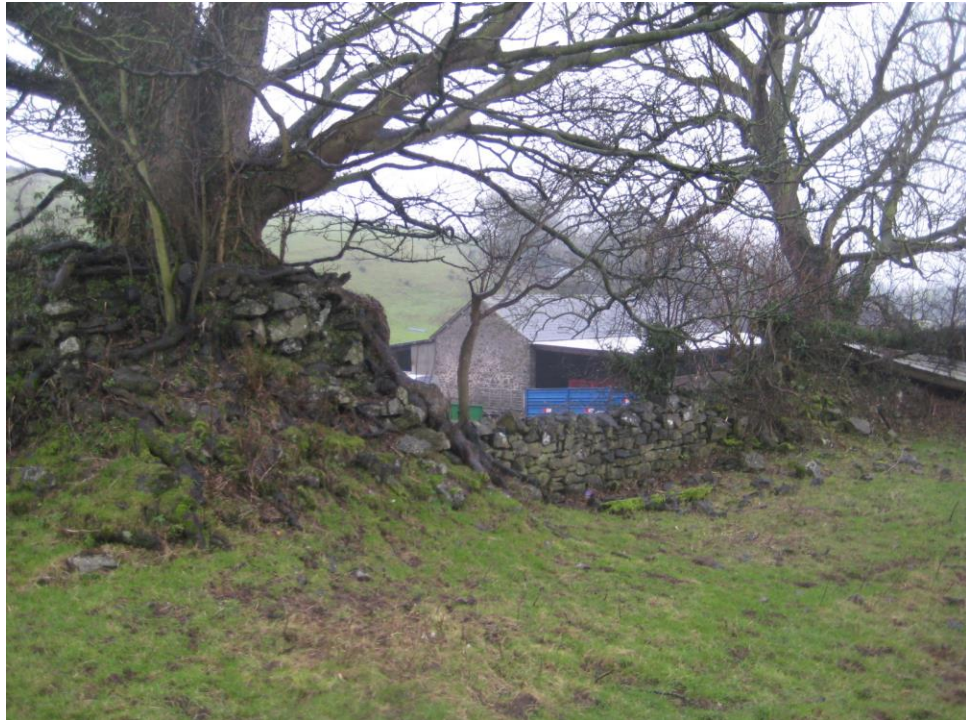
- 3.8.1 A fourth tower at the north east corner of the complex and a wall connecting the tower to the hall are identifiable only as earthworks (Plate 20a). A wall within the modern farm buildings built over the eastern curtain wall survives in relatively good condition and may be the southern wall of the tower. A lump of ruined masonry survives in the modern boundary wall adjacent to the road; an infilled gap in this wall suggests it may have served as a relatively recent entrance to the site, or provided access for robbing. The remainder of the structure is represented by poorly defined low rubble mounds.

Plate 20a. Site of the north east tower, facing south east
