THE MILITARY HERITAGE OF SOUTH WALNEY

ARCHAEOLOGICAL SURVEY AND RECORDING ON WALNEY ISLAND, BARROW-IN-FURNESS

This report details archaeological survey and recording in the area of South Walney, Walney Island, Barrow-in-Furness, Cumbria. The survey activity was integral to the training of local volunteers in archaeological recording. A series of recording workshops and survey days were undertaken, where the under-recorded military heritage of South Walney was surveyed.

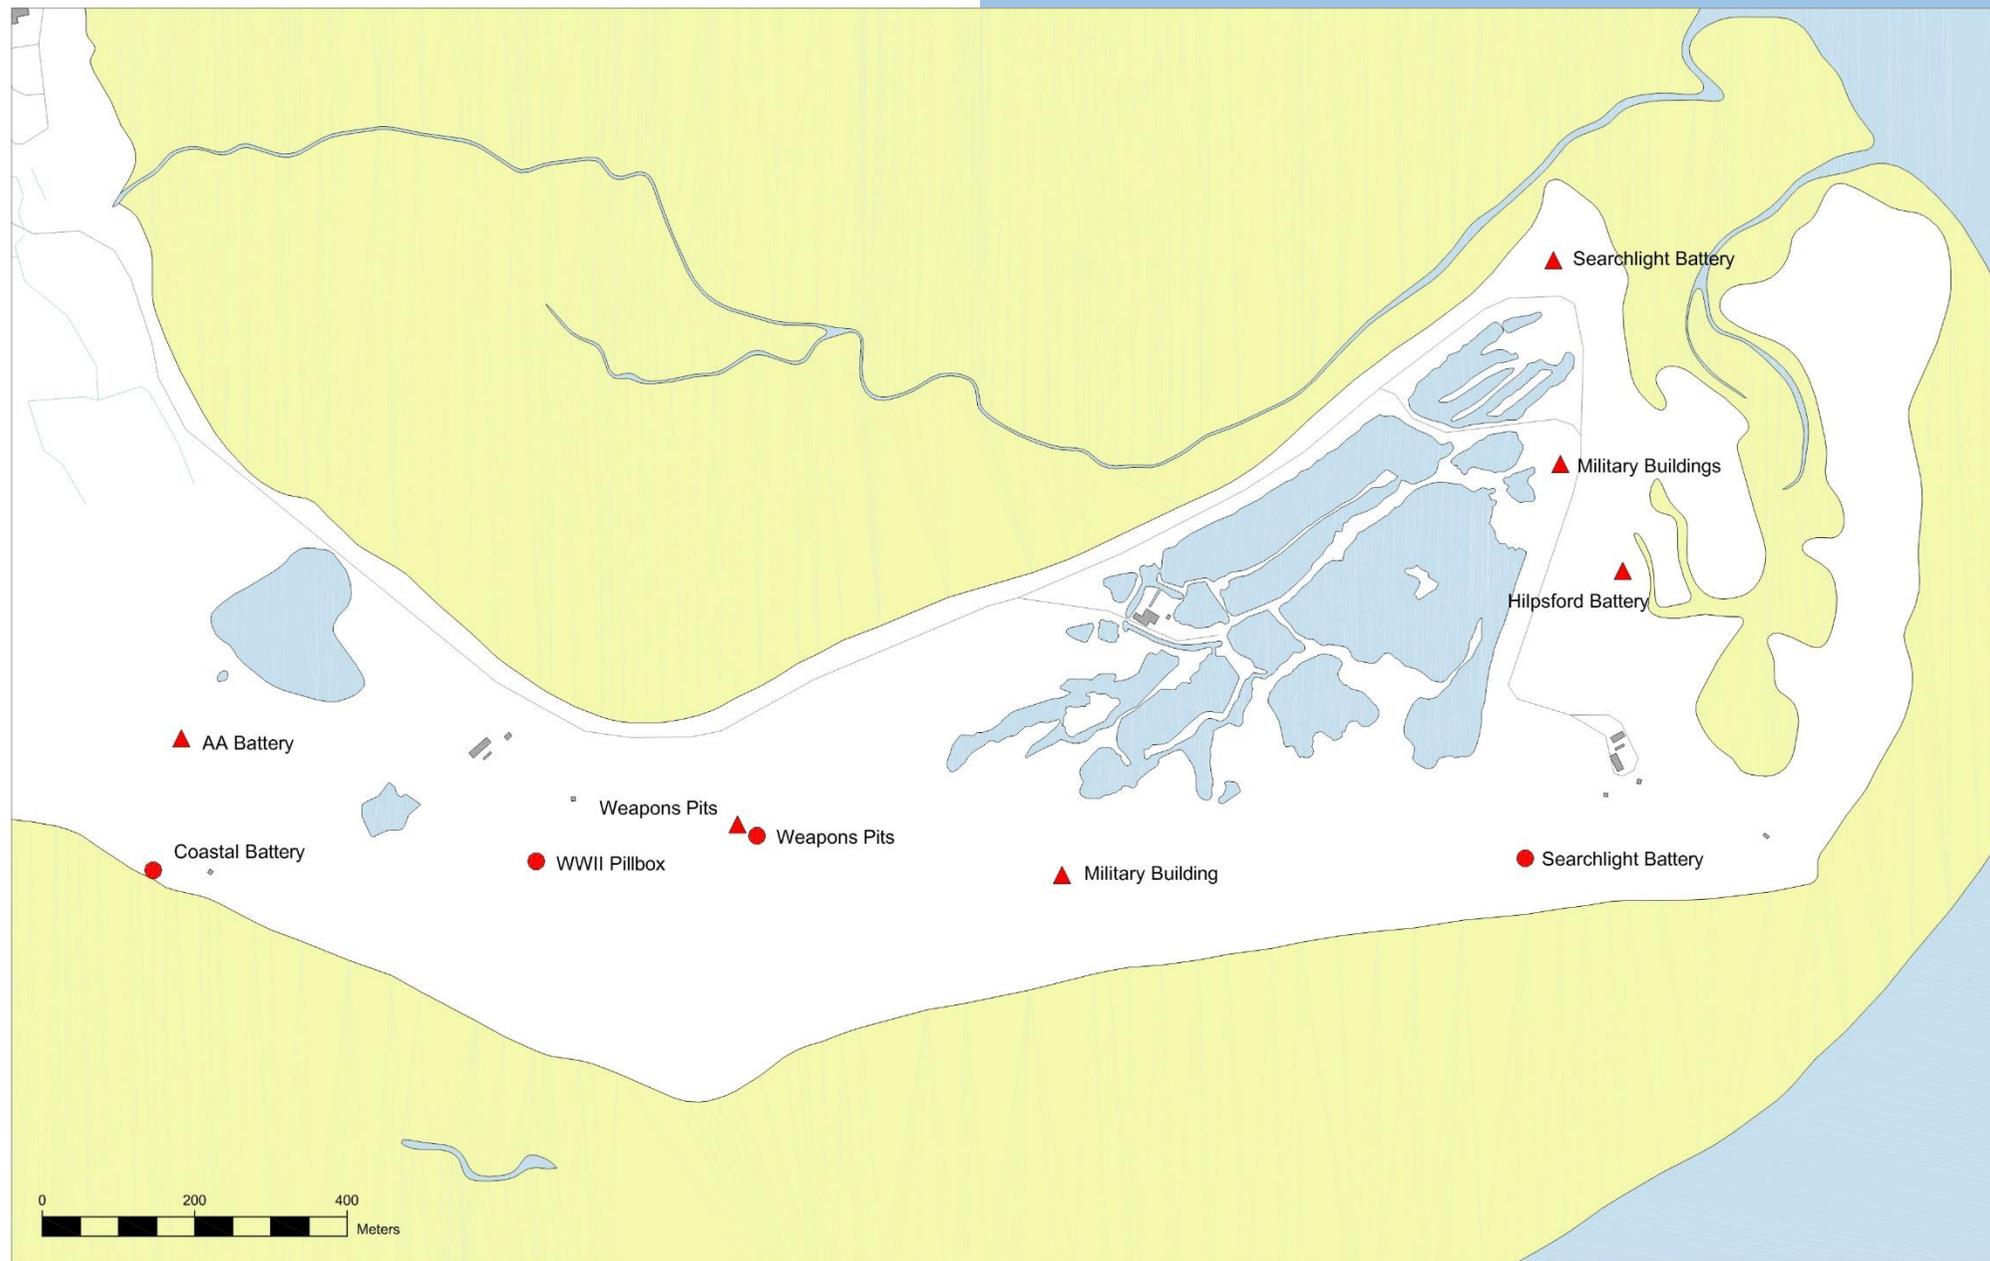
Figure 1: HER and NMR data points drawn from public records

The NMR list seven separate relevant data points for the survey area on South Walney (see figure 1, below). In addition to describing the data extracted from these archives, this section will also indicate whether structures are visible on the ground currently. Where location information may be described as inaccurate as a result of the walkover survey undertaken as part of this survey, a statement on the reliability of the spatial information will be provided (see tables).

HER and NMR Data Points at South Walney

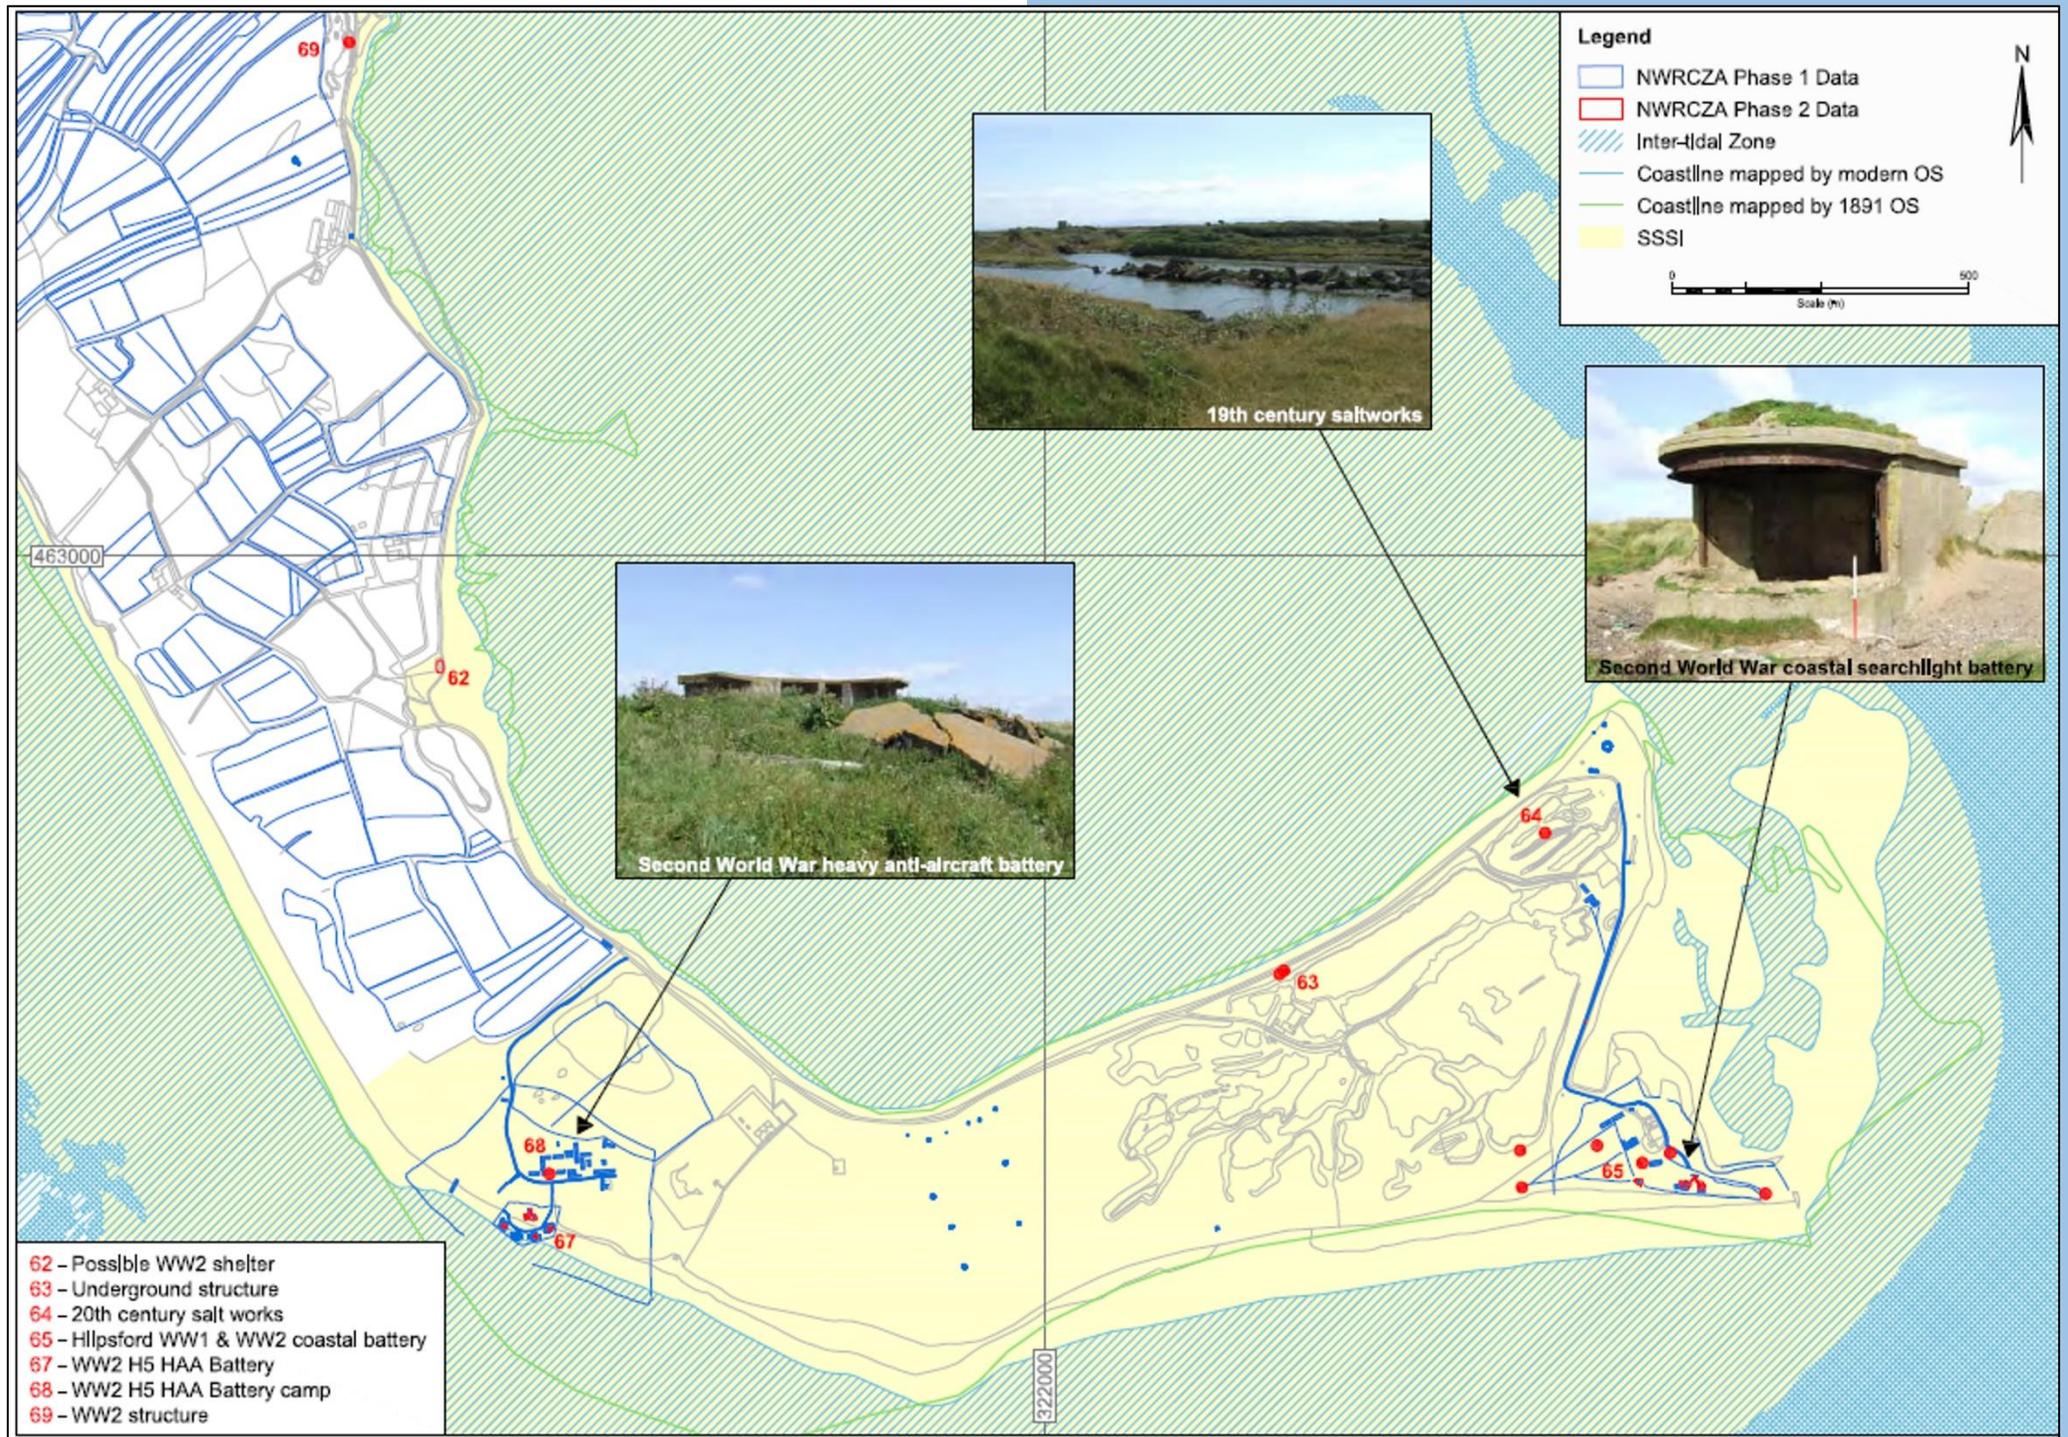
10
Figure 2: Summary map from the Rapid Coastal Zone Assessment (after Eadie 2012)

The Rapid Coastal Zone Assessment found few new sites on South Walney but did provide a useful summary of existing information synthesised with aerial photographic information from 1945. See figure 2 for a summary of the RCZ data from South Walney.

This data clearly displays the regression of the southern coastline around the HA5 Heavy AA Battery, and the recorded extent of the camp to its north. Similarly, military buildings and roads associated with the Hilpsford Battery and searchlight emplacements can clearly be seen.

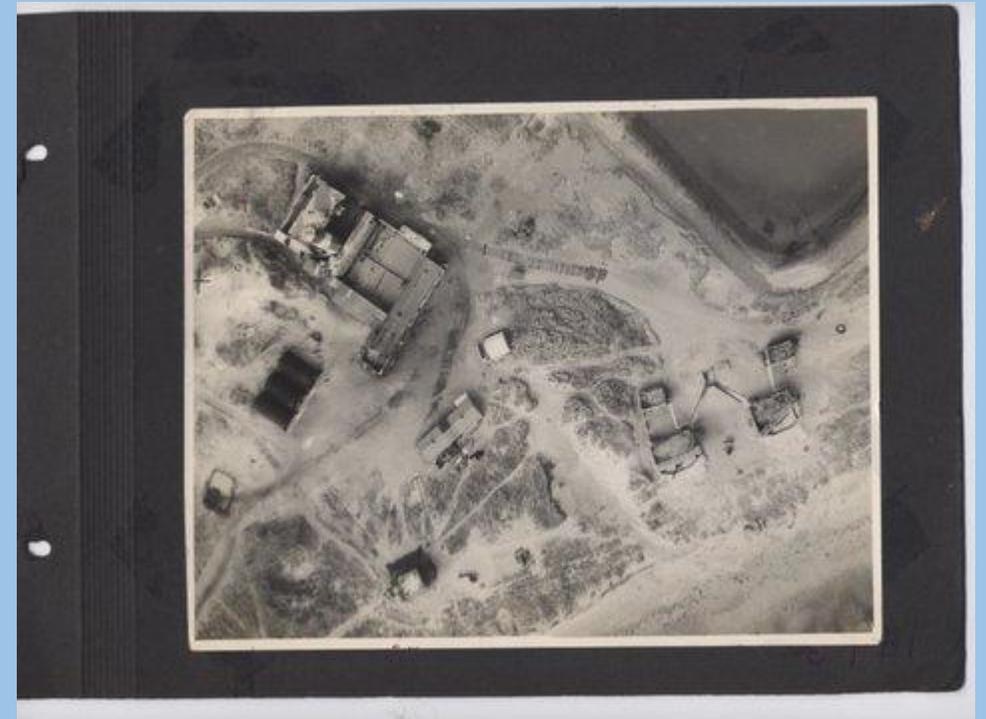
Plate 1: Aerial view of the Hilpsford Battery, 1943

Copies of photograph's submitted through Sarah Dalrymple, South Walney Warden, Cumbria Wildlife Trust are shown on the previous page as Plates 1 and 2 and provide some limited photographic reference material for the recommissioned Battery during the Second World War. Particularly interesting are an aerial view of the Hilpsford Battery (plate 1) and the size and extent of the associated camp around the lighthouse to the north of the guns (plate 2). There is scope to undertake further documentary research such as acquiring resources held at the National Archives which may provide further details of the plan and form, in particular of late 19th and early 20th century installations.⁴

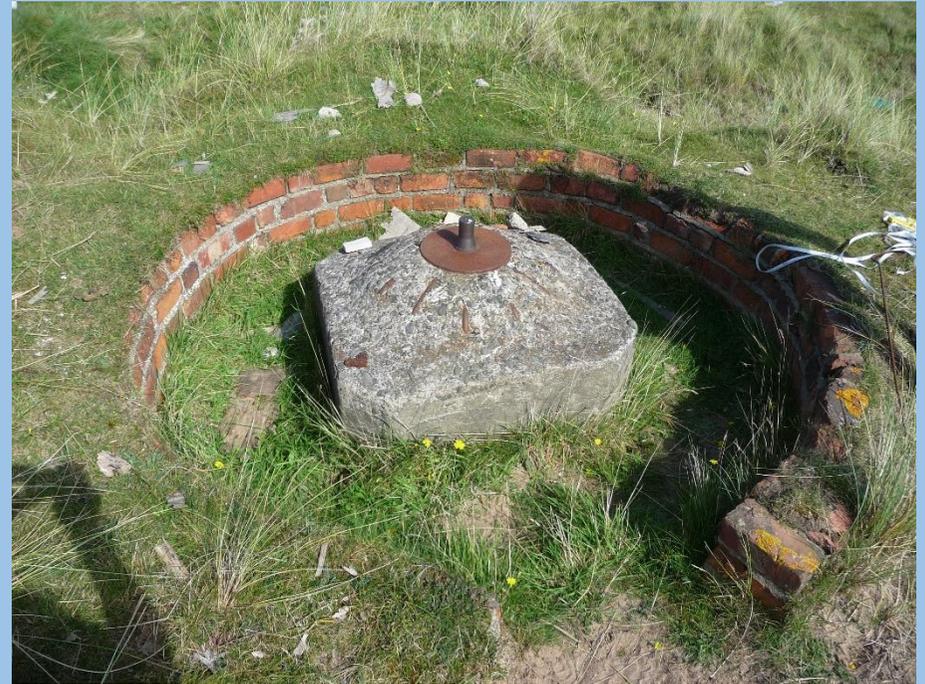
Figure 3: #17 - Spigot mortar emplacement

| 17 | Spigot Mortar | 2.3m dia | Rectangular spigot mortar base in circular brick lined gun-pit. | Fair | Metalwork in good condition, bricks somewhat decayed. |

A well preserved spigot mortar emplacement was discovered on a low rise to the north-east of Hilpsford Fort. It is a brick-lined sub-circular pit, diameter 2.3m, with a concrete pillar in the centre mounting the metal spigot fixture for the mortar. Entry is provided by a gap in the brick lining. It is in excellent condition: the bricks are slightly decayed, but the metal mounting is undamaged and not corroded. See figure 4.

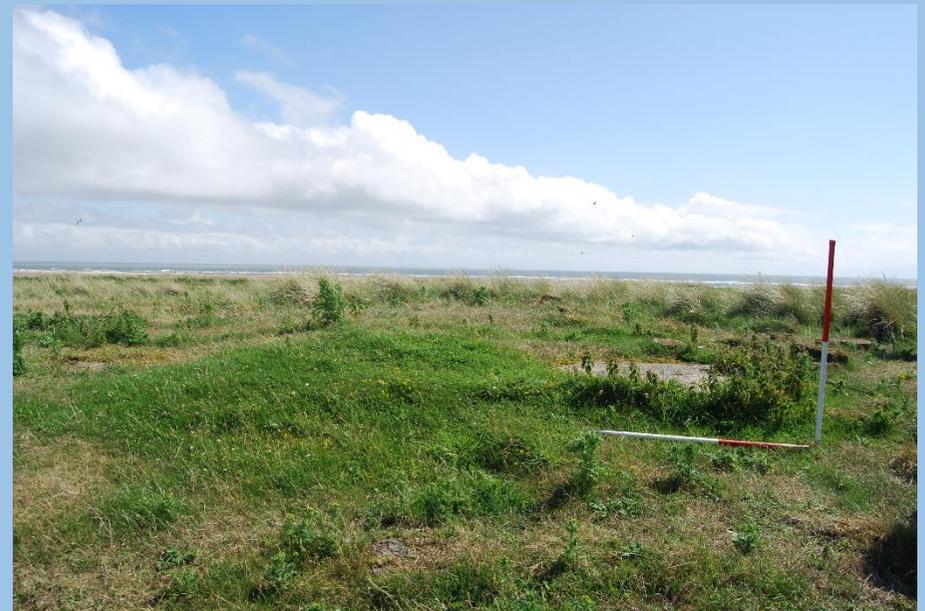
Figure 4: #6,22 – Concrete base

| 22 | Unknown - Concrete Base | 5.8 x 5.4m | Rectangular concrete slab base with cinderblock debris surrounding. | Very Poor | Earthfast block mainly overgrown, very badly damaged. |

A duplication on the survey. A concrete base (5.8 x 5.4m, long axis E-W) surrounded by cinder blocks and brick debris, apparently from damaged walling.

This feature probably represents a concrete raft foundation for a small military building of unknown function. See figure 4.

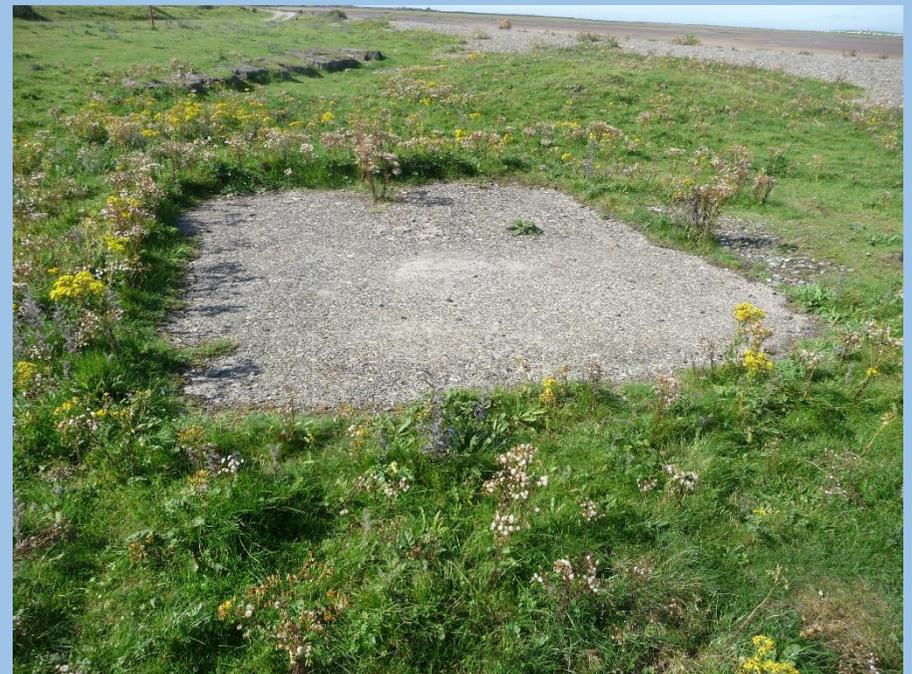
Figure 7: #9 – Concrete base

A concrete raft foundation base (3.8 x 4.6m) on the north-eastern point of South Walney, 150m north north west of the concrete structure at #7, and constructed from concrete identical to other such bases in the area. Some little evidence of brick walling associated with the base, now collapsed.

Whilst no positive identification of this feature is possible, its location does correspond to that of a searchlight emplacement listed on the NMR (1488354), and it would be well placed for such a feature to sweep the channel between South Walney and Piel Island to the north.

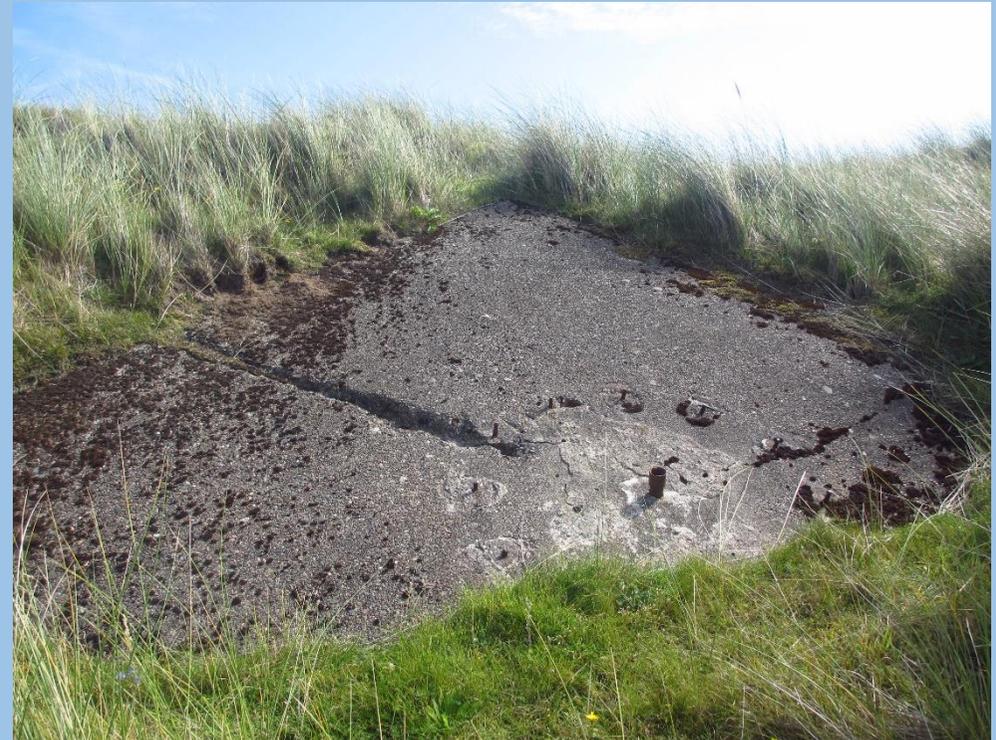
Figure 8: #10 – Gun base and mounting

A rectangular concrete base (3.8 x 4.6m) with the holdfast for a gun in the centre. The holdfast has 8 visible 30mm diameter bolts, possibly 12 originally, arranged in a circle, with a central 50mm diameter bolt standing 90mm in height. The base is very badly damaged having largely collapsed down the side of a gravel extraction pit to the west. See figure 8.

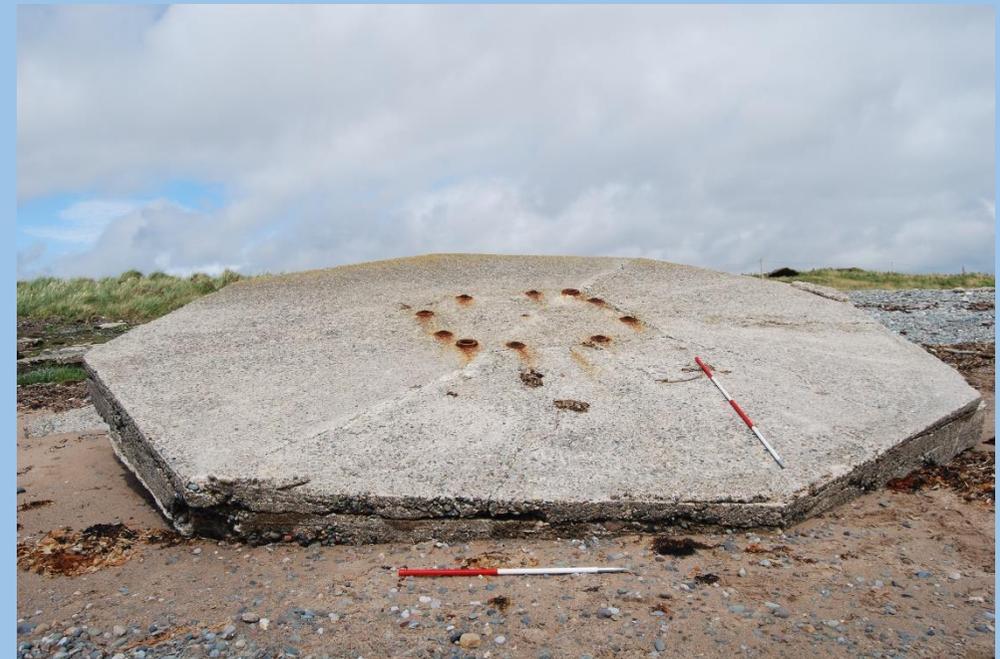
Figure 10: #20 – HA5 heavy AA gun base

Three octagonal concrete bases (7.8 x 7.8m) with ten visible steel fixings and two further larger fixing points – 2.6m across. Fixing points are corroded but visible. The bases are approximately 0.5m thick, with a larger central column visible where bases are undermined by coastal erosion. It appears that the concrete was poured into sandbag formers, as the weave of the bags is visibly impressed into the cement. Steel rebar is visible within the formed concrete where it has become damaged. The concrete is low quality and uses beach pebbles in the matrix, presumably extracted from the location of construction.

These three gun bases are surrounded by cinder block and brick rubble that relate to ammunition storage buildings, examples of which are still visible to the rear of gun emplacement #21 (below). All three have suffered due to the regression of the shoreline, leading to their collapse onto the beach, in one case leading to partial burial under the beach pebbles. It is this erosion that has exposed the undersides of the gun platforms. This has badly damaged elements of the concrete foundations and the bases are visibly under threat of fragmentation. See figure 11, below.

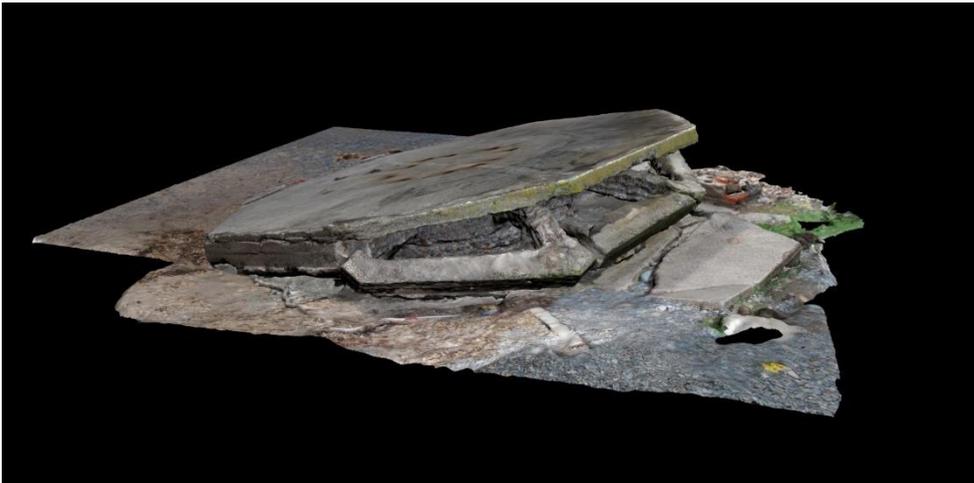
Figure 13: #20 – Render of 3D model

In addition to the written and photographic record of the battery, photogrammetric recording was undertaken to model one of the gun bases (#20) in order to provide a permanent record of its state of repair. The 3D model that resulted from this recording is fully scalable and can be manipulated to provide a variety of different angles of viewing. Figure 13, below, is a render of the gun base to illustrate the results of the technique.

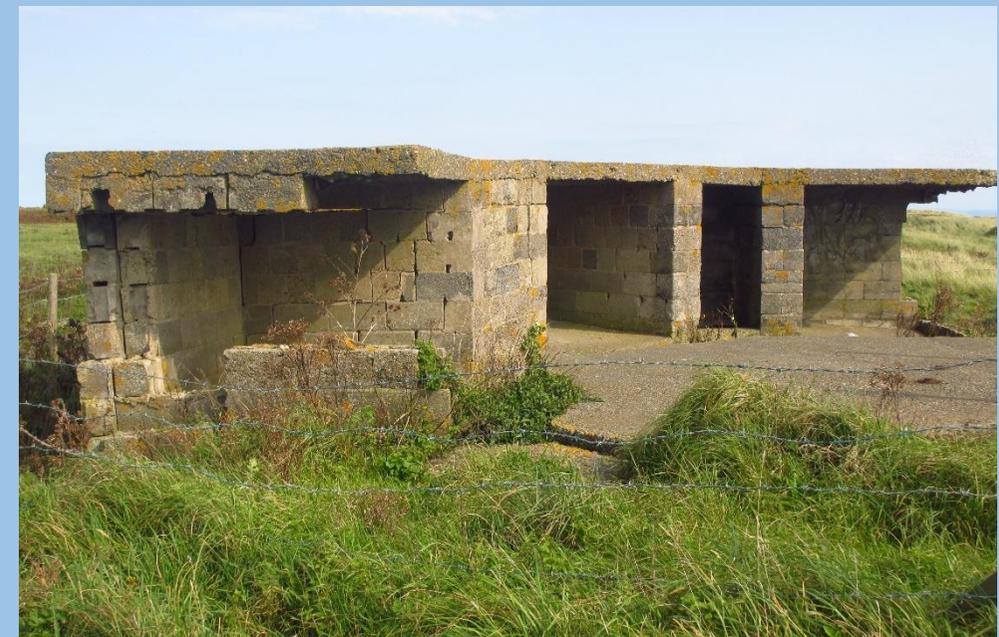
Figure 12: #21 – Ammunition storage buildings

| 21 | Gun Emplacement | 7.8 x 7.8m | Octagonal concrete base with associated cinderblock and brick storage buildings. See also #18-20 | Poor | Concrete base in reasonable condition, but ancillary structures dangerous and collapsing - no public access due to safety concerns. |

The octagonal gun base on this emplacement is still largely in its original position, though is becoming undermined by shoreline regression. It is otherwise identical to the three others (#18-20). In addition to the base, this emplacement has intact ancillary ammunition storage buildings to the rear (see figure 12). These comprise three cinder block three-sided bays without surviving doors. The roof is a concrete slab, now in bad condition – the area has been closed to access due to the threat of collapse.

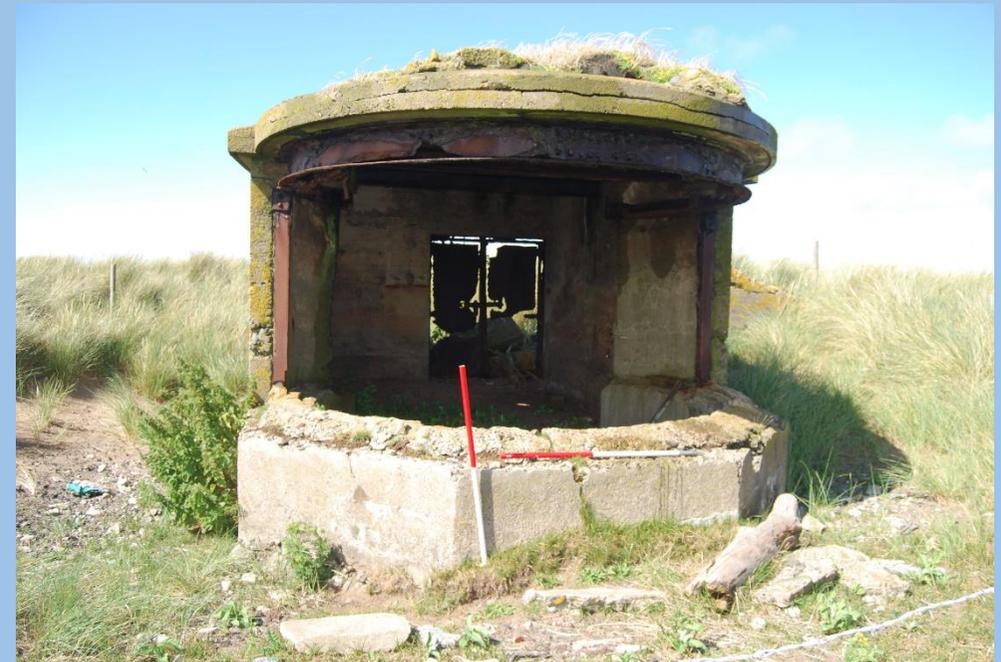
Figure 14: #1 – Searchlight emplacement

| <i>ID</i> | <i>Type</i> | <i>Dimensions</i> | <i>Description</i> | <i>Condition</i> | <i>Condition Comments</i> |
|---|---|---|---|---|--|
| 1 | Searchlight Emplacement | 6 x 4m | Concrete building with steel beams. Steel beam supporting concrete roof at opening. Faces 190 degrees south west. | Very Poor | Concrete spalling, deterioration of steel beams, vegetation on roof. Corroded rear doors. |

The condition of this emplacement is poor. The roof is covered with a depth of soil and vegetation which is visibly straining the steel beam across the curved front opening – its only support in this area. The concrete overall is badly spalled, and the steel rear door is badly corroded. The emplacement has been closed to public access due to the danger of collapse. See figure 14.

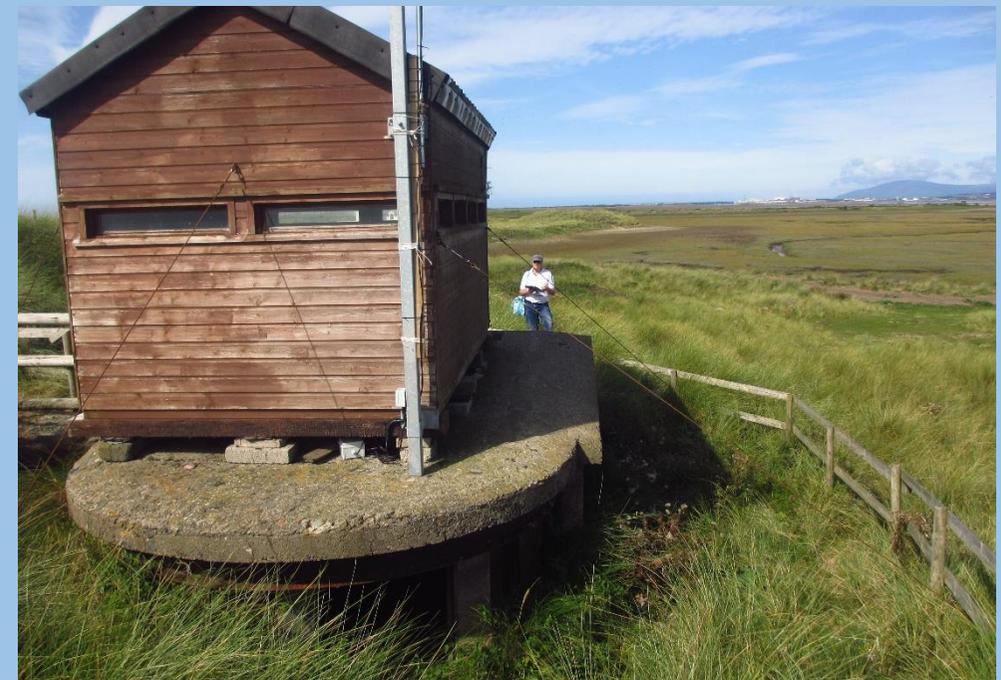
Figure 15: #5 – Searchlight emplacement

| <i>ID</i> | <i>Type</i> | <i>Dimensions</i> | <i>Description</i> | <i>Condition</i> | <i>Condition Comments</i> |
|---|---|---|---|---|--|
| 5 | Searchlight Emplacement | 4.23 x 4.1 x 1.8m | Concrete searchlight emplacement, shutters still in place. | Fair | Partially buried by sand dunes, shutters in poor condition, has bird hide built on top. |

The second searchlight emplacement is identical in form to the first (#1) but it differs significantly in condition. In this case the structure has been partially buried by sand-dunes, which has presumably aided its preservation. As a result, it

is in excellent structural condition, with its shutters still in place. There is a bird-hide placed onto the roof, which was closed at the time of the survey whilst assessments are made to the integrity of this structure. See figure 15. The rear access is now buried in sand, but access to the interior is possible through shutters. The interior is now used for storage and has evidence of concrete spalling and cracking, and suffers from the ingress of roots and moisture.

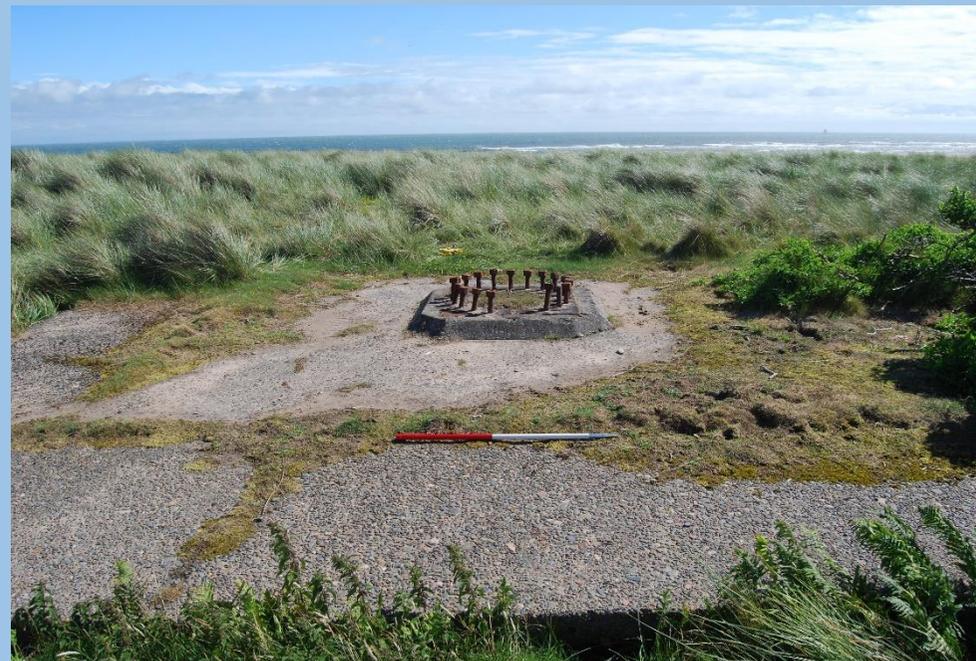
Figure 16: #2 – Gun base with holdfast

To the west of searchlight emplacement #5 is a complex of features that represent the remains of the battery itself. This comprises two gun bases (#2,3) and a pair of sunken ammunition stores, linked to the gun bases by two trenches sloping up to ground level. The gun bases are two rectangular concrete slabs (7.9 x 5.4m) with central octagonal holdfasts made up of 20 in-situ steel bolts, placed on a 1.5 sq m raised plinth in the centre. The western holdfast is partially covered with vegetation and the eastern is cracked and partially collapsed on two sides. Both are associated with brick and concrete rubble that may represent ancillary buildings or structures. See figure 16.

From evidence provided in the NMR (1429214), the battery mounted a pair of six-inch naval guns.

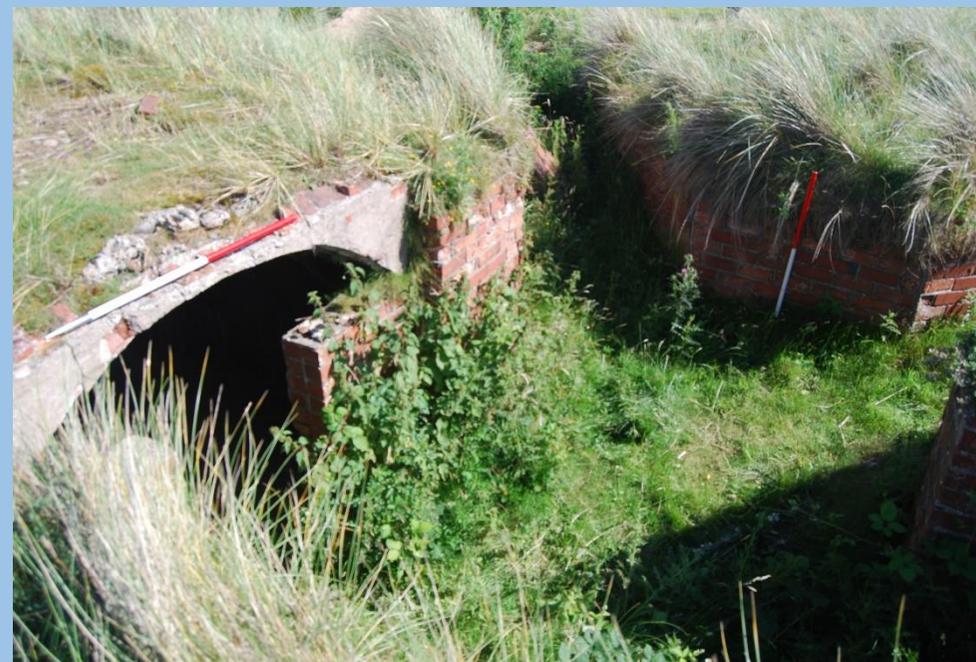
Figure 17: #4 – Ammunitions stores and trenches

| <i>ID</i> | <i>Type</i> | <i>Dimensions</i> | <i>Description</i> | <i>Condition</i> | <i>Condition Comments</i> |
|---|---|---|---|---|--|
| 4 | Ammo Store | 1.4 x 3.1m (x2) | Two sunken nissen huts with Y-shaped slit trenches leading to gun platforms. Brick lined trenches. Huts 1.7m below surface. Brick-built, corr. iron roof. Trenches 6.5m in length sloping to surface. | Fair | Overgrown, some collapsed brickwork. Iron roofs in good condition, except near entrances. |

From the sunken area between the stores two diverging trenches slope up to ground level, leading to each of the gun bases. These trenches are brick-lined and measure 6.5m in length. They are in fair condition, with some collapsed brickwork from the walls, but as the bases are grassed there is no evidence of any features for the transportation of ammunition.

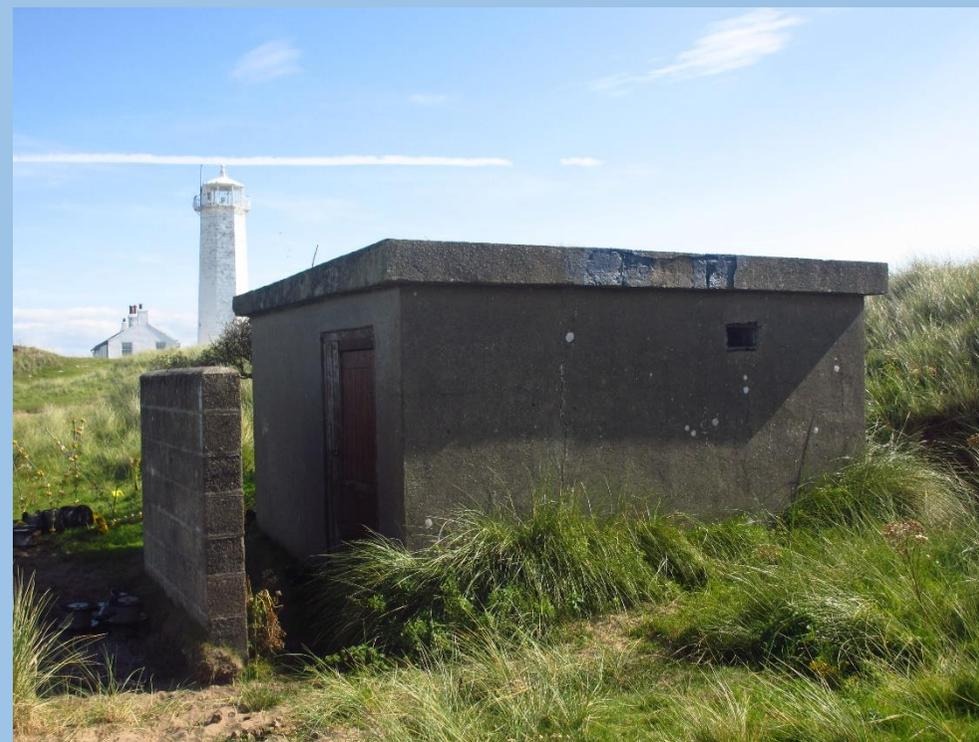
Figure 18: #14 – Concrete building

A rectangular concrete building with a breeze block wall protecting the entrance, measuring 3.7 x 4.1m. In good condition, now used for storage by the occupant of domestic dwellings at the lighthouse. See figure 18. It is likely that this building is a survival, in addition to #15 to the west, of the ancillary buildings associated with Hilpsford Fort.

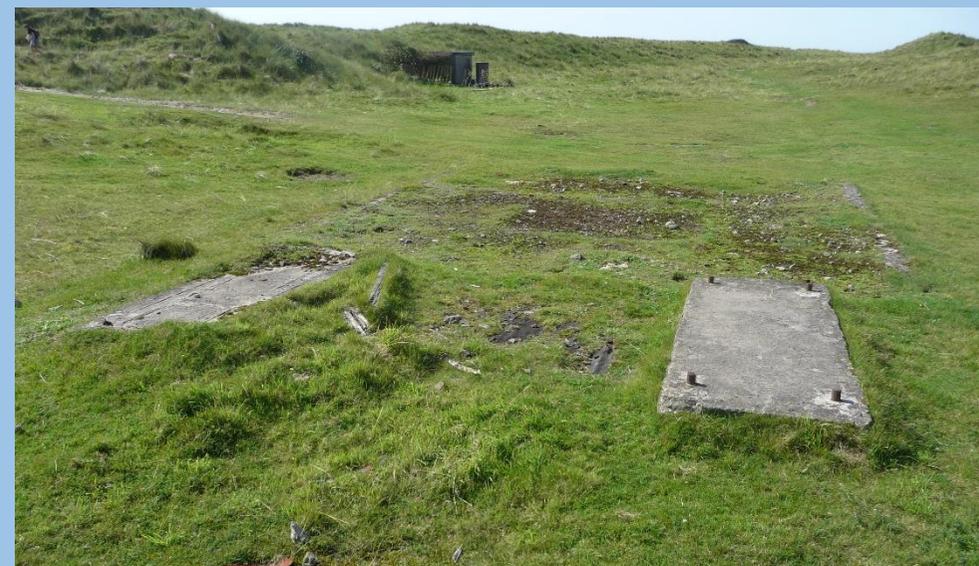
Figure 19: #16 – Concrete base

| 16 | Concrete Base | 7.8 x 4.7m | Structure outline, brick wall remains on 3 sides. 4th side open facing two separate concrete blocks (2.65 x 1m) with protruding steel rebar. | Fair | Mainly covered in grass, spalling of concrete bases. |

Within the area previously covered by Hilpsford Fort is a concrete base 7.8 x 4.7m in size. There are remains of brick walls on three of the sides, with the fourth apparently open, facing two further small concrete bases (2.65 x 1m) with protruding steel rebar. The base is somewhat overgrown with grass and there is evidence of concrete spalling. The steel is somewhat corroded. See figure 19.

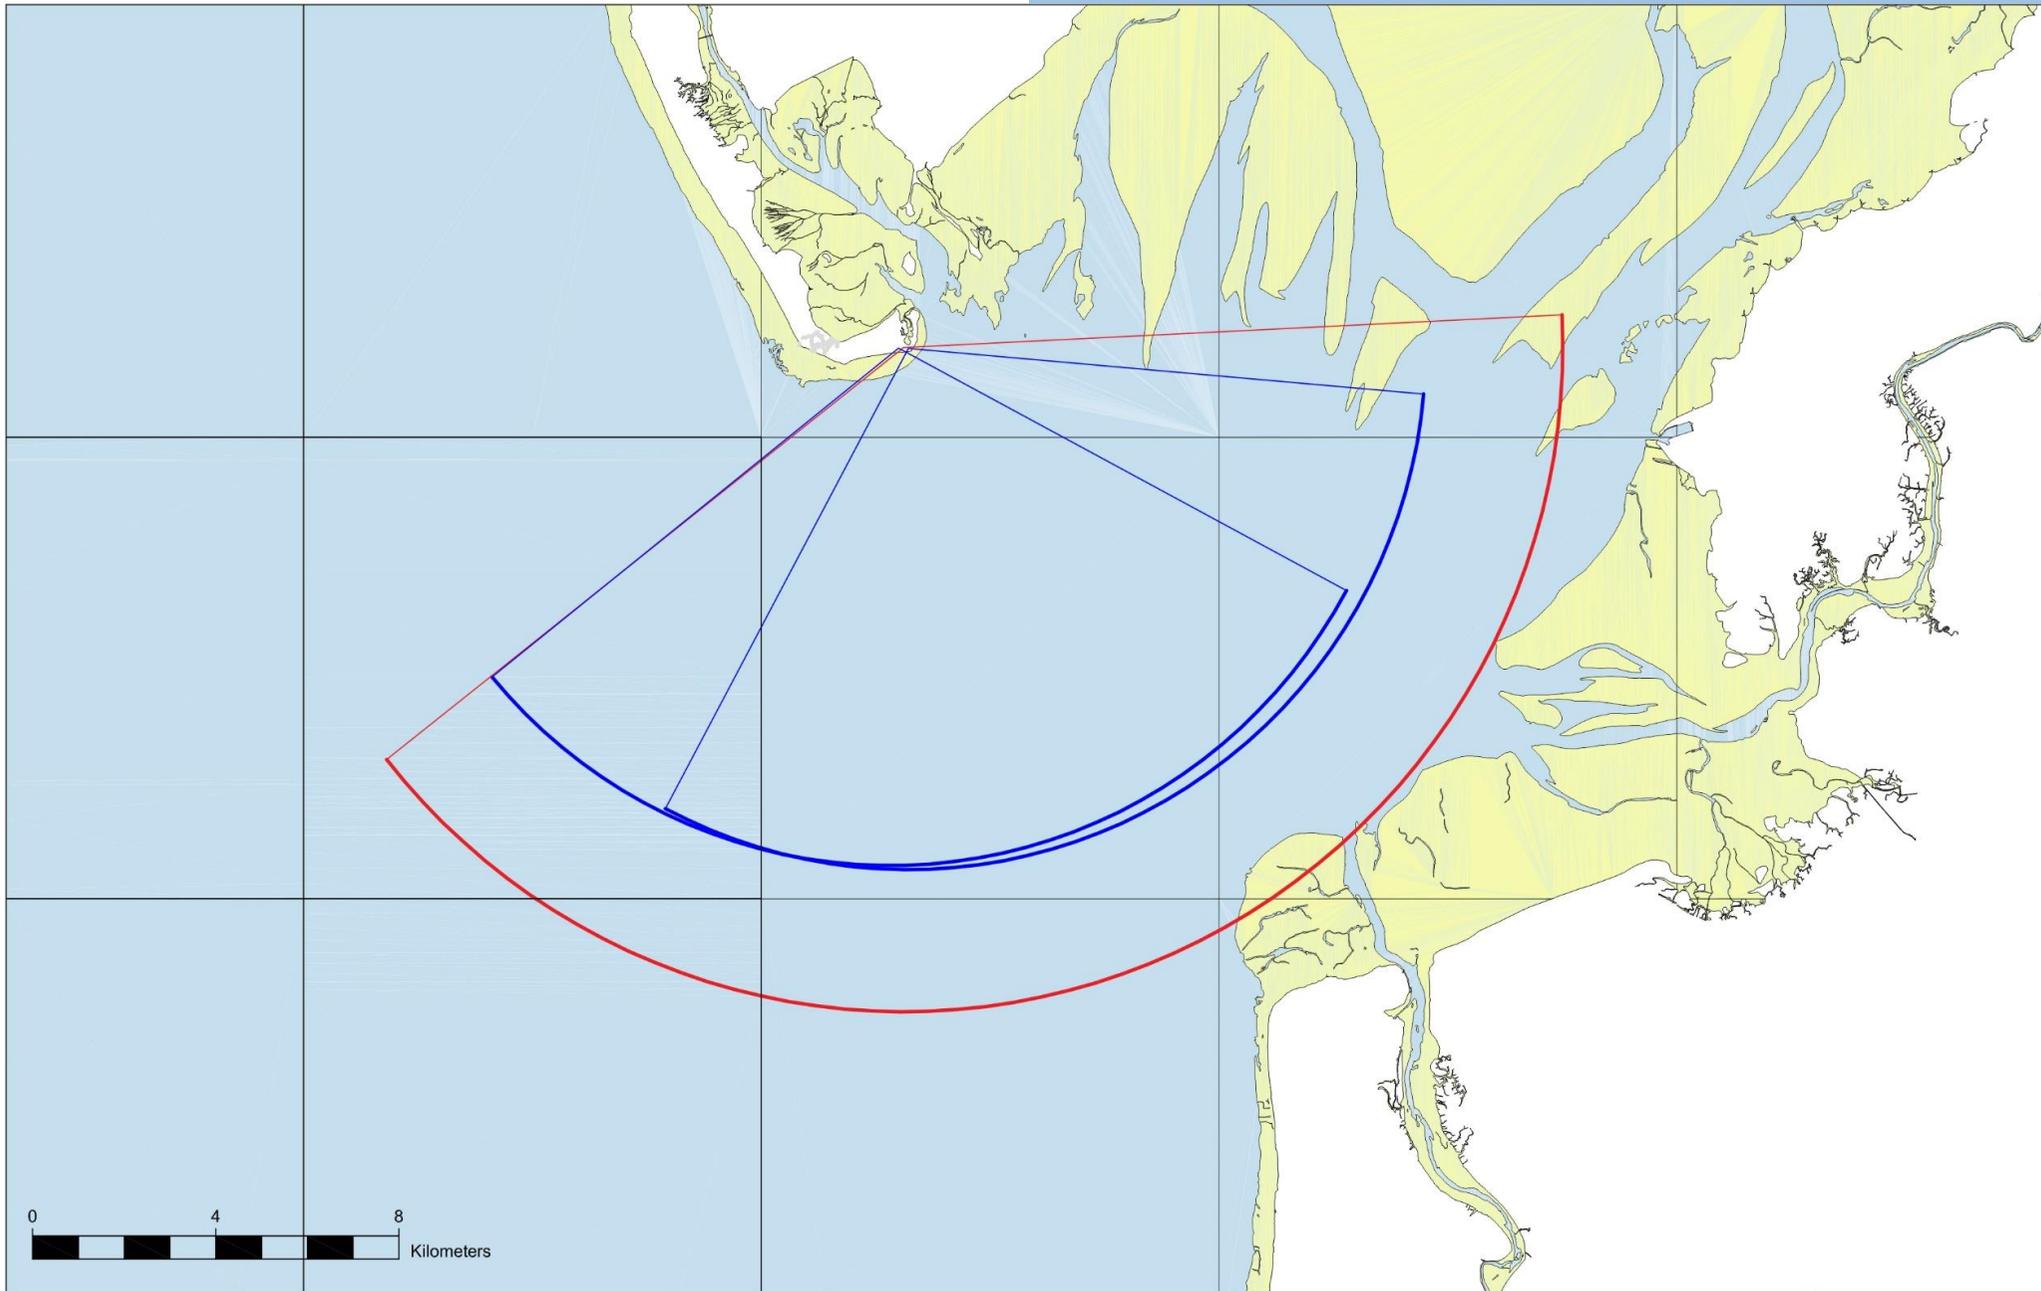
WWII Battery and Searchlight Ranges, Hilsford Fort

- Range of Mk.VII 6" Naval Gun
- Range of Searchlights (horizon distance)
