# MORECAMBE BAY PARTNERSHIP

Headlands to Headspace

## Jenny Brown's Point Archaeological Survey 2014-2016

Land off Lindeth Road  
Silverdale  
Lancashire

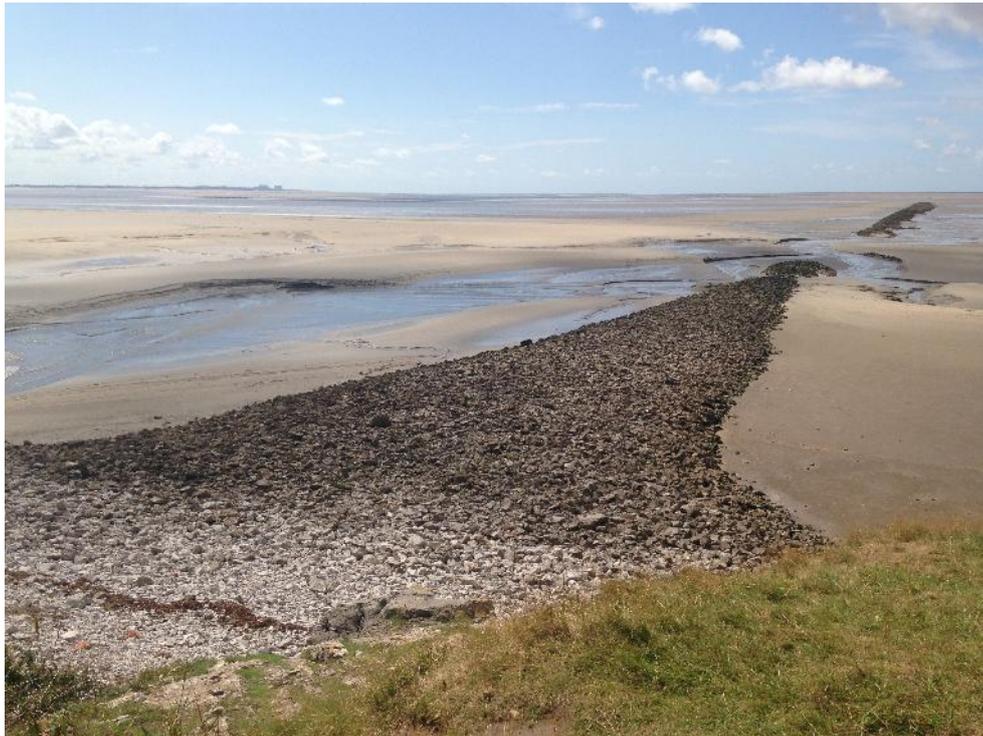
Plate 4. The remains of the embankment in 2015 formed of stone cobbles extending out into Morecambe Bay from Jenny Brown's Point, looking south-west

- 3.10 The remains of the embankment, which survive for a distance of c.1.66km into the Bay, were part of an ambitious land reclamation scheme-the vision of Herbert Walduck, a Manchester Metal Broker (Eadie 2012, 158 and Williams 2014, 17). The schemes laudable aim was to reclaim thousands of acres of land by building walls and embankments into Morecambe Bay, with the reclaimed land being used for agricultural purposes as well as constructing villa homes along the new shoreline and providing quicker railway access to the Furness Peninsula and coastal towns of Westmorland and Cumberland (Williams 2014, 16-17).

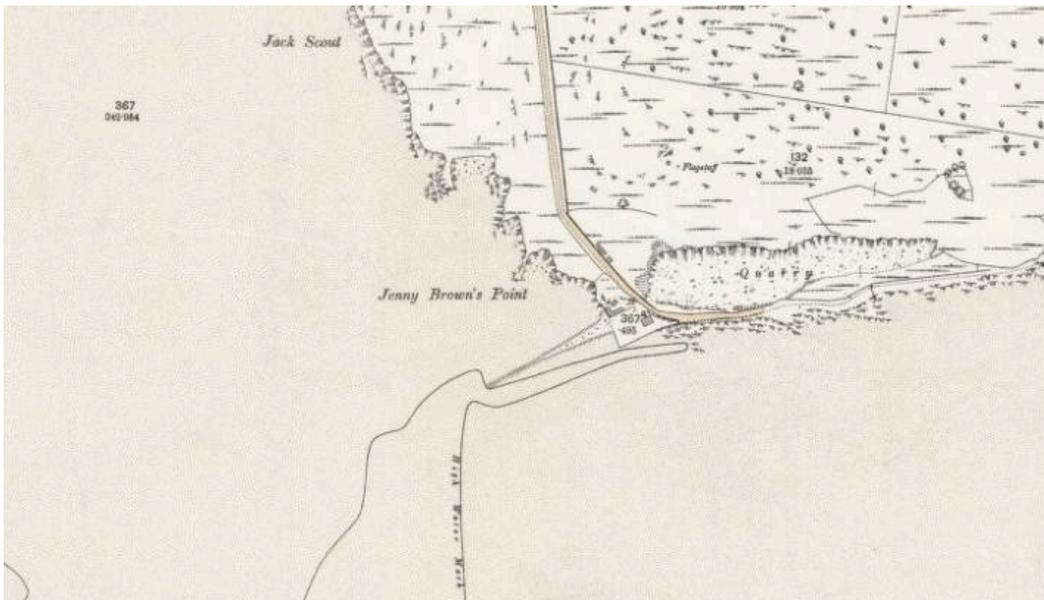
Plate 6. Excerpt of the 1891 25inch to 1 mile Ordnance Survey map of Jenny Brown's Point showing the embankment and the l-shaped area of the quay. Sheet XVIII.14. Surveyed 1889

- 3.15 The 'embankment' was constructed of limestone quarried from a large sub-rectangular quarry to the north of Lindeth Road (Lancashire HER PRN 12271), the extent of which is shown on historic mapping and can still be seen today (see Figure 2 and Plate 6).

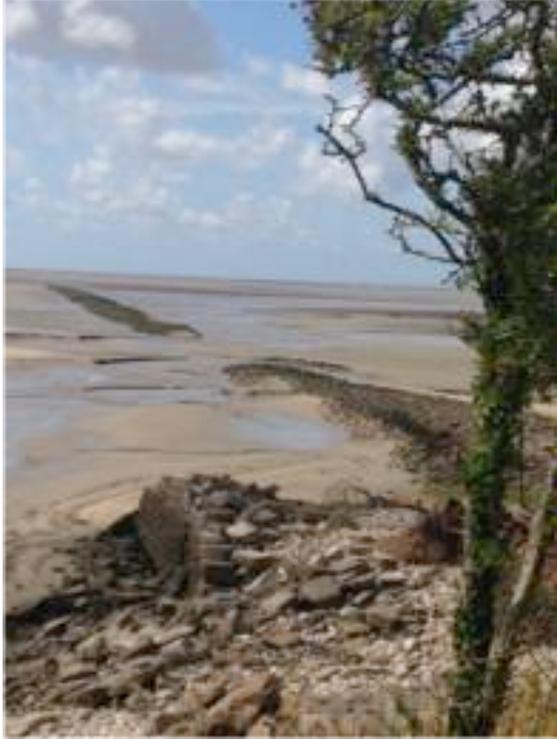
*Plate 8. Site 1B (front left) with the embankment (Site 1A) in the background (August 2014)*

- 3.21 Little is known about the substantial L-shaped quay, which survives (now partially collapsed especially in the centre) at the north-eastern tip of the embankment (see Plates 8-11). Whilst the relationship with the embankment (Site 1A) is unclear on the ground/in plan, it is recorded in the HER (PRN 11302) as being directly associated with the embankment. Perhaps this quay was used to bring in equipment/materials for the embankment construction works?

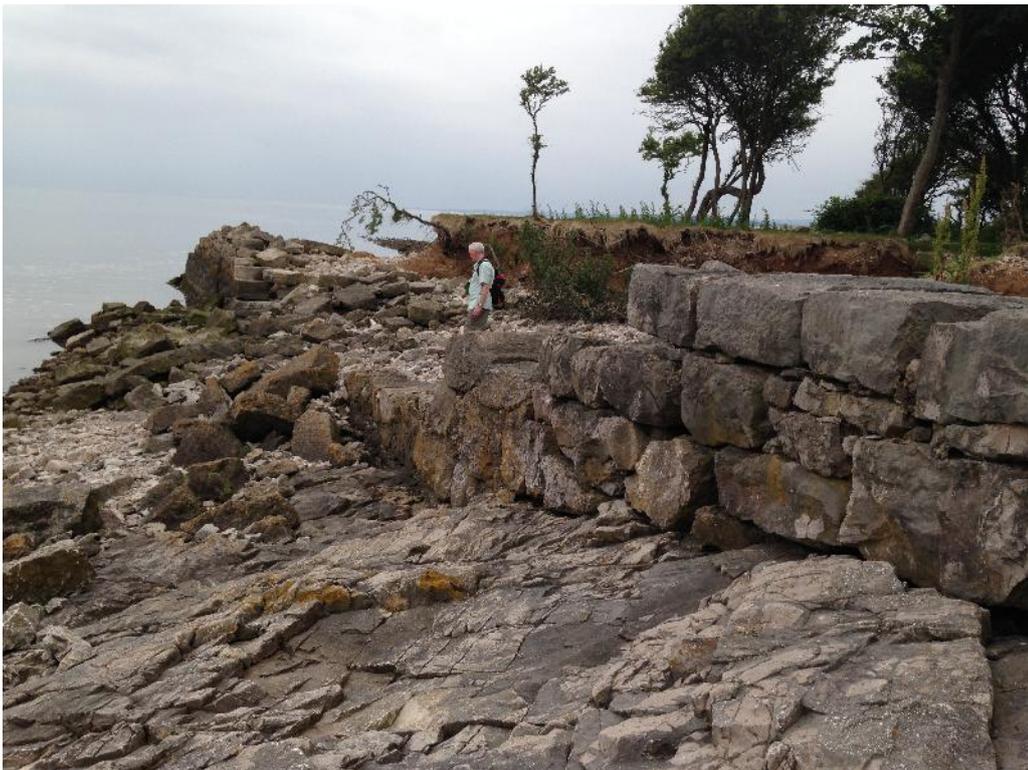
*Plate 9. The north-eastern extent of the remains of Site 1B showing the collapsed central section (August 2014)*

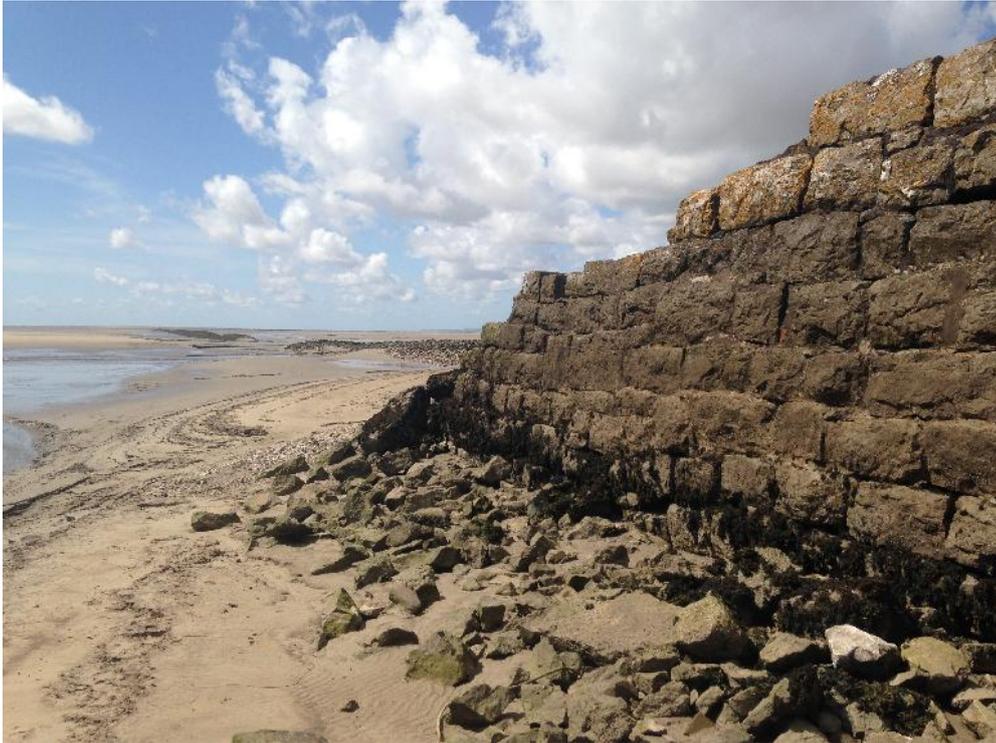
*Plate 10. The south-western limits of the stone quay/jetty with the embankment (Site 1A) in the background (August 2014)*

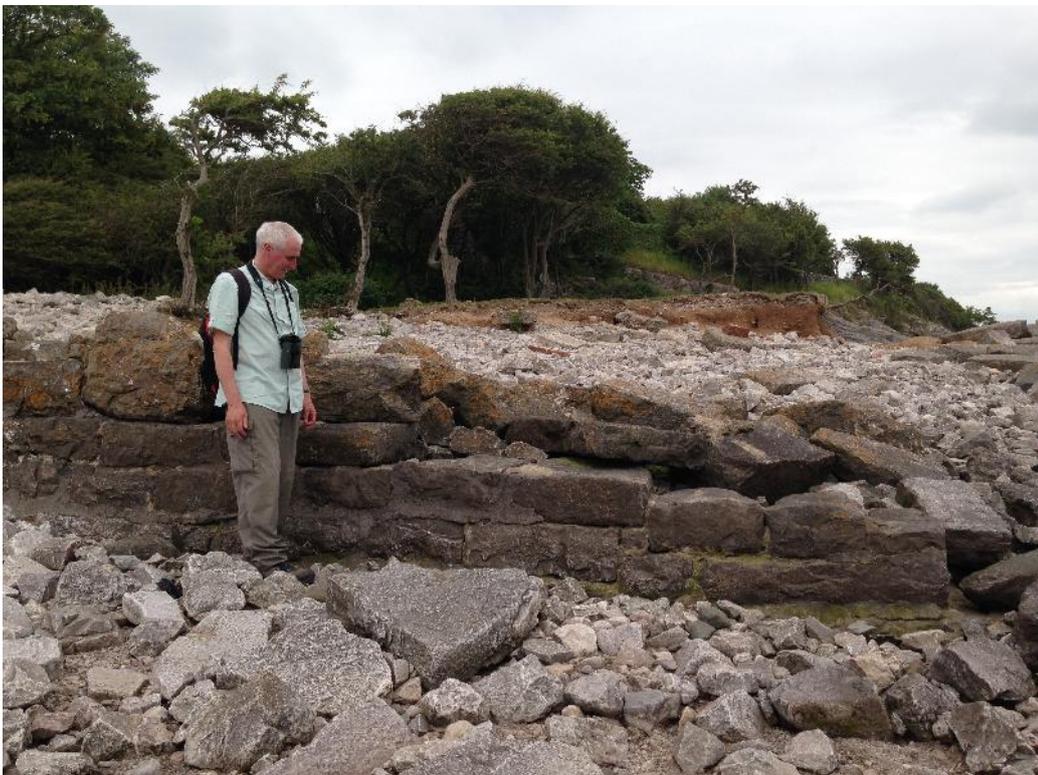
*Plate 11. Volunteer Simon Williams inspecting the north east-south west wall forming the southern side of the quay. The rubble of the embankment is in front. (August 2014)*

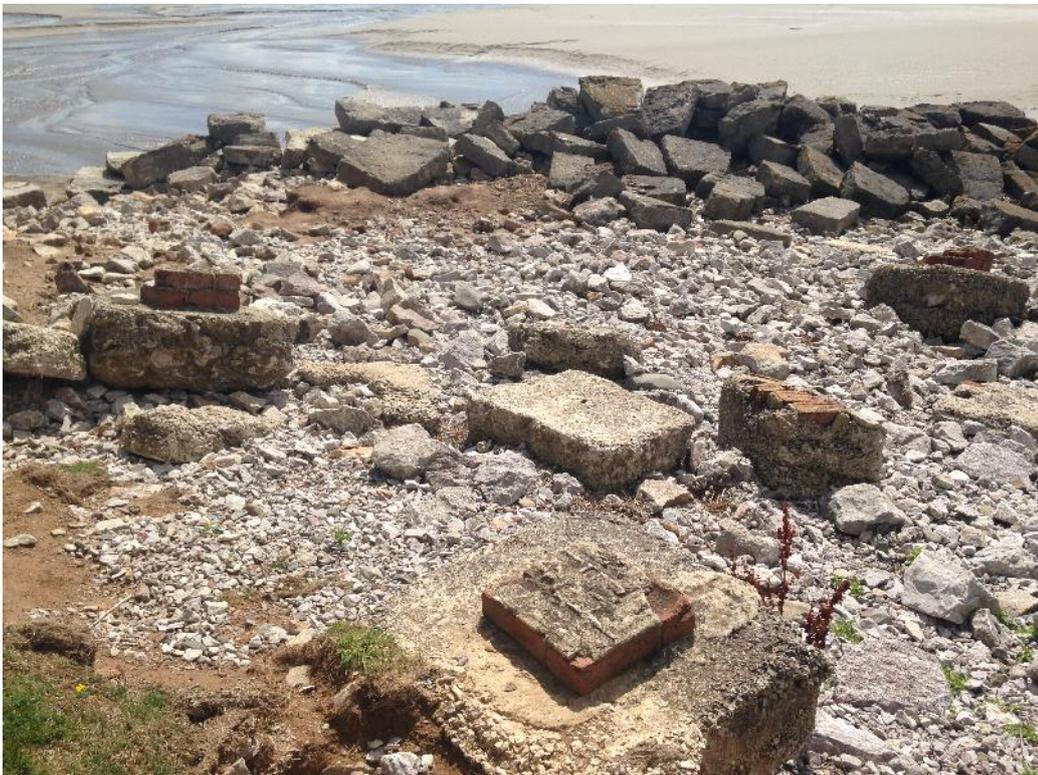
*Plate 12. Brick and concrete remains, forming part of a structure constructed above the embankment (Site 1A). Note, the collapsed rubble/remains of the quay/jetty in the background (Site 1B).*

- 3.23 A number of brick/concrete foundations are visible on the north-eastern tip of the embankment (Site 1A). These appear to post-date the embankment, however, what survives is fragmentary and collapsed. It is possible that these features are associated with the military use of the area in the Second World War, although no sites are listed in this area in the Defence of Britain database (<http://archaeologydataservice.ac.uk/archives/view/dob/>). Bombing targets and associated military buildings were mapped through aerial photographs and are recorded on Lancashire HER as PRN 33125. Upright posts that still can be seen in the distance to the south-west of Site 1C. These apparently supported a large canvas sheet with a target, which was used for bombing practice. The staff who controlled the bombing range were billeted at Brown's Houses. The remains at Site 1C require further investigation to determine if they formed part of this bombing practice range.

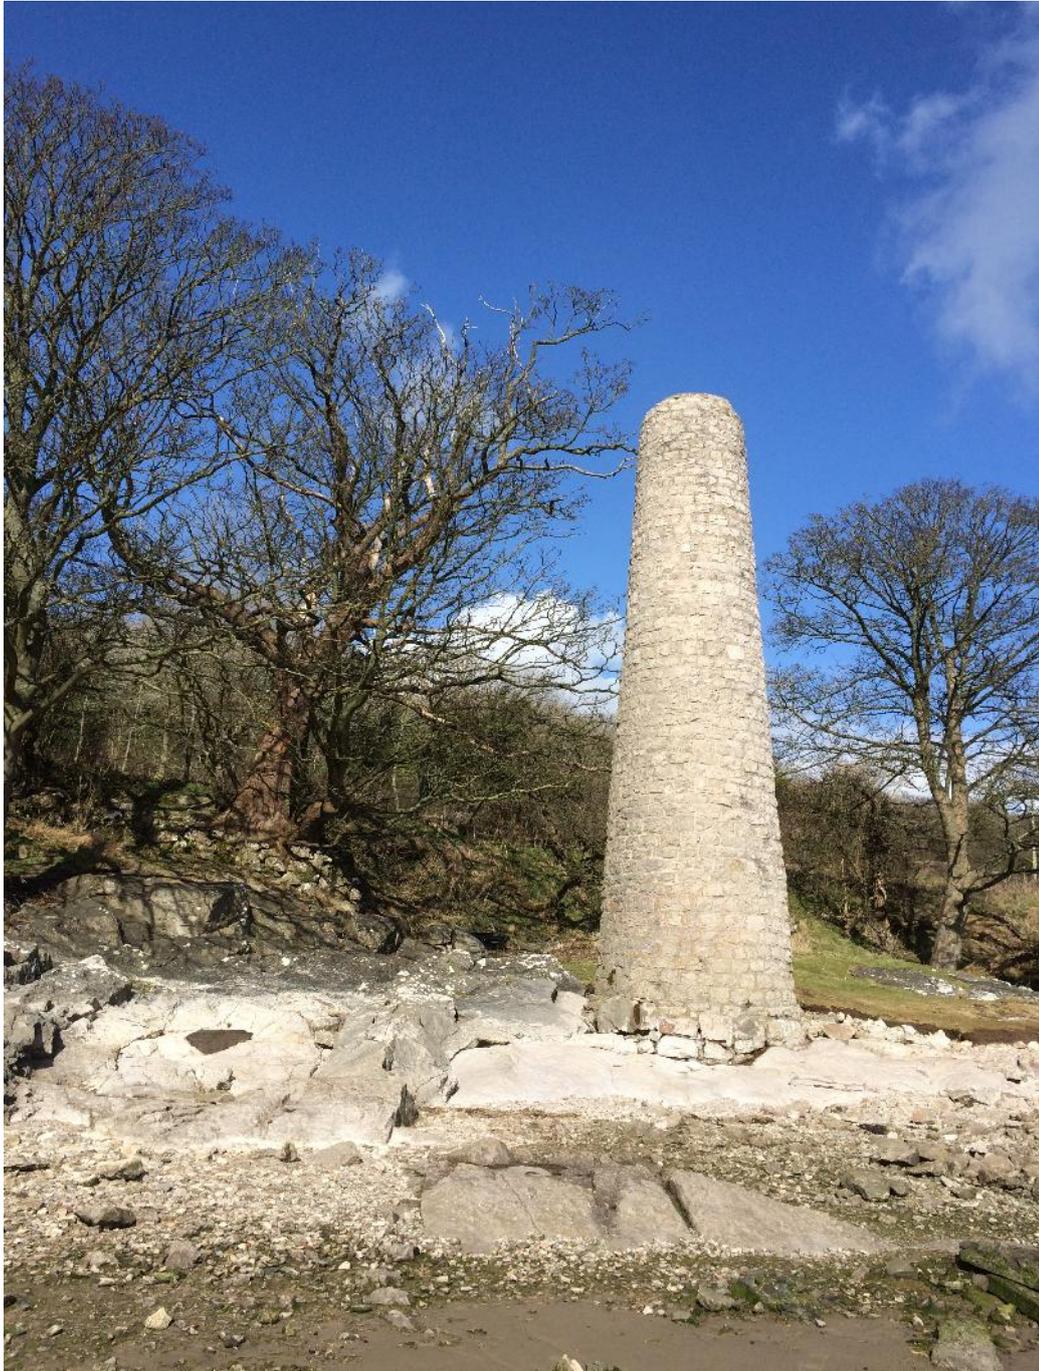
*Plate 13. The chimney at Jenny Brown's Point (Site 2A), looking east (March 2015)*

- 3.25 The chimney (Plates 12-13), which stands c.12m in height, forms one of the most iconic sites on the coastline of Morecambe Bay. It is located to the east of the headland at Jenny Brown's Point, and to the east of Brown's House, north of Quicksand Pool, a stream which flows into Morecambe Bay from Leighton Moss and skirts the southern edge of site (Figure 2).

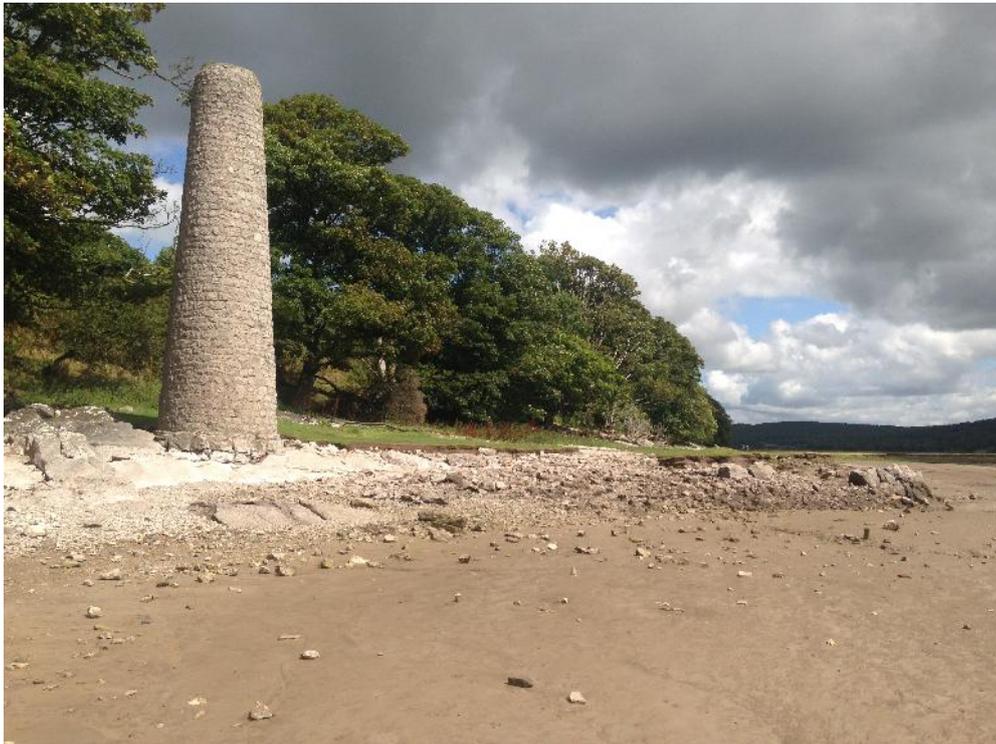
Plate 14. The chimney site (Site 2A) to the left with the remains of the revetment/quay (Site 2C) to the right, looking north-east (August 2014)

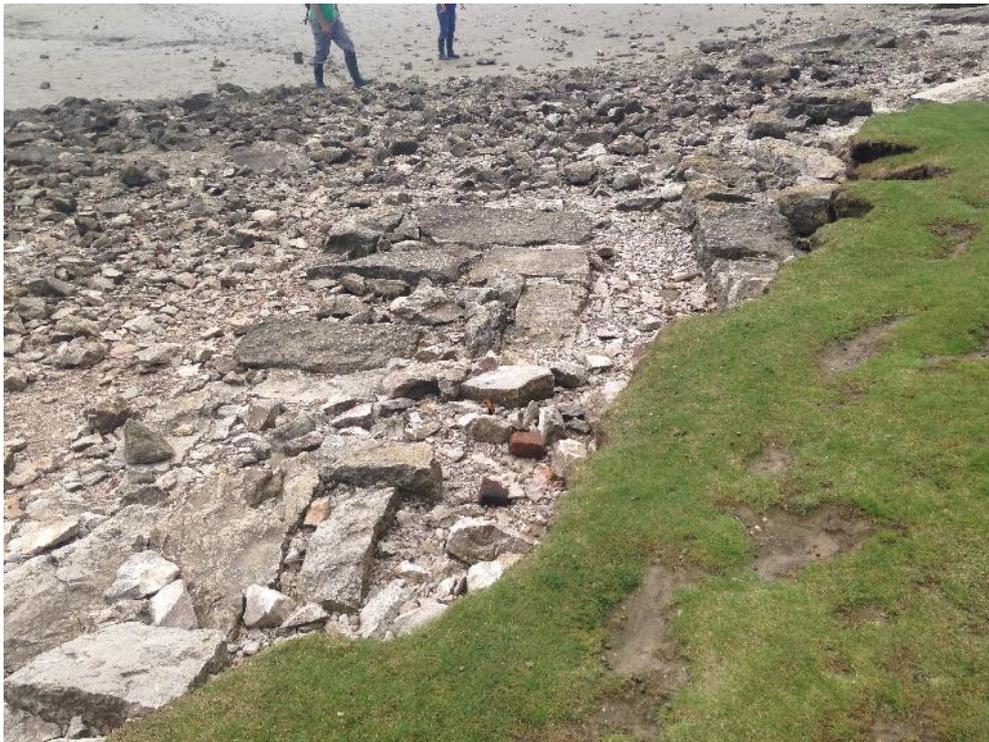
Plate 17. Site 2B: Wall foundations located to the east of the chimney, eroding from the saltmarsh, looking south-west (August 2014)

3.53 To the east of the chimney site, the limestone remains of building foundations are clear (Plate 16), eroding from the small section of salt marsh which remains in this area. This area of saltmarsh can be seen as occupying the surface of an artificial platform extending out from the natural shoreline and retained on its south side by revetment wall 2C (see below), with the built features exposed by tidal erosion either along the south edge, or within a more limited erosion scar on the surface of the platform (which lies just below current maximum high-tide level).

3.54 Communication recorded in the HER (PRN 4821) indicates that in 2008 erosion relating to high tides began to reveal possible flooring, sandstone flags and large dressed limestone blocks. These foundations were mentioned in the Phase 1 NWRCZA (Johnsons 2009, 216) and recorded rapidly during Phase 2 of this project (Feature 158, Eadie 2012, 155-6), where they are described as consisting of:

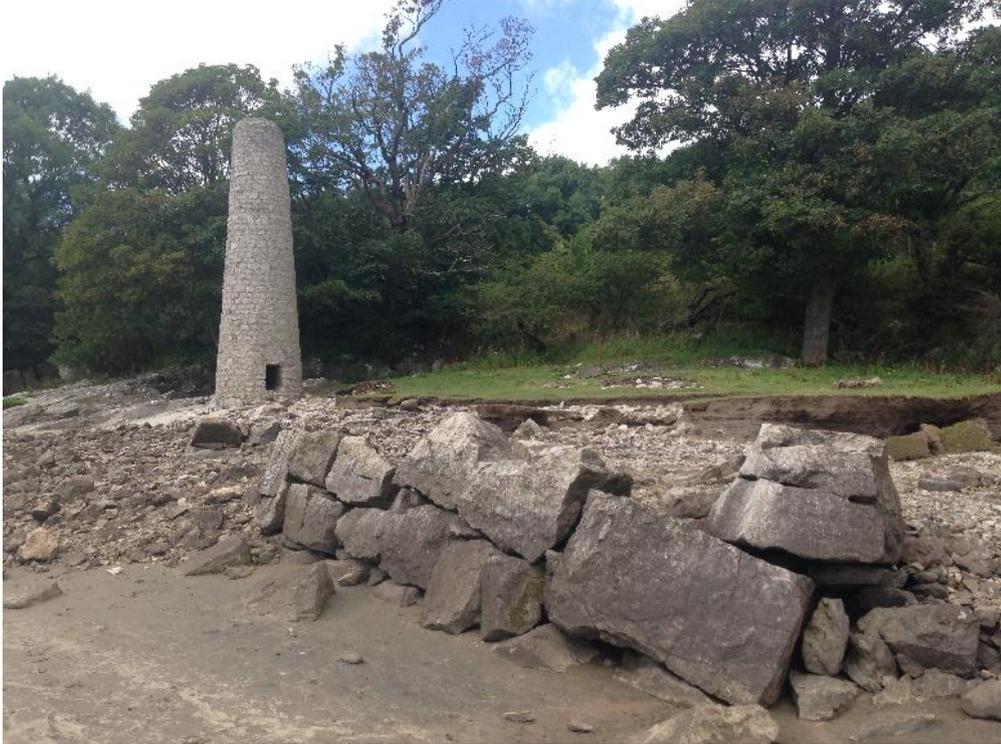
*Plate 20. Site 2C: The stone wall (in the foreground) forming a possible revetment, looking north-west*

3.59 To the south-east of the chimney (Site 2A) and the south of the building foundations (Site 2B) large, roughly square cut limestone boulders form an arc around the southern extent of the site (Plate 20).

3.60 This feature was interpreted as a jetty in the NWRCZA and given its proximity to the chimney stack (Site 2A) a functional relationship was suggested for the two features (Eadie 2012, 156). During the 2012 survey the 'jetty' was recorded to be c.17.5m in length and stand to a maximum height of c.1.2m (ibid). As noted above, it is now seen as the revetment or wharf wall of the site to its north.

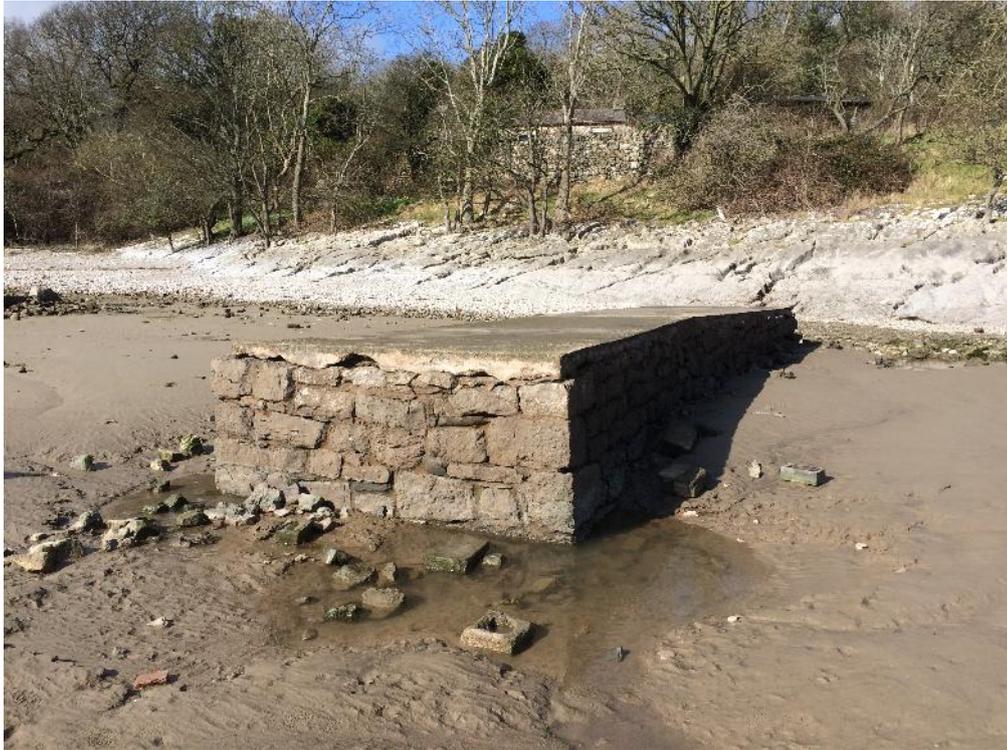
Plate 21. The sub-rectangular stone structure located to the south-west of the chimney, interpreted as a jetty/quay, looking north-west

3.61 Located c.64m to the south-west of the chimney (Site 2A) a sub-rectangular stone-constructed feature with a recent concrete cap remains extant (Plate 21). This structure has been interpreted as a quay/jetty which was only recently (re)exposed through erosion and the changes in the course of the Quicksand Pool- the stream located to the south of the site (P. Iles, pers. comm; HER PRN 4821).

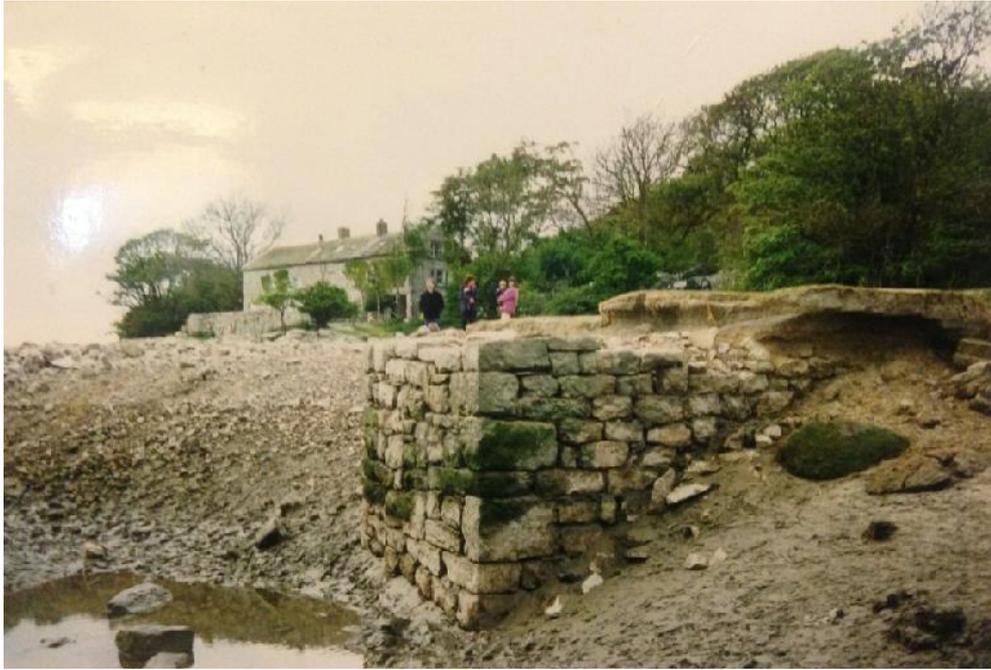
Plate 22. The southern end of Site 2D being eroded from the saltmarsh. Photo by Barry Ayres dated c.1995. Note at least seven courses exposed in this image.

*'constructed of large limestone blocks, laid flat, with a rubble core. A large baulk of timber can be seen within the core at the seaward end, by erosion of the fill. Any flagging or other surface has disappeared without trace. A few stones from the top course at the seaward end appear to be dislodged, and some small amount of the core washed away exposing the timber mentioned above, but otherwise the jetty appears in a similar condition to the earlier visit. Erosion of the salt marsh hereabouts appears to be accelerating, and Quicksand Pool is moving closer to the shore. The farmer's access bridge has been undermined and collapsed into the Pool...(P. Iles 1997, Pers. Com. From HER 4821).*

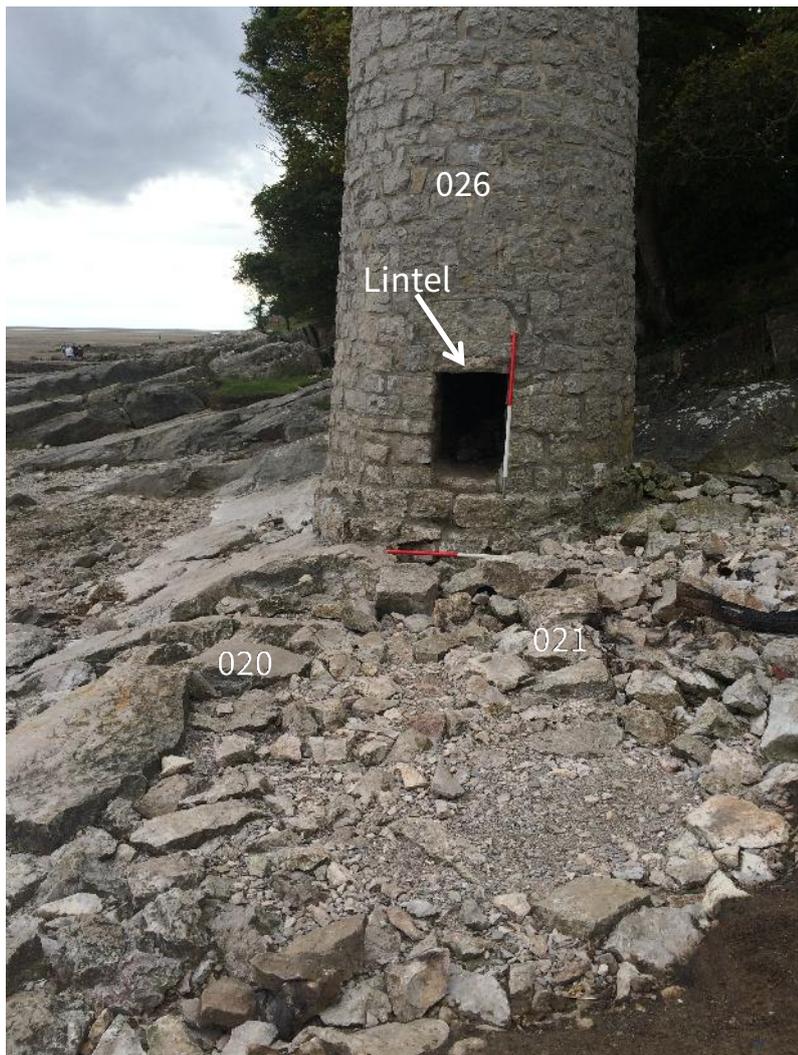
*Plate 34. Lower elevation of Chimney 026 showing the east-facing opening and foundations 021/021*

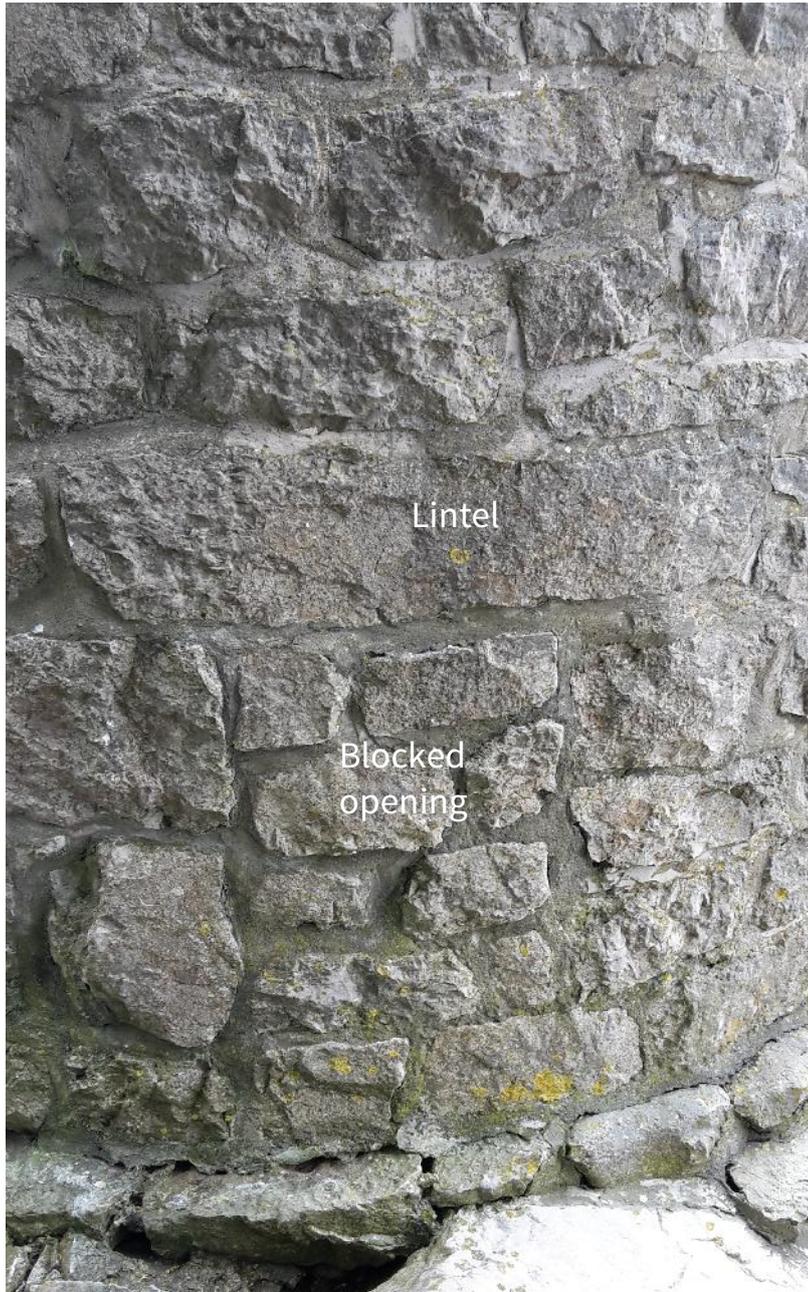
*Plate 35. Lower elevation of Chimney 021 showing blocked western opening and foundations 021/021. Photograph by Claire Asplin*

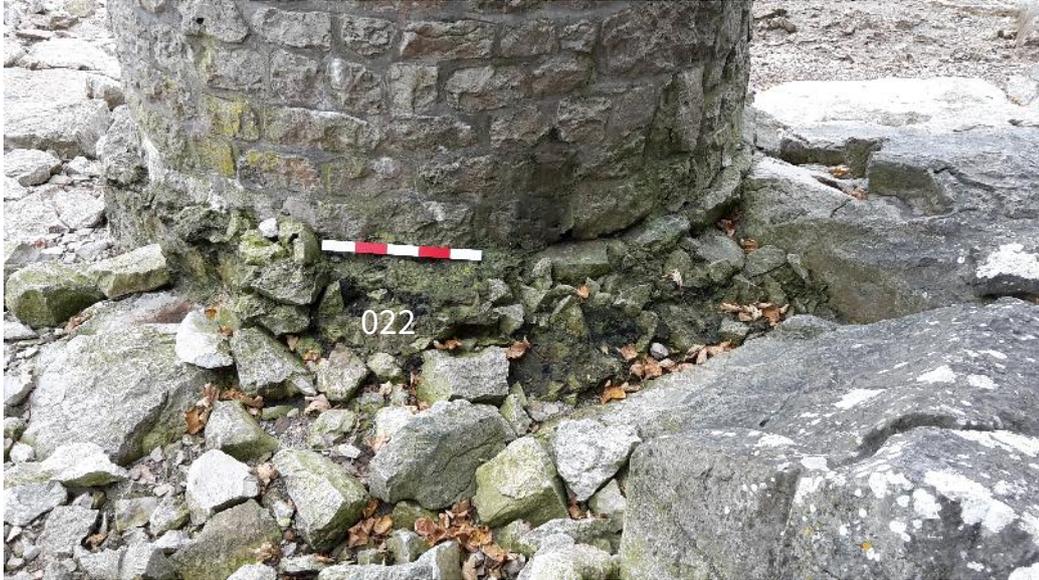
*Plate 36 Coal rich deposit 022 observed to the north of the chimney 026, looking south.  
Photograph C. Asplin*

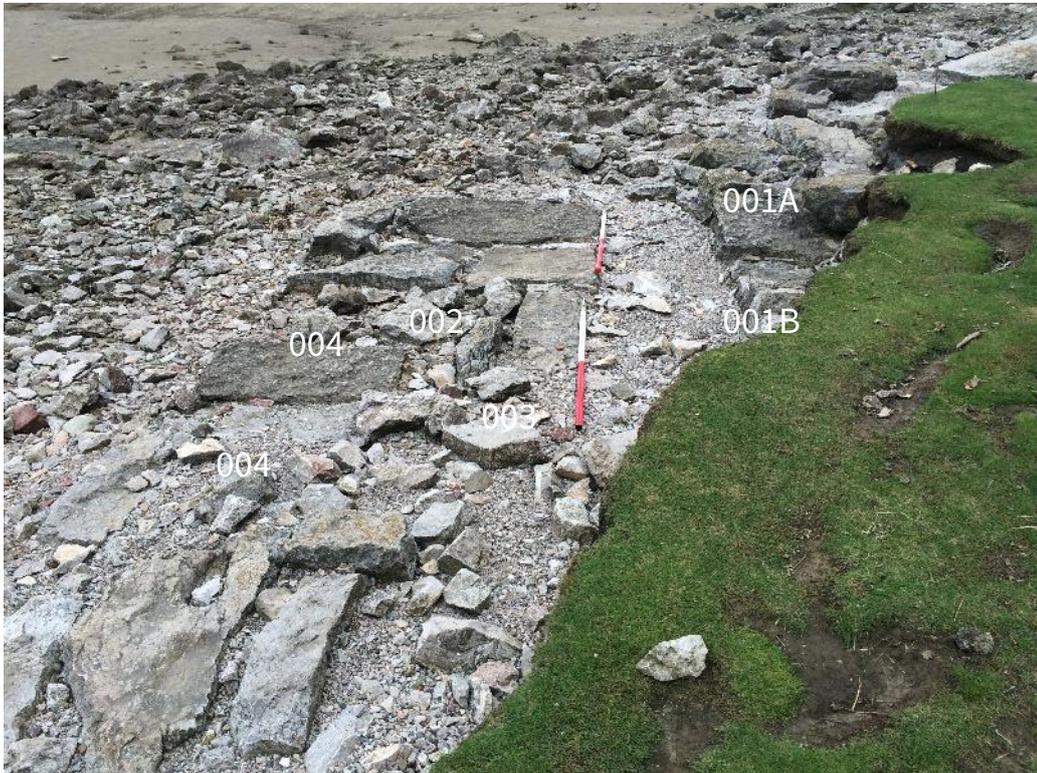
*Plate 37 North-east to south-west aligned wall foundations, noted to the south-east of the chimney, looking south-west*

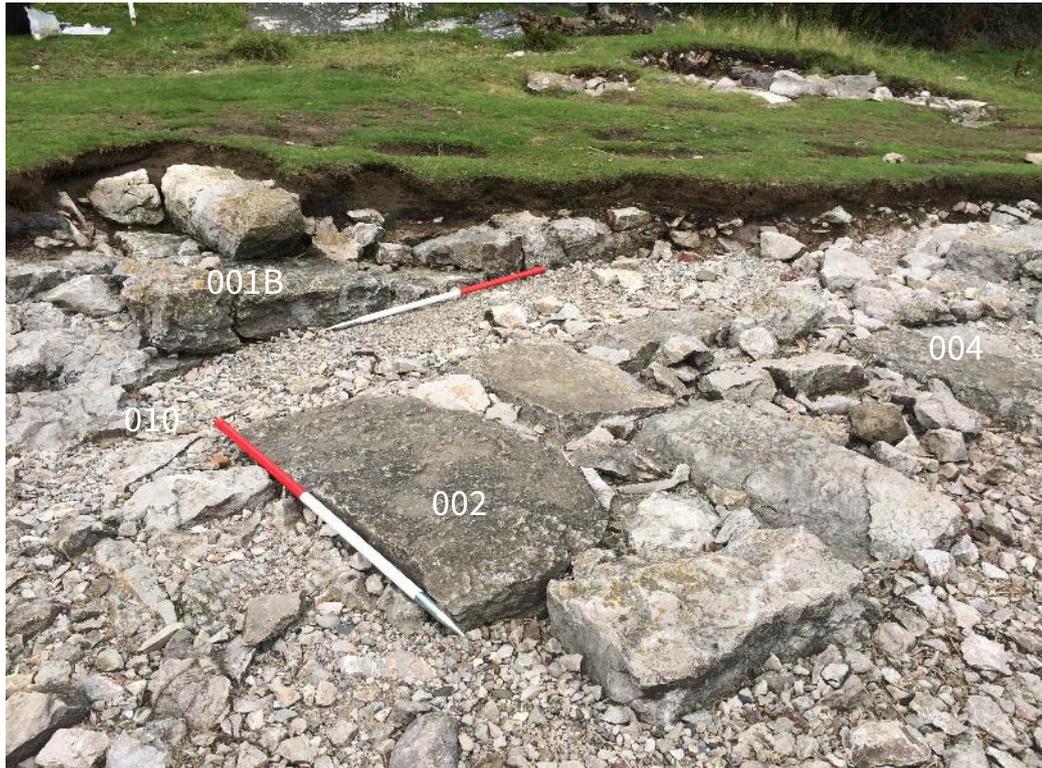
Plate 38. Wall foundations 001B and 002/004, looking north

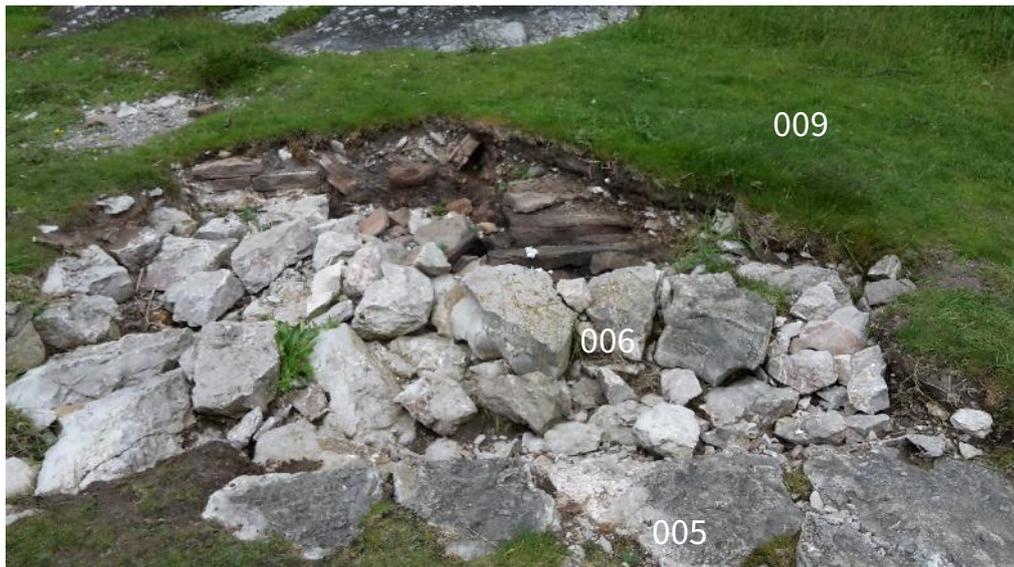
Plate 39 Wall foundation 005 and 006 and possible 'hearth' area, looking north

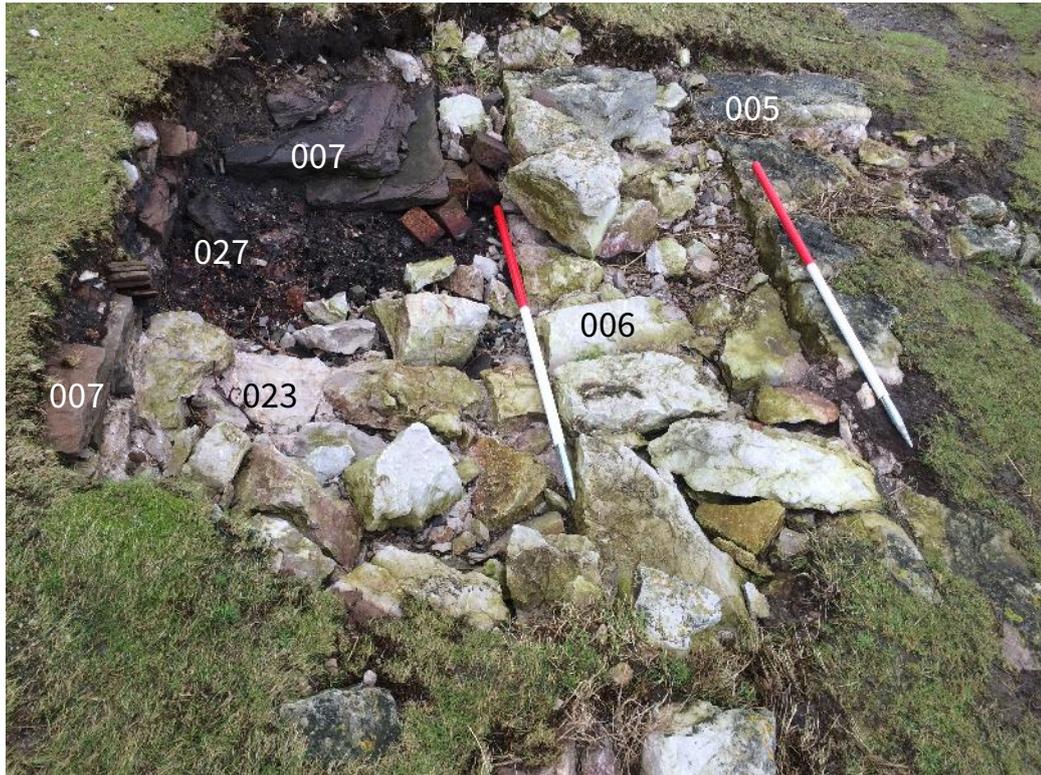
*Plate 40 Wall foundations 005, 006 and 023, and possible hearth area (007/027)*

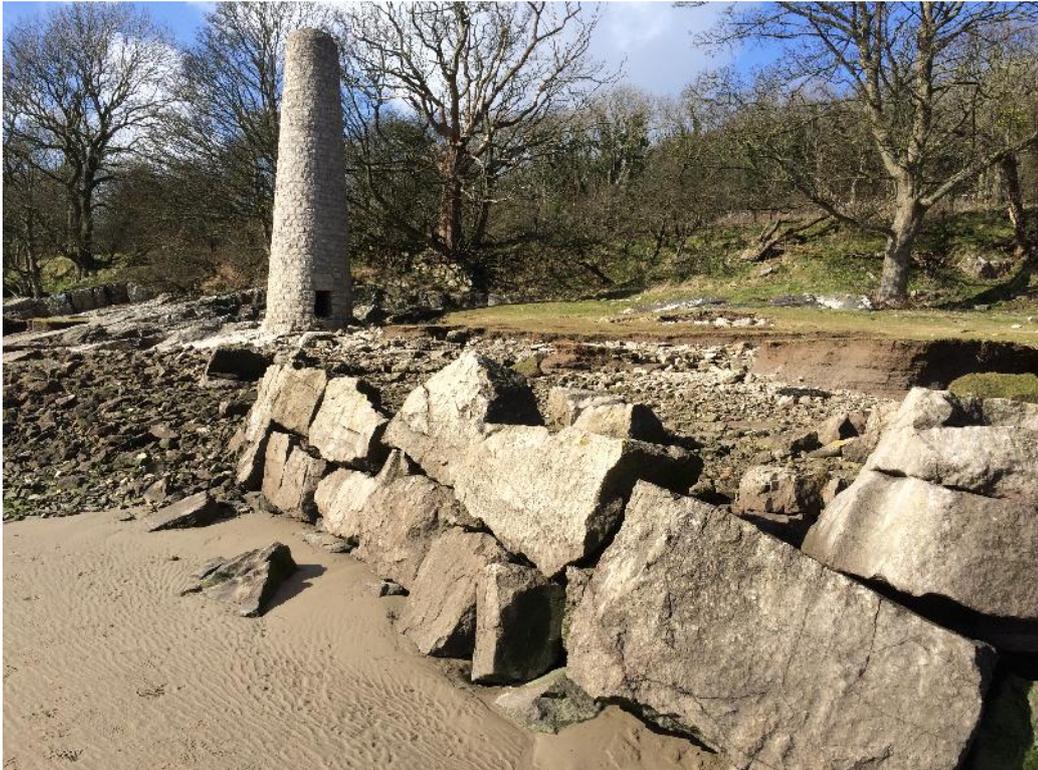
*Plate 41. Wall foundations 017 (foreground) showing relationship to chimney site, March 2017, looking north-west*

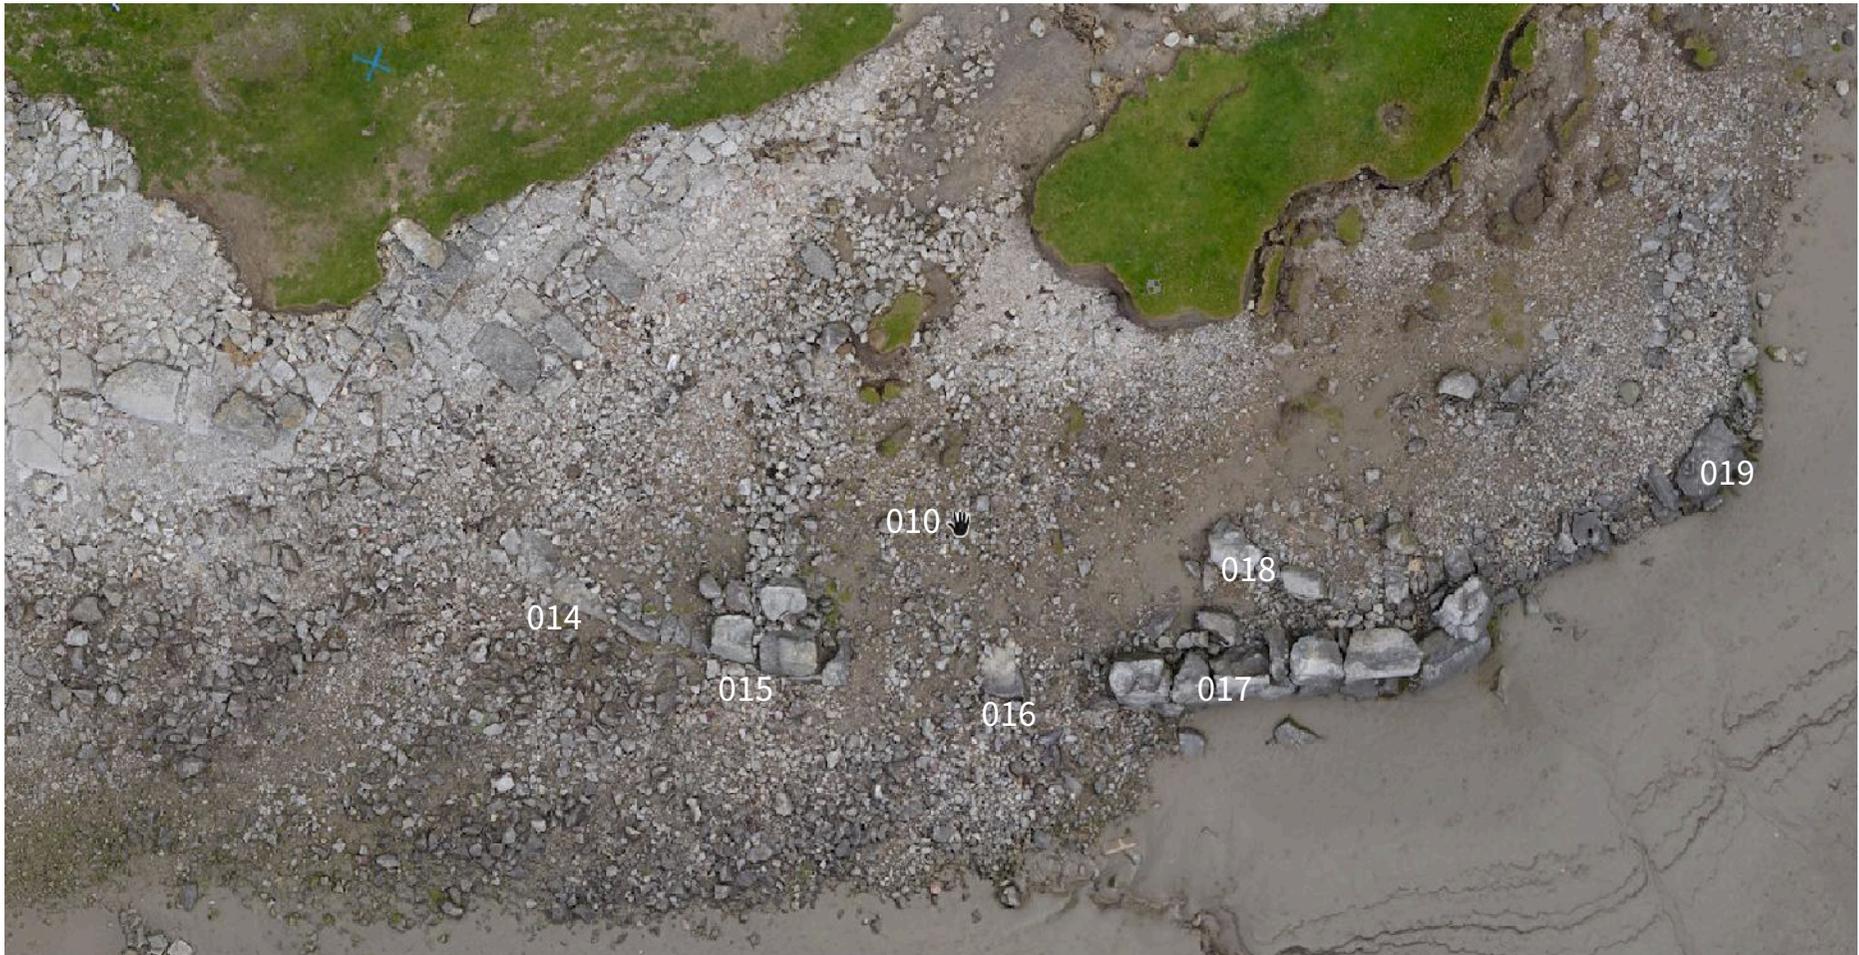
Plate 42 Aerial plan view showing the possible revetments walls 014-019

- 6.37 It is unclear if there are foundations beneath the blocks forming wall **(017)** and whilst on a similar alignment to **(014, 015, 016)** the difference in construction may suggest a different phase and/or use of this part of the structure. It certainly seemed to post-date **018**.
- 6.38 Since starting survey work at the site in 2015, a large channel has opened up to the immediate south of wall **(017)** following storms in the winter of 2015/6 (see Plate 45).
- 6.39 Targeted work is required to record/study these foundations and their relationships in more detail as only an overview is presented at this stage. This work is critical given the continued erosion of the site.

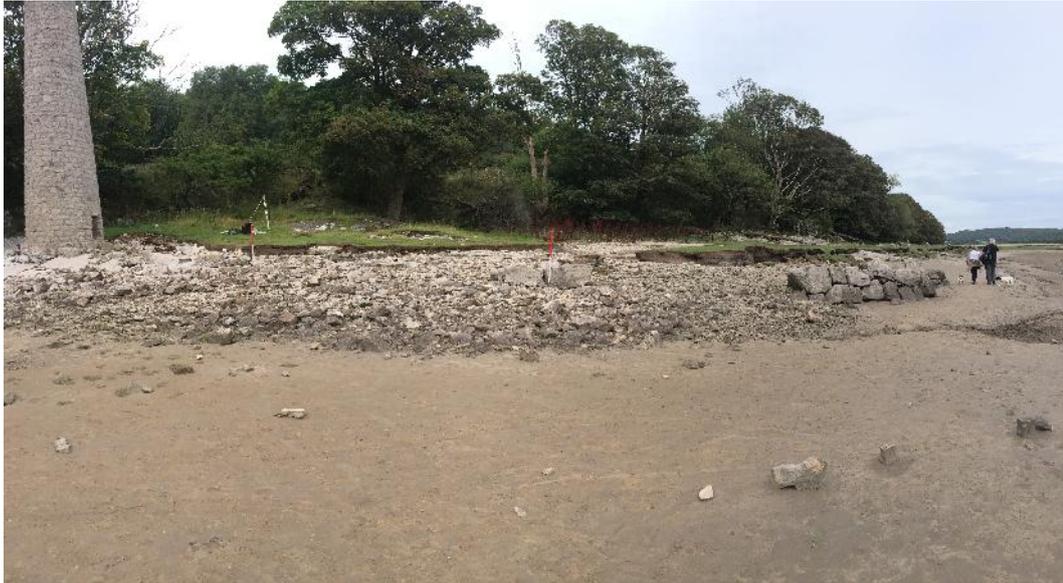
*Plate 43. Ranging poles define the north-western end of (014) left, wall (015) (centre) with wall (017) to the right, August 2015*

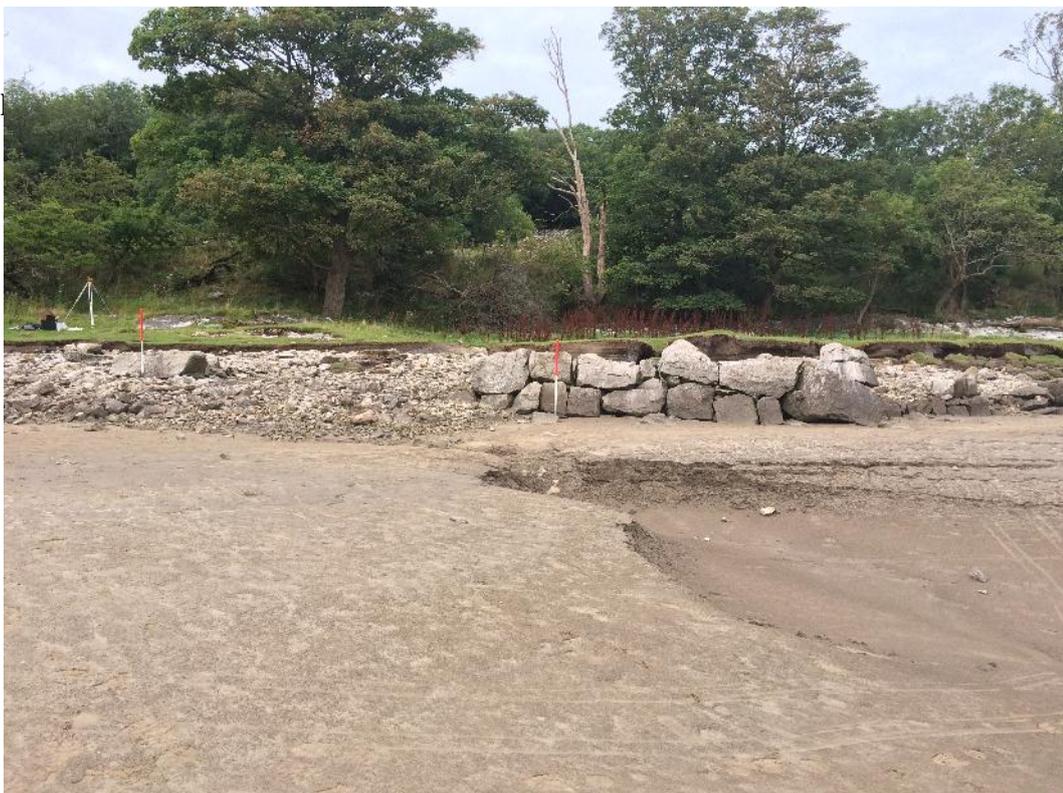
*Plate 44. Ranging poles define wall (015) left, wall (017) (centre), August 2015*

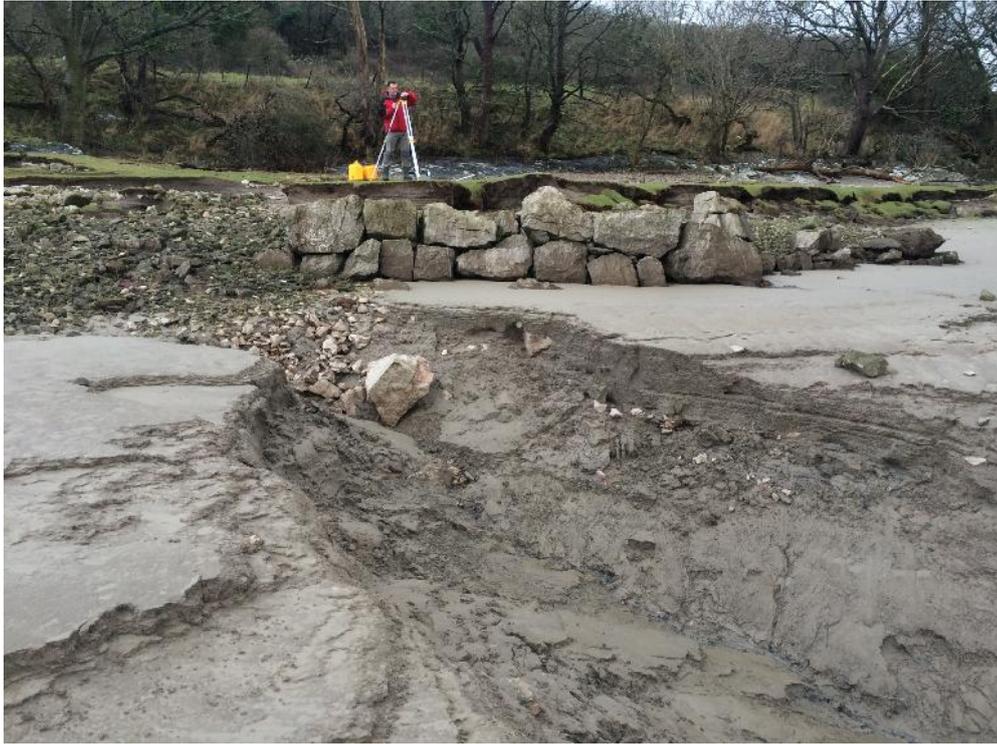
*Plate 45. Wall 017 showing the deep channel that had opened up in front of the structure during the winter of 2015/6. February 2016*
