# MORECAMBE BAY PARTNERSHIP

Headlands to Headspace

## Jenny Brown's Point Archaeological Survey 2014-2016

Land off Lindeth Road  
Silverdale  
Lancashire

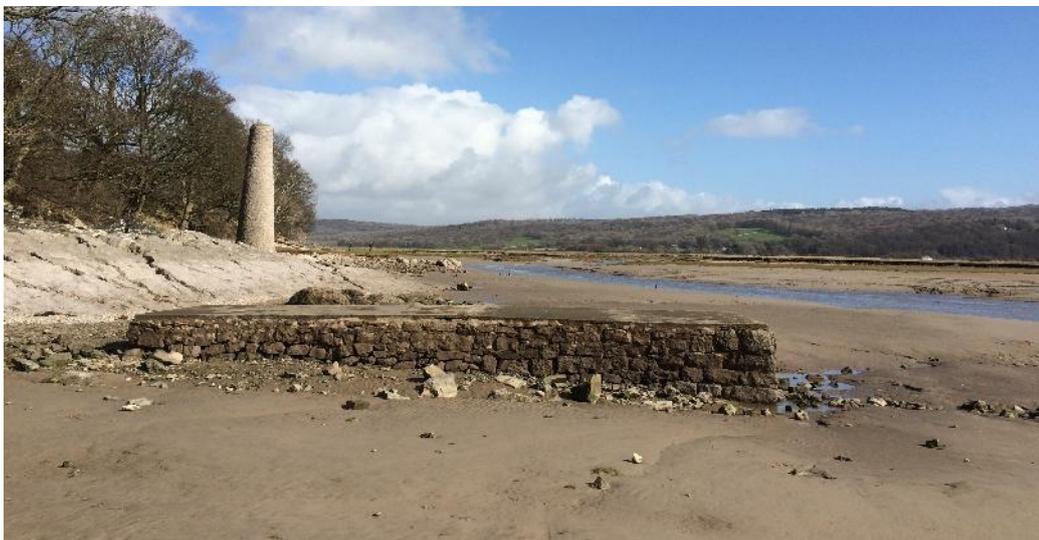
*Plate 46. Western elevation of possible jetty/quay (**100/101**) with the chimney (**026**) in the background, looking east. March 2015*

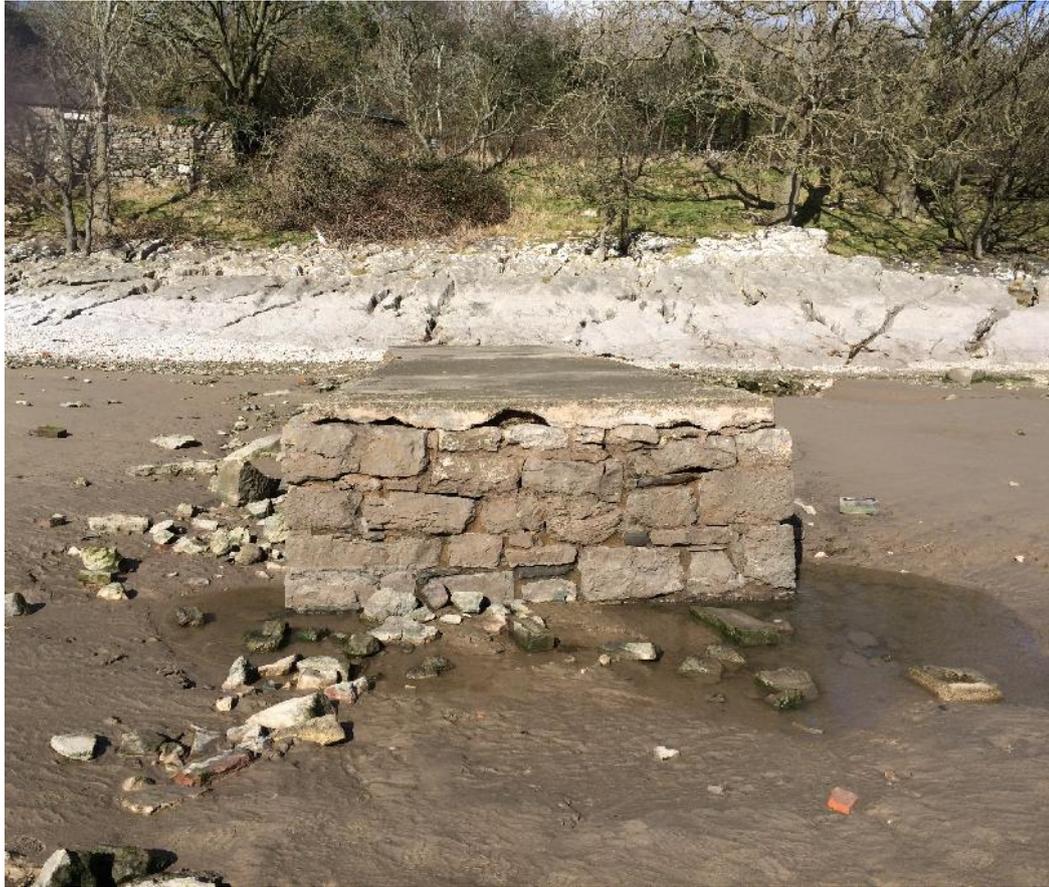
*Plate 47. Southern elevation of the possible jetty/quay (100/101) at Site 2B, March 2015*

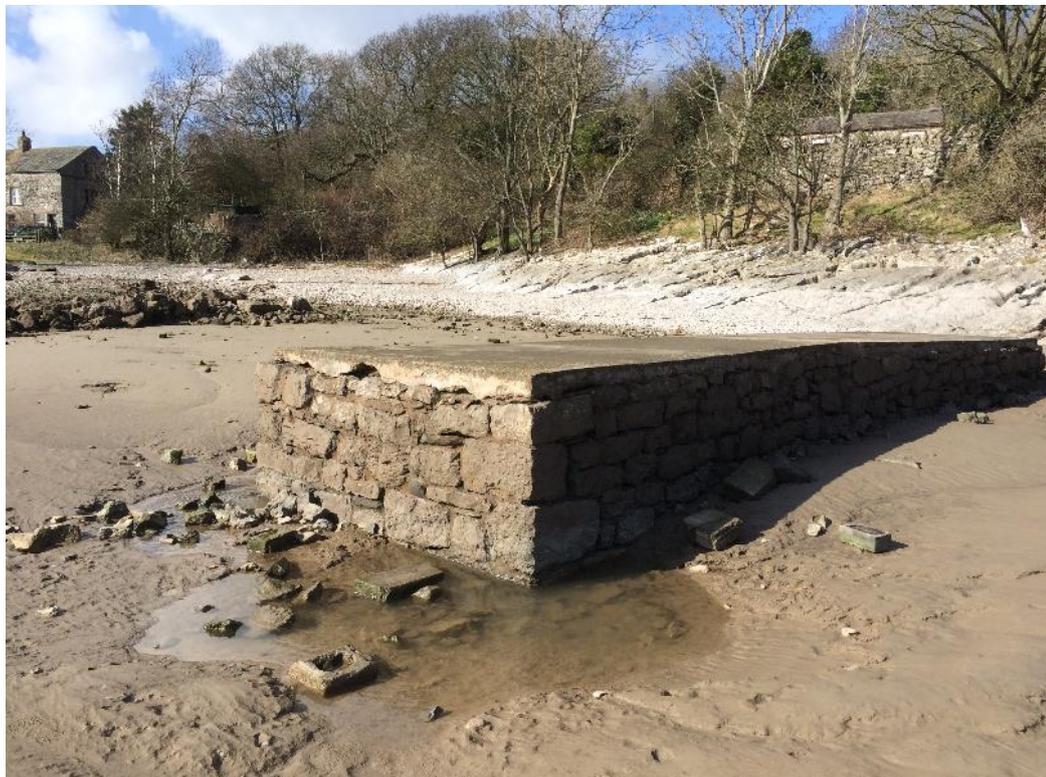
*Plate 48. South and east facing elevations of the possible jetty/quay at Site 2B, March 2015*

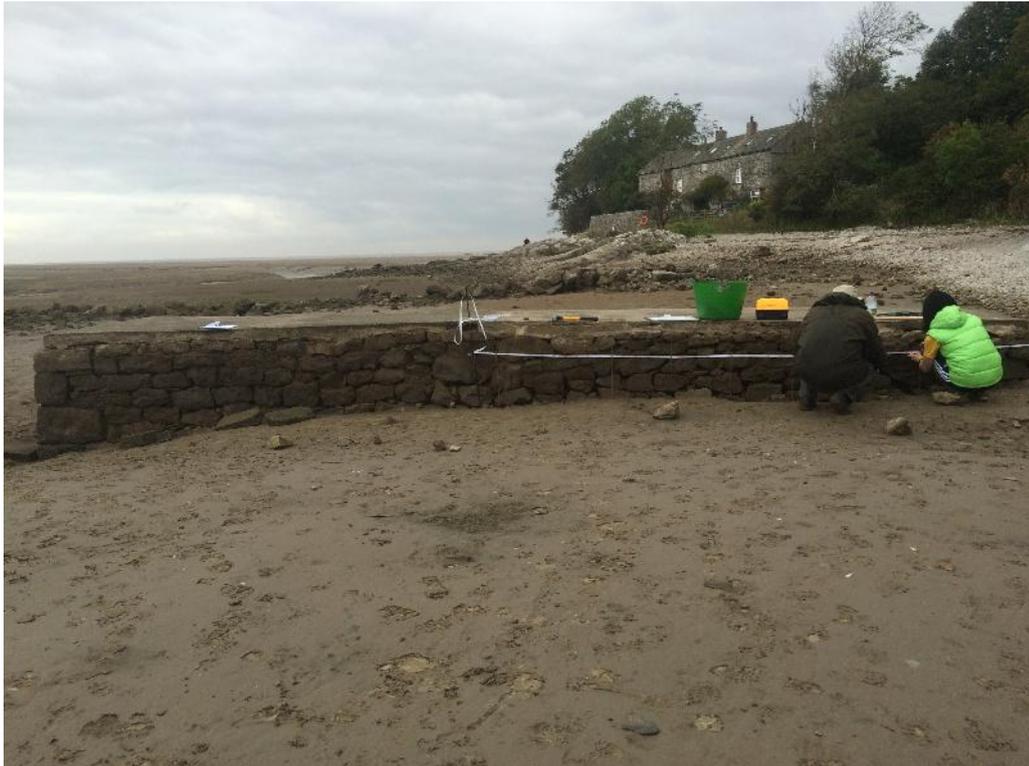
*Plate 49. Volunteers recording the eastern elevation of the possible jetty/quay (100/101) during August 2015*

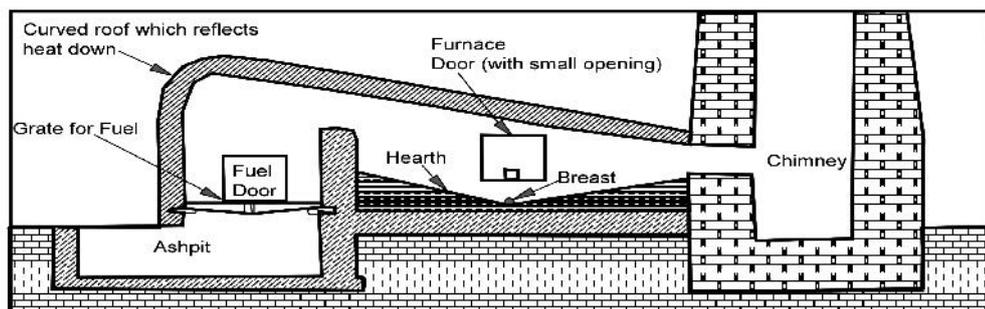
Figure 7. Schematic cross-elevation of a typical reverberatory furnace for copper smelting (Figure adapted by Louise Martin from Fig. 10, Danforth 1912)

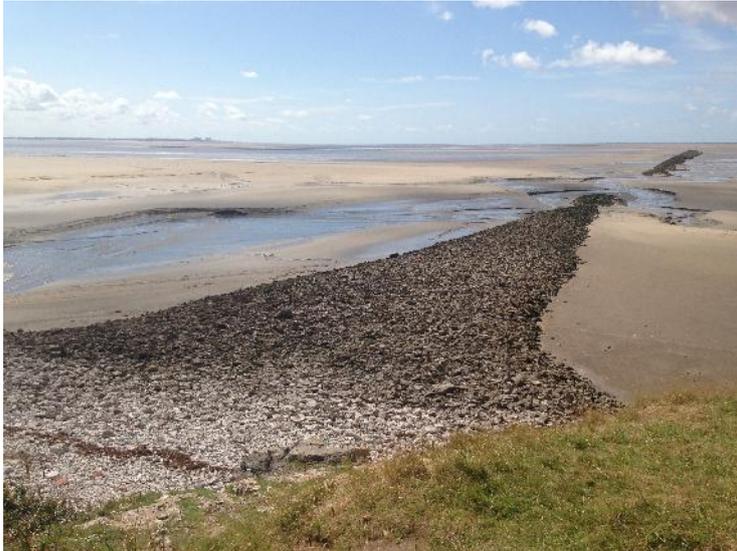
Plate 1. Stone embankment

**Site 1:** Comprising the remains of stone embankment associated with the failed late 19<sup>th</sup> century land reclamation scheme (Plate 1), a substantial stone constructed L-shaped wall (forming a ?jetty/quay/landing platform; Plate 2) and concrete/brick/ metal remains that appear to be associated with a 20<sup>th</sup> century military features (Plate 3).

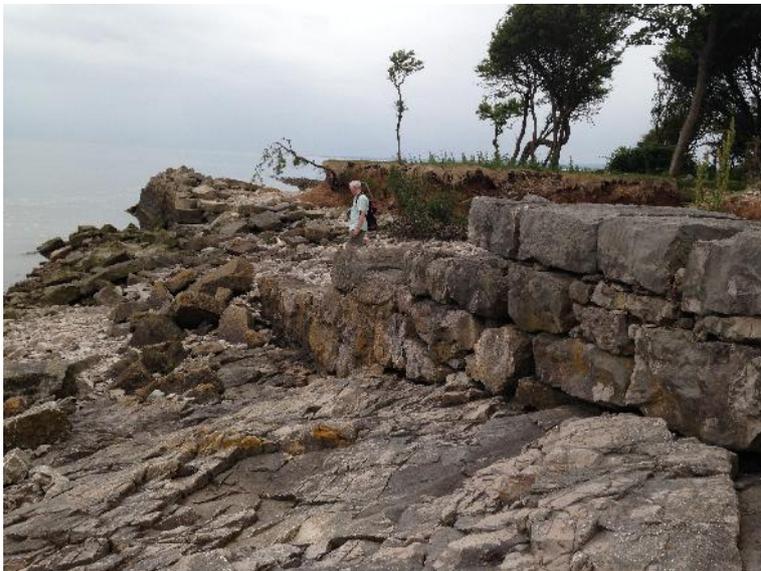
Plate 2. Substantial L-shaped ?revetment wall

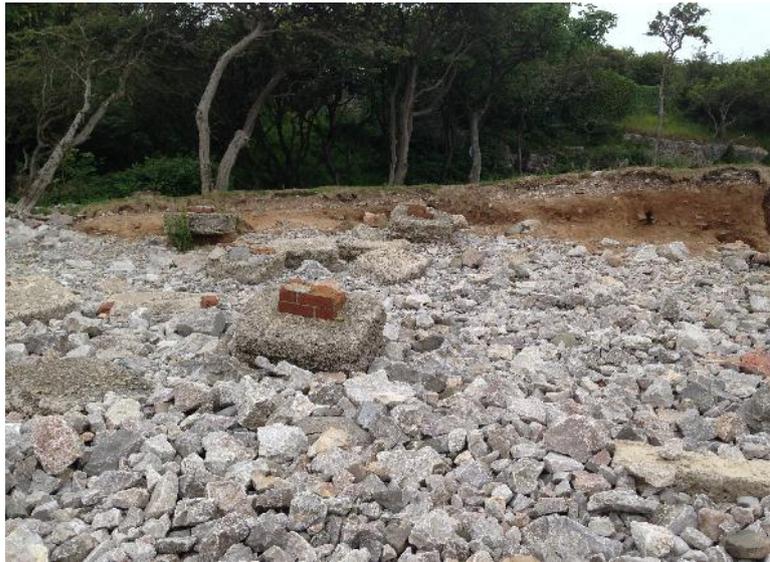
Plate 3: Concrete and brick features, possibly 20<sup>th</sup> military features  
**Site 2:** Comprising a stone chimney (Plate 4) and ?associated stone foundations (Plates 5/6), together with a jetty which may form part of a late 18<sup>th</sup> century copper smelting site (Plate 7).

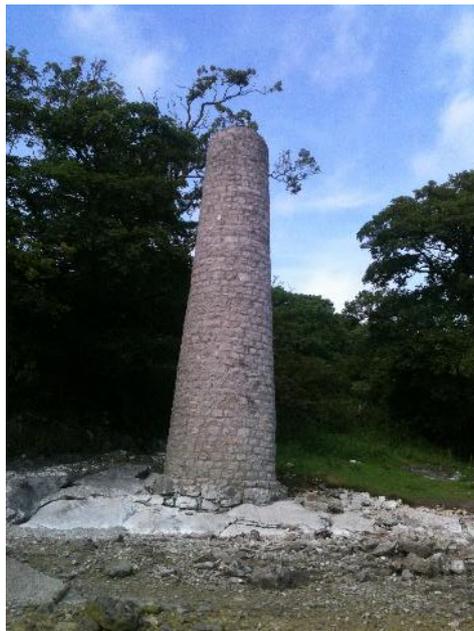
Plate 4. Chimney at Site 2

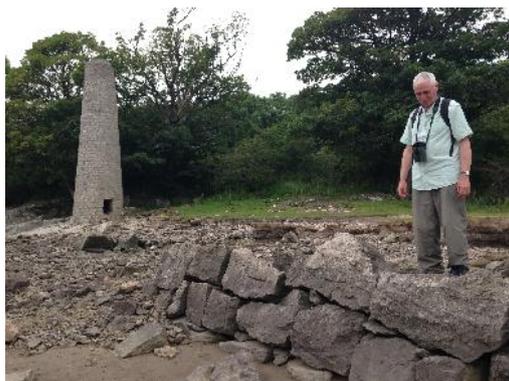
Plate 5. Walls observed to the east of the chimney

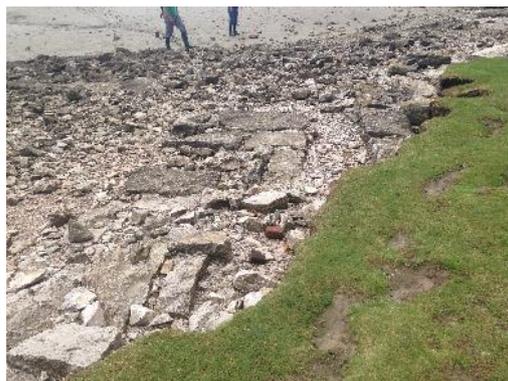
Plate 6. Wall foundations continuing into the salt marsh

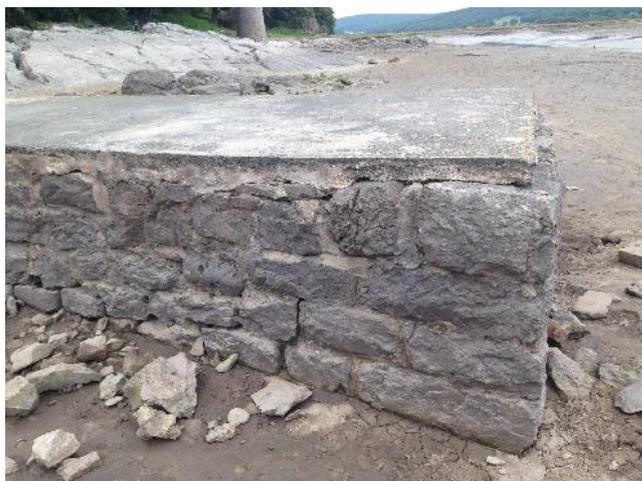
Plate 7. Jetty situated to the south-west of the Chimney

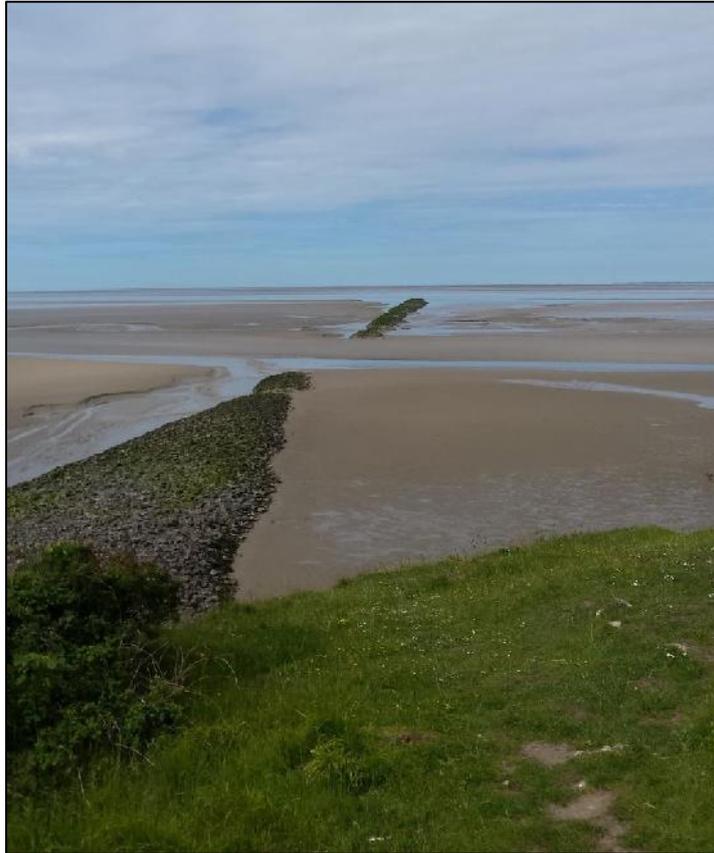
*Figure 7: Walduck's Wall (PRN 11302). View to the southwest.*

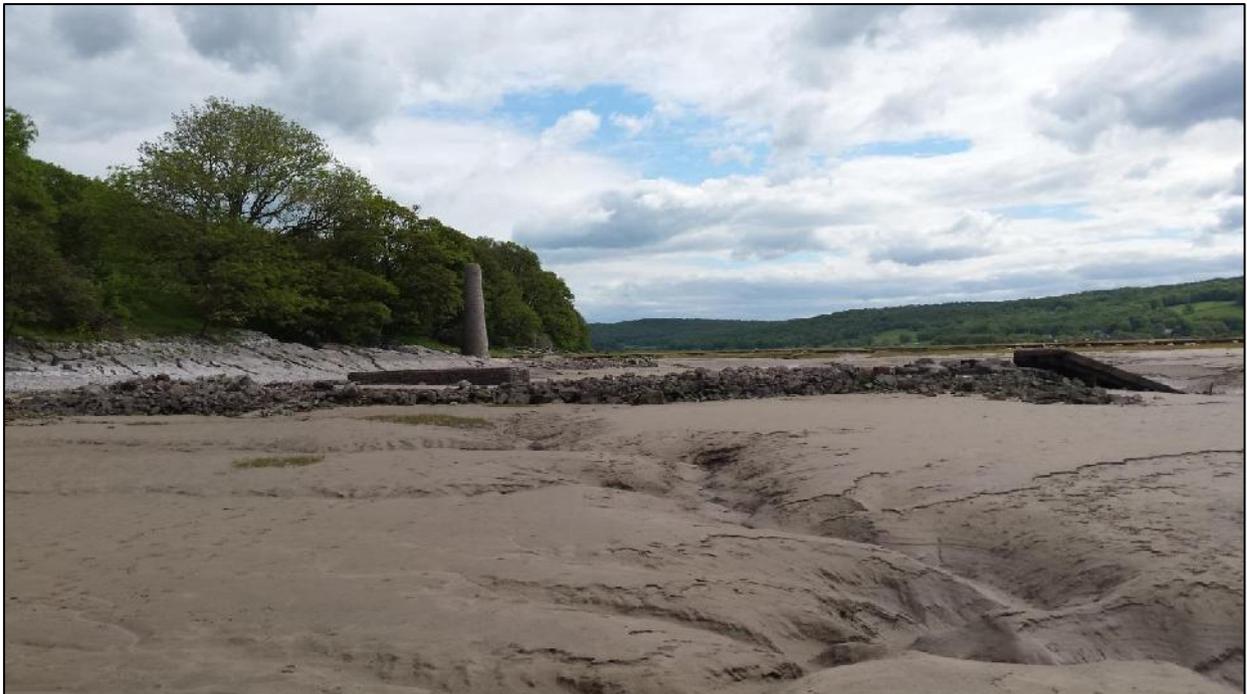
*Figure 8: The foreshore at Jenny Brown's Point, showing the collapsed bridge (foreground), the small stone quay (PRN 520; middle ground) and chimney (UID 181949/PRN 4821; background). View to the northeast.*

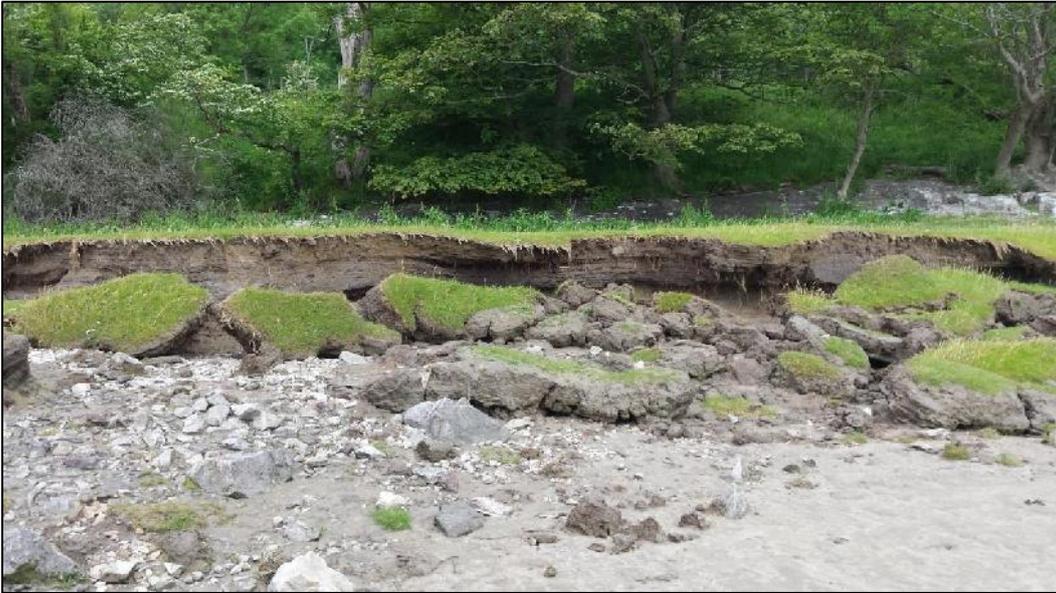
*Figure 9: Erosion of the salt marsh edge. View to the north.*

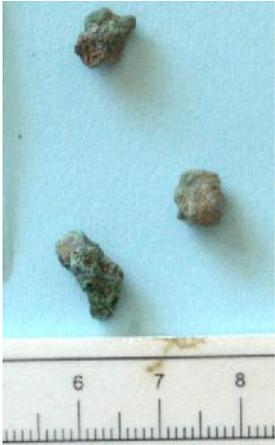
**Plate 1 Group 1 Copper Ores Sample JBP1**

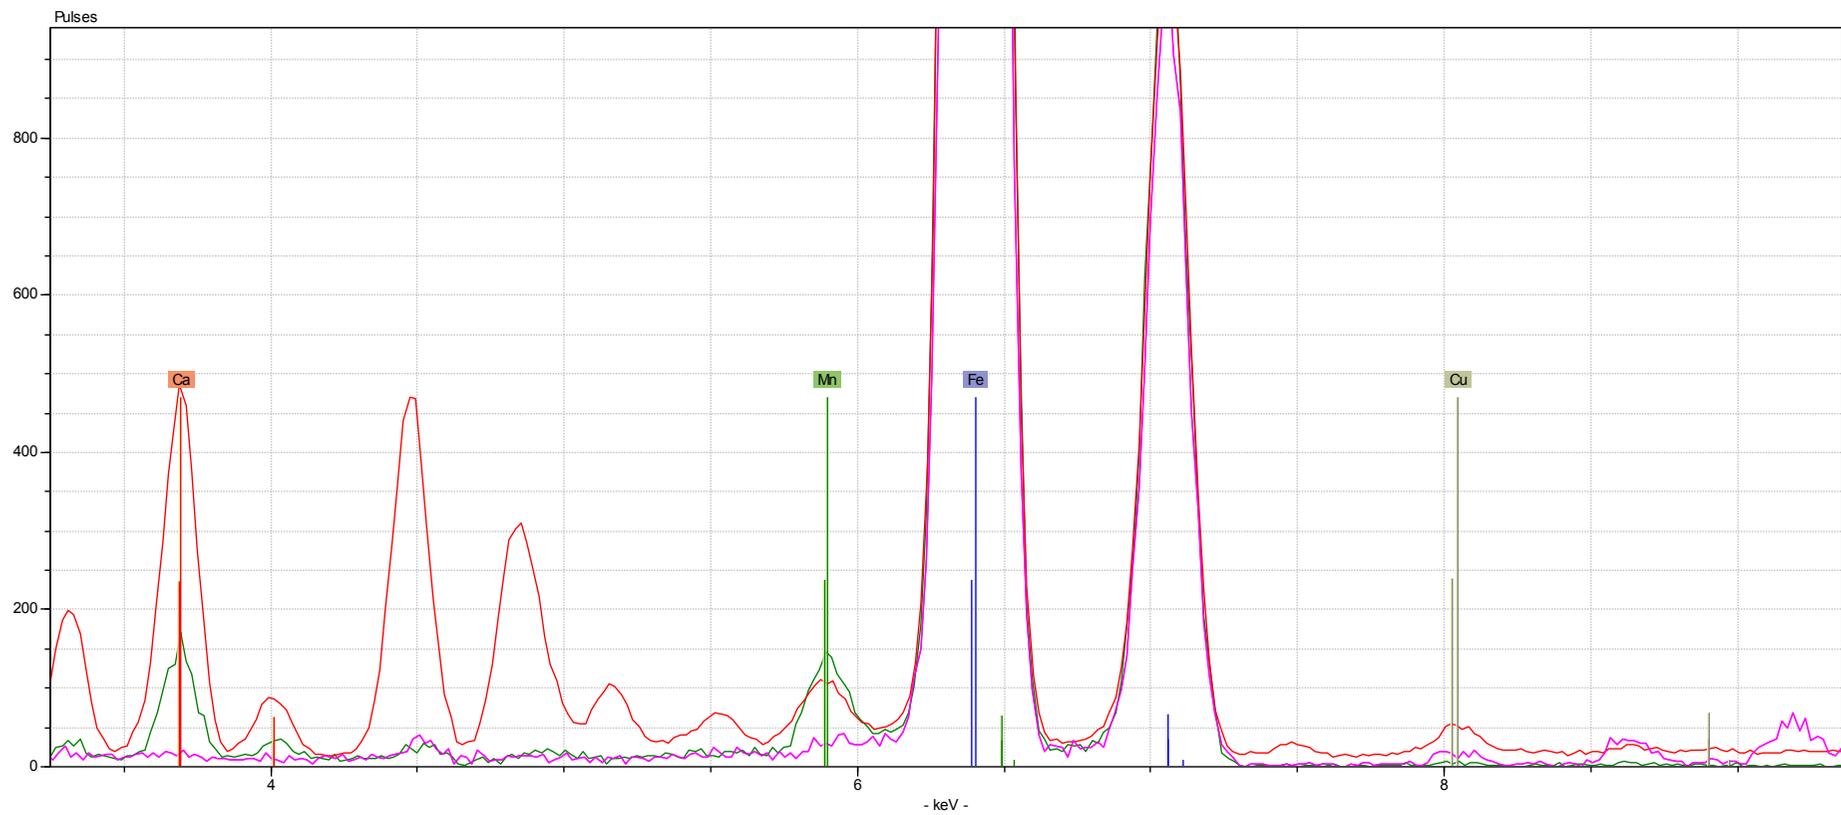
**Figure 5 Comparison of the spectra derived from JBP7.3 (red), North Yorkshire iron smelting slags (green) and Spanish copper smelting slag (pink)**
