Walney Island

PHASE 2 CONSERVATION STATEMENT

Issue 3

June 2016

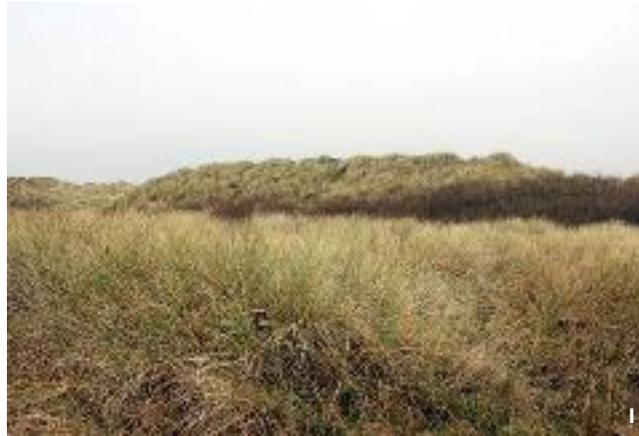
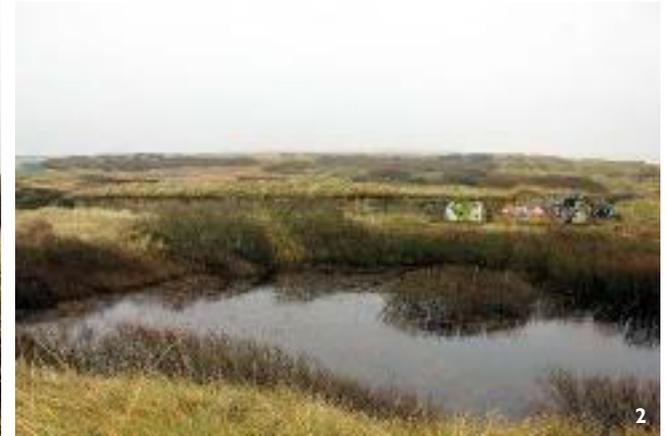
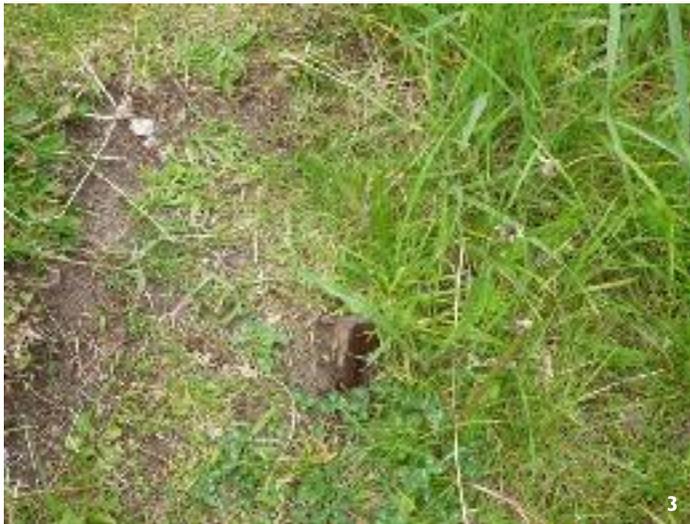
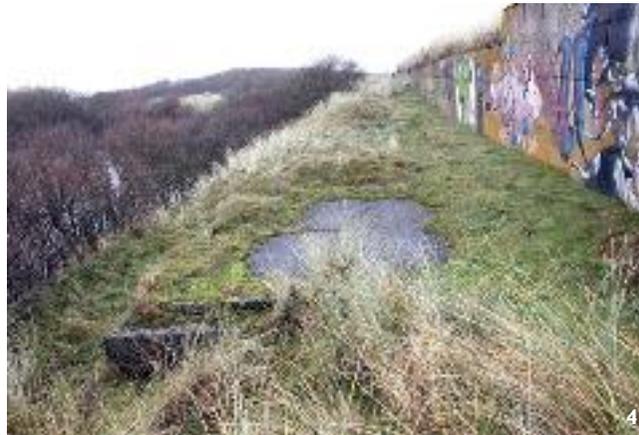
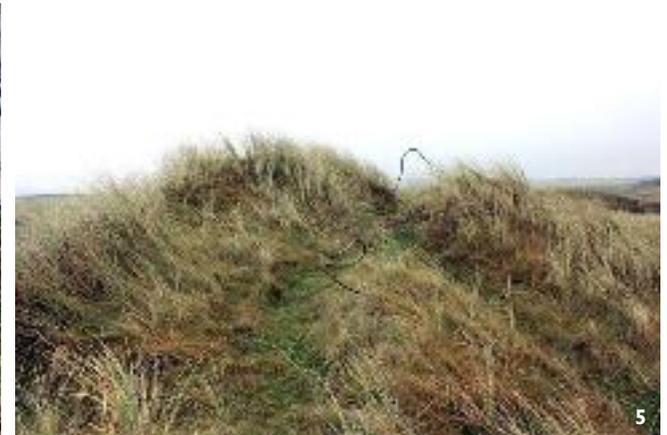
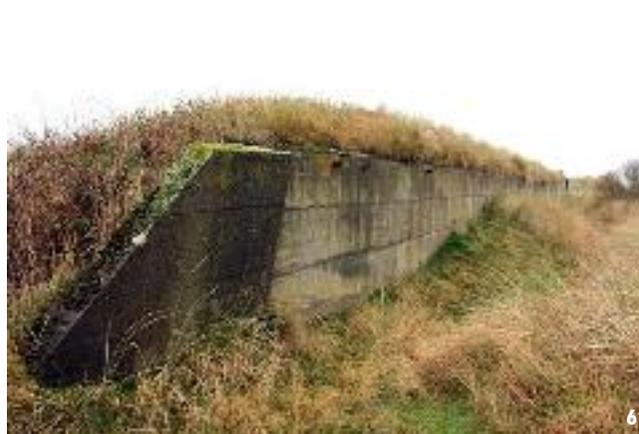
2.4.1 SITE B - RIFLE RANGE (HER NO. 19874)

- 1 Butts
- 2 View from butts towards the southern embankment
- 3 Remains of target mechanism
- 4 Concrete revetment and concrete platform
- 5 Twisted metal on top of butts
- 6 Concrete revetment

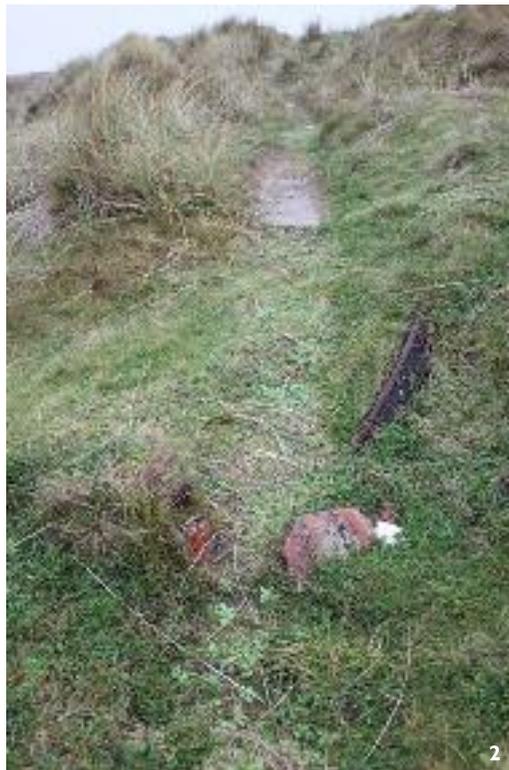
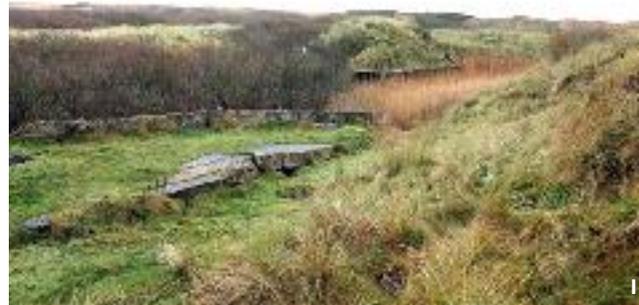
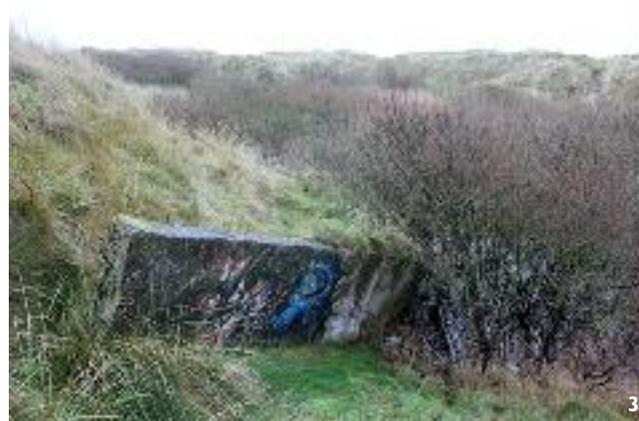
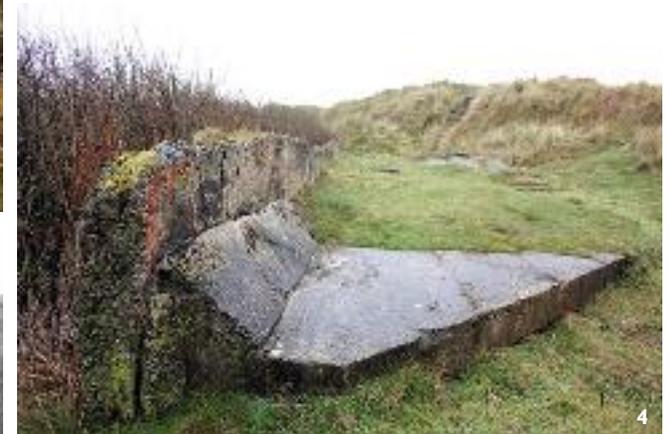
2.4.2 SITE C - AIR GUNNERS RANGE (43984)

- 1 Remains of air gunner range
- 2 Remains of track
- 3 Remains of air gunner range
- 4 Remains of air gunner range

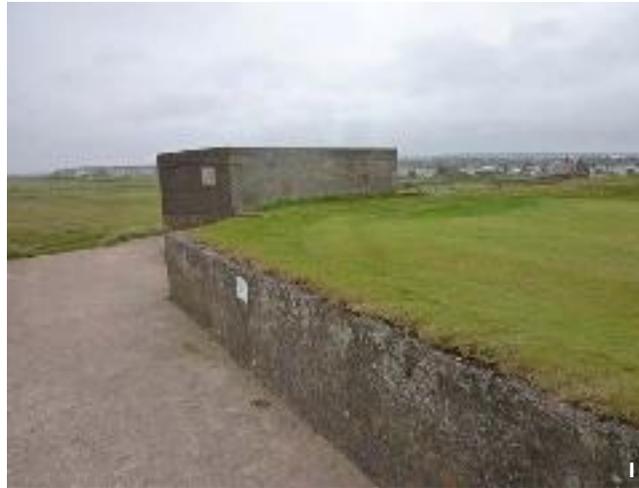
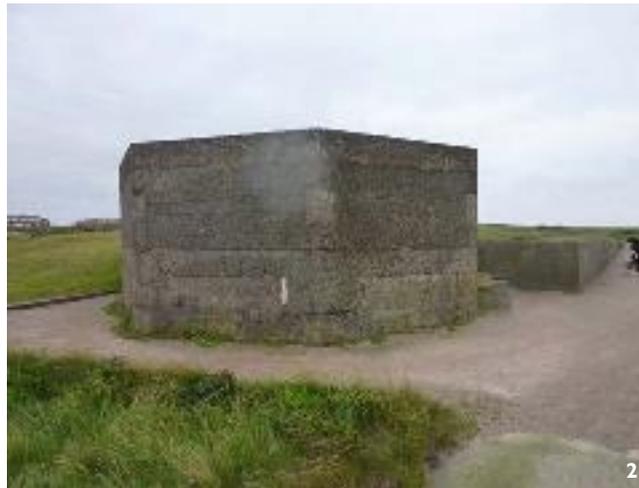
2.4.3 SITE D - PILL-BOX AND TWO COASTAL ARTILLERY SEARCHLIGHT (CASL) EMBLEMMENTS NEAR EARNSE POINT (HER NO. 19876):

- 1 Pill-box
- 2 Pill-box

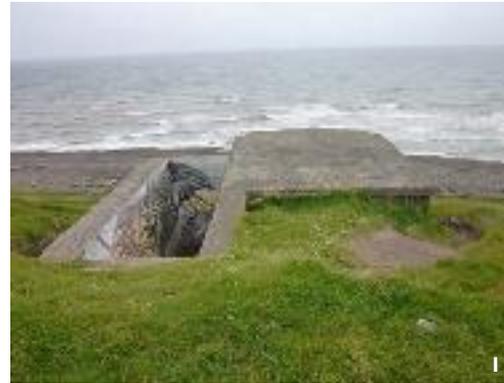
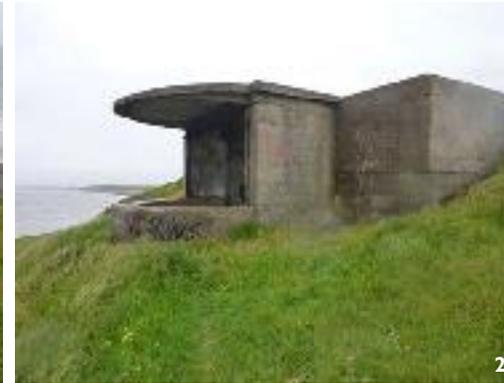
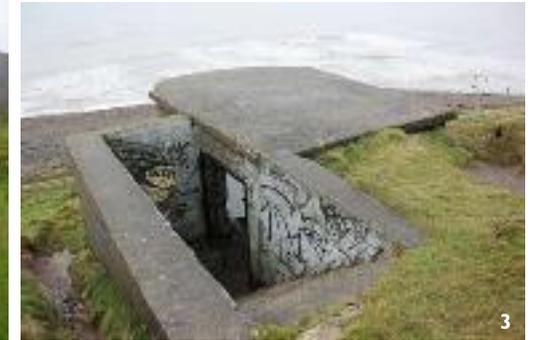
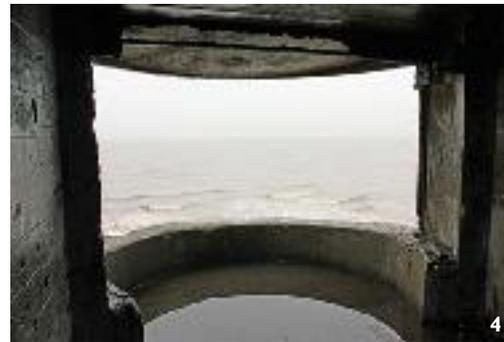
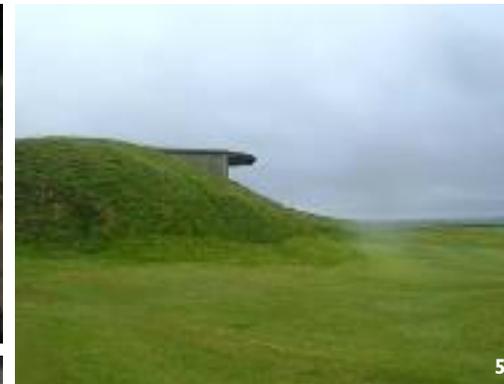
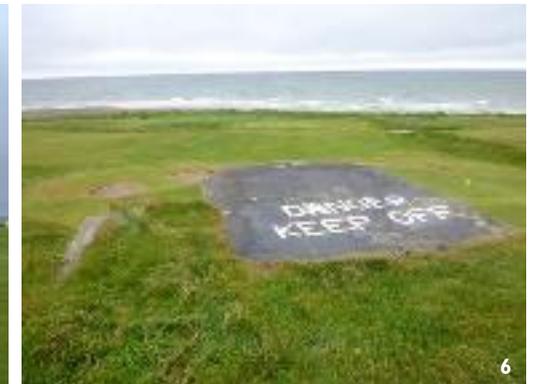
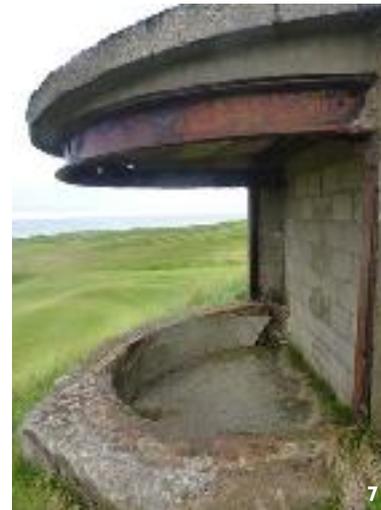
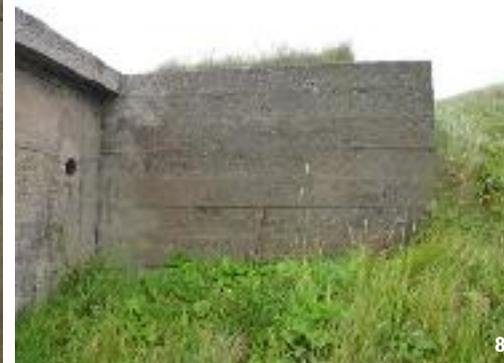
A concrete Coastal Artillery Searchlight (CASL) emplacement to the north of the pill-box is typical of those found on Walney, with its cantilevered opening, which would have had metal shutters, now lost. To the south is its counterpart; this CASL emplacement is integrated into the golf course and its opening has been blocked up.

- 1 Searchlight (north)
- 2 Searchlight (north)
- 3 Searchlight (north)
- 4 Searchlight (north)
- 5 Searchlight (south)
- 6 Searchlight (south)
- 7 Searchlight (south)
- 8 Searchlight (south)

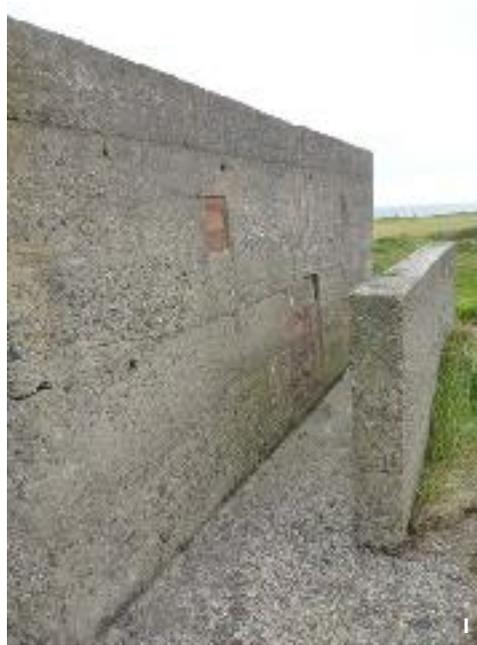
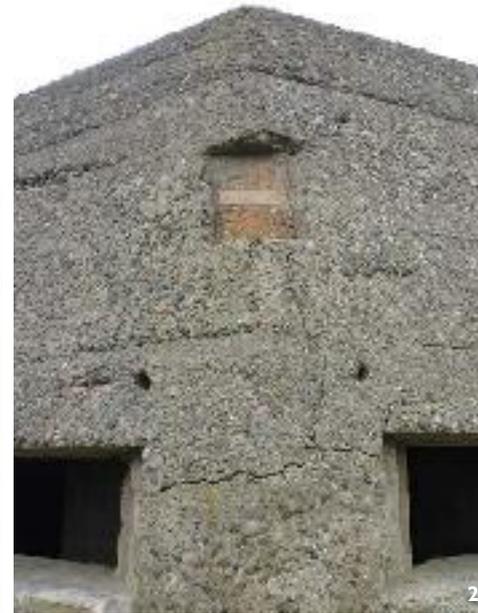
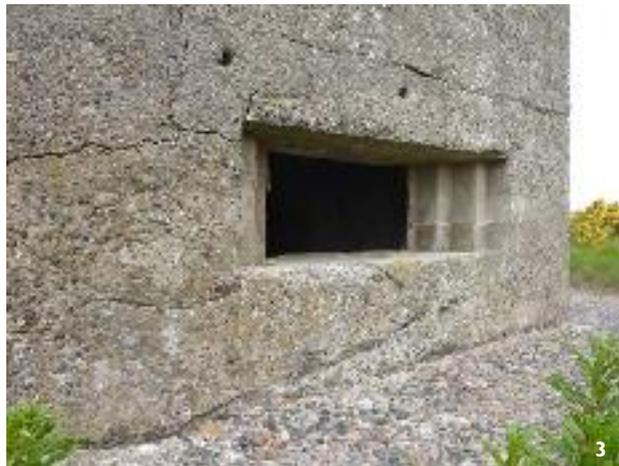
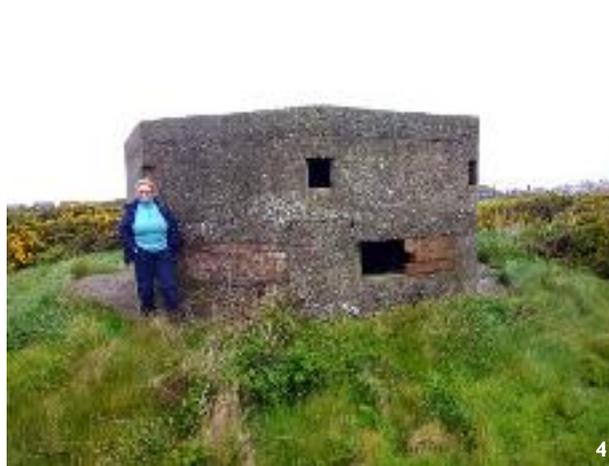
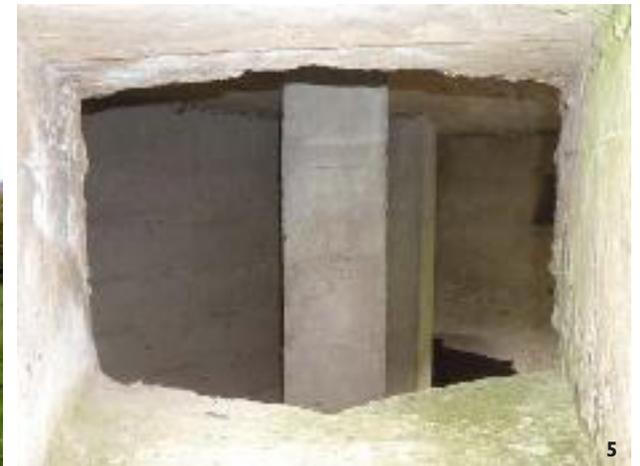
2.4.4 SITE E – PILL-BOX ON GOLF COURSE (HER 19838)

Further south on the golf course is another Type 24 Pill-box, with unusual corner loop-holes with a short section of detached flanking wall on its longer east side. Most of the openings have been bricked up and the interior could not be accessed, although a ricochet wall could be appreciated inside.

- 1 Pill-box
- 2 Pill-box – bricked corner openings
- 3 Pill-box
- 4 Pill-box
- 5 Interior

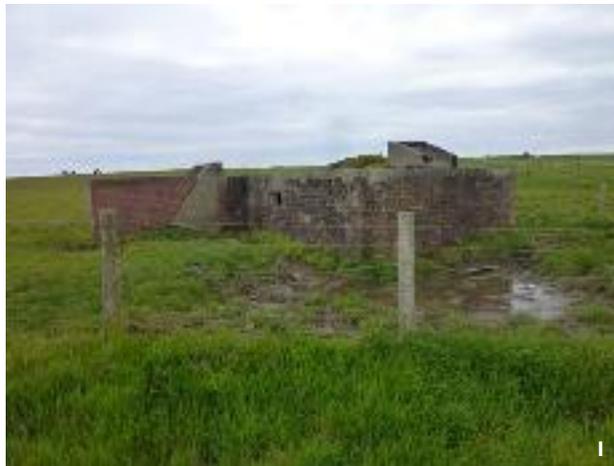
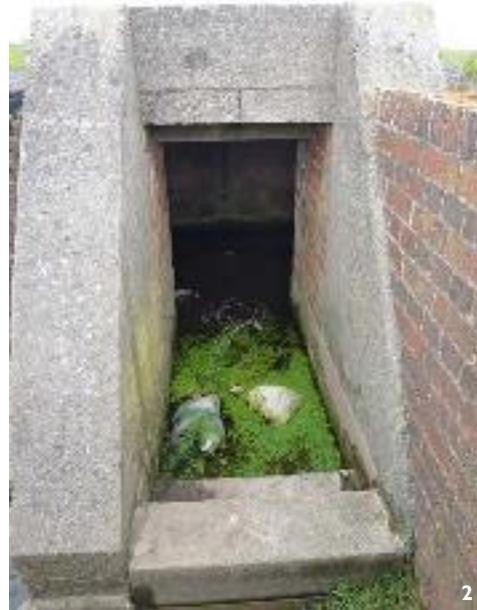
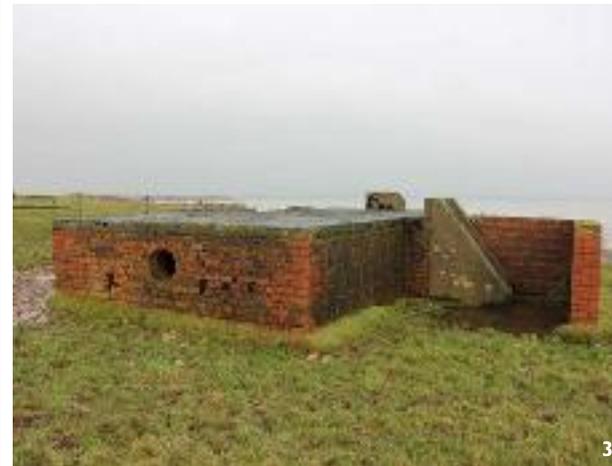
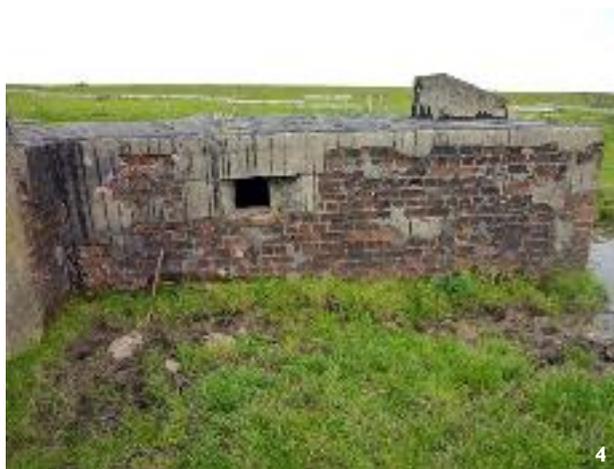
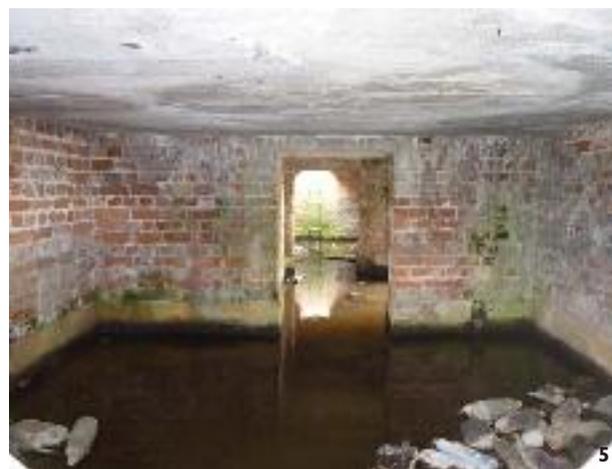
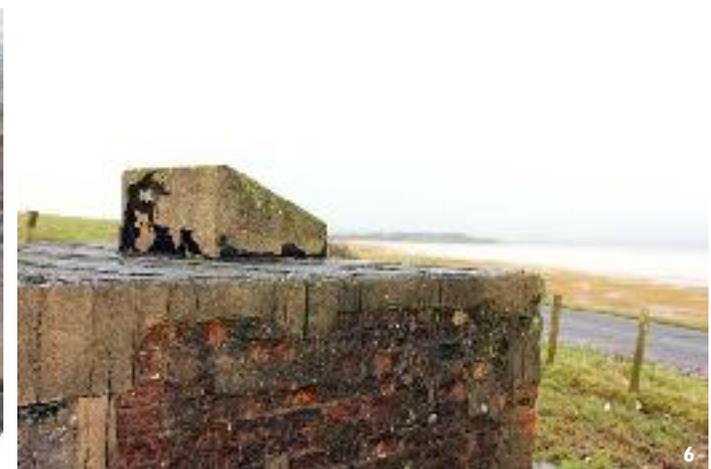
2.4.5 SITE H - PILL-BOX NEAR HILLOCK WHINS (HER NO. 19872)

top, which appears to have had a metal shutter which was accessed by a metal ladder internally. There is a circular opening on the west elevation and a loop-hole facing south-east. The interior of the building was inaccessible due to flooding.

- 1 The site from the road
- 2 Entrance
- 3 Entrance and circular opening
- 4 Loop-hole and remnants of cement render
- 5 Interior
- 6 Hatch

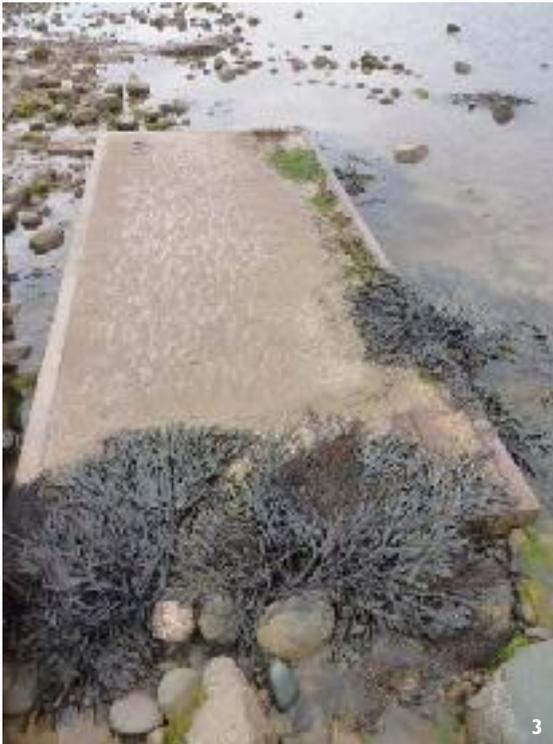
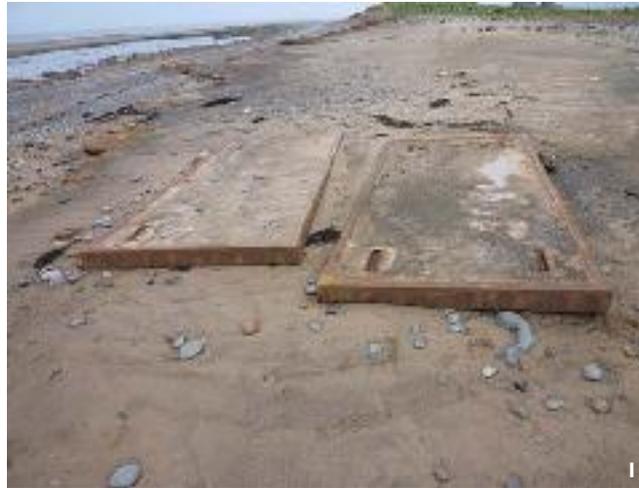
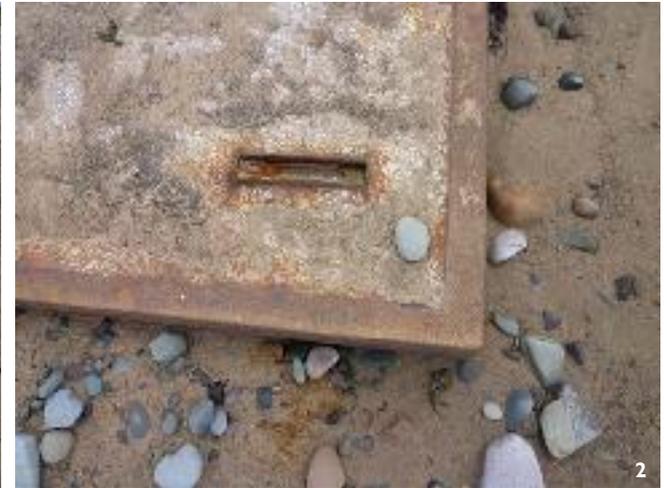
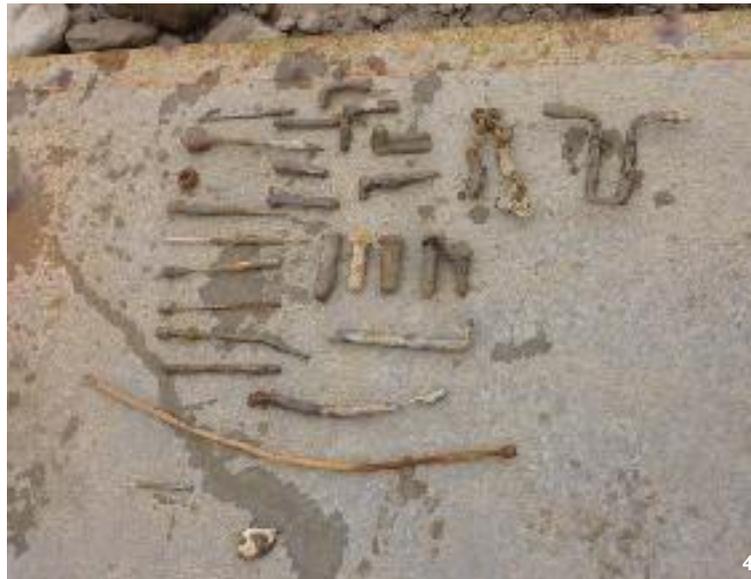
2.4.6 SITE 1 - ANTI-AIRCRAFT DEFENCES (?) (HER NO 19858)

This site consists of a number of loose concrete slabs eroded onto the beach. They have iron edging and fixings in each corner, which may have been used to affix anti-aircraft guns or to anchor the slabs together as a temporary pontoon. Various loose tool bits and fixings were found in the vicinity of the blocks. The forms and function remains unknown.

- 1 Concrete slabs
- 2 Concrete slabs
- 3 Concrete slabs
- 4 Fixing found on beach

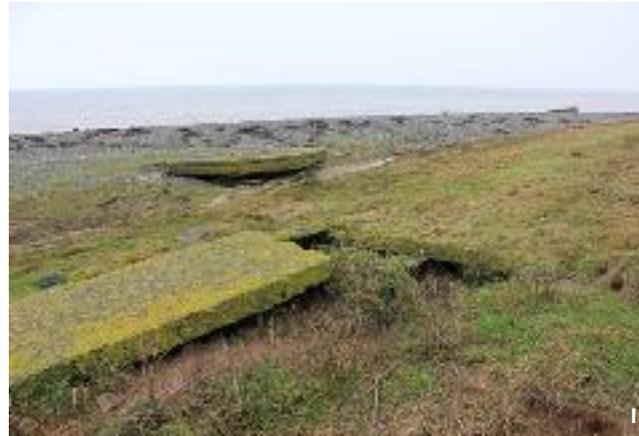
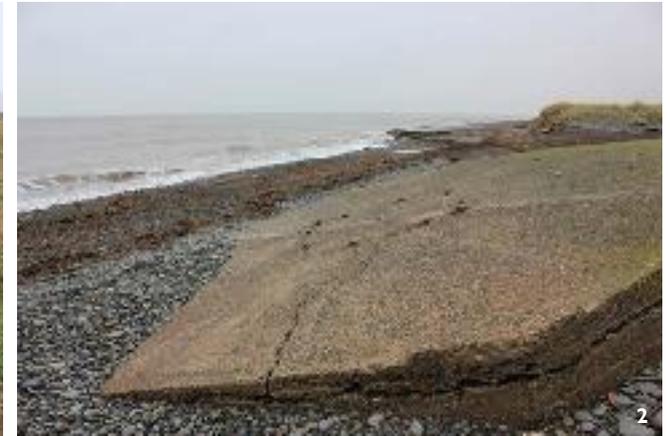
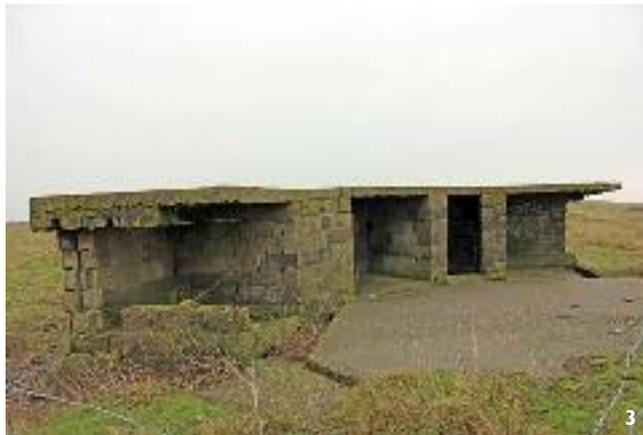
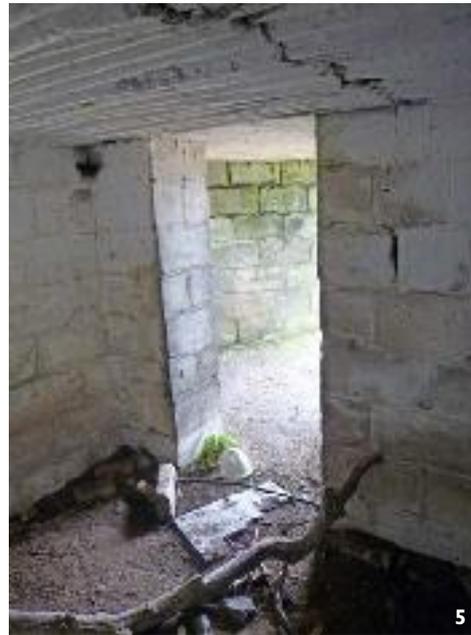
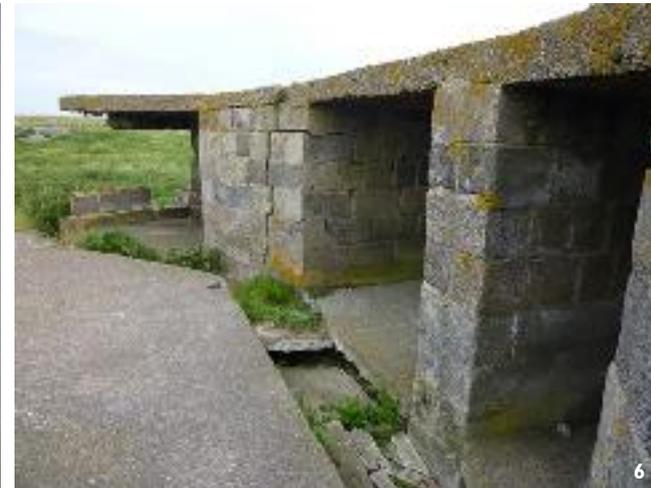
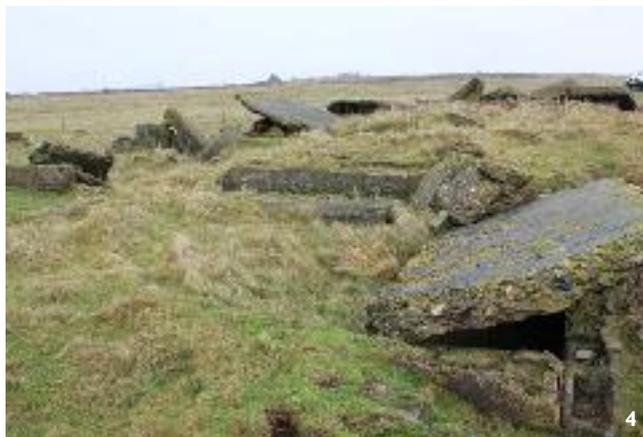
- 1 Octagonal gun platform
- 2 Gun platform
- 3 Upstanding structure
- 4 Command building (?)
- 5 Interior
- 6 Gully

The only remaining upstanding structure in the coastal battery is in very poor condition and consists of a concrete building, comprising four bays which were ammunition lockers, surrounding a large octagonal gun platform. It formed a battery of four such structures, two of the other gun platforms remain on the shoreline. There was a command building the centre of the battery but this has been demolished for safety reasons.

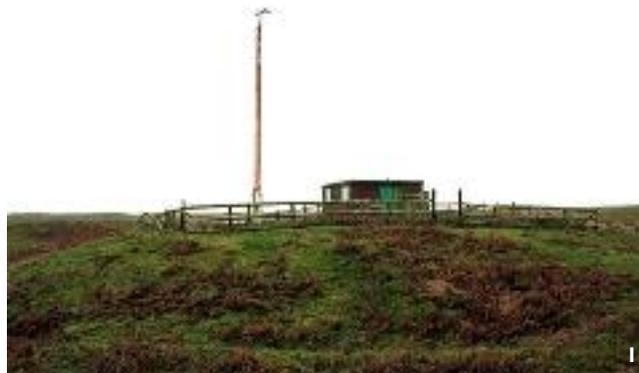
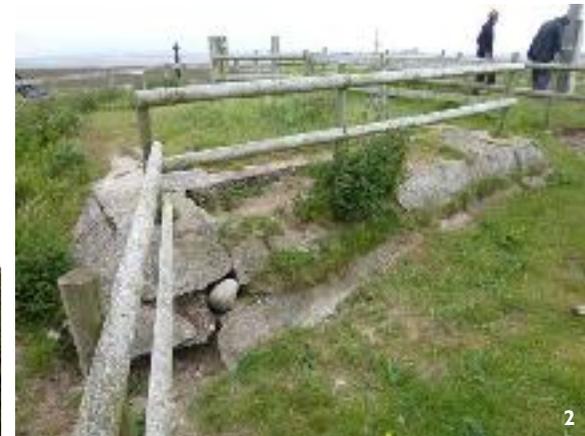
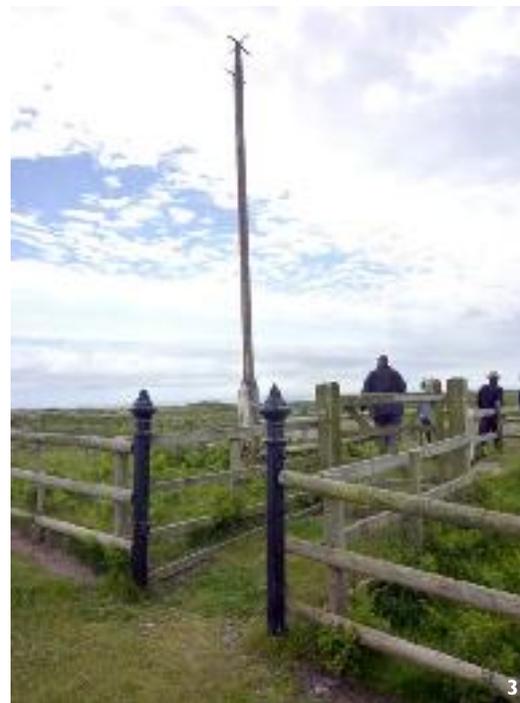
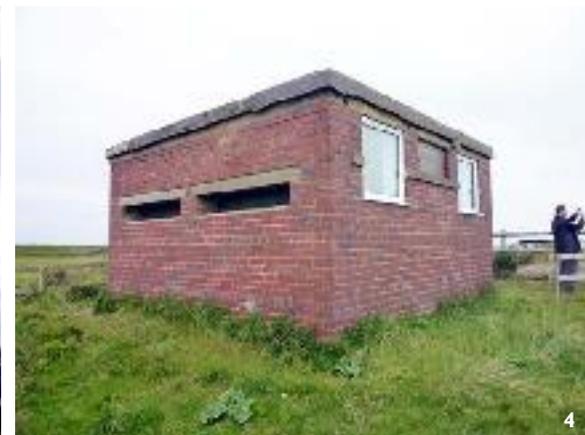
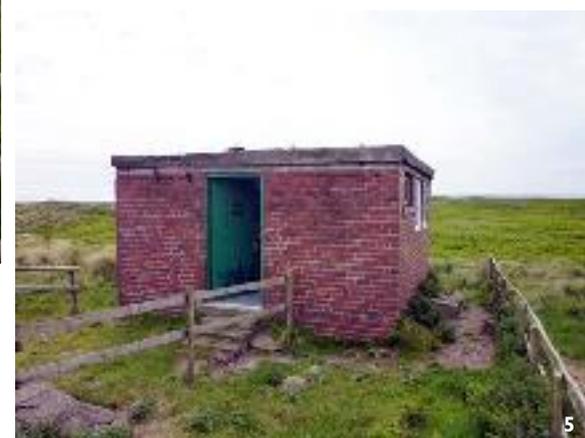
- 1 Site K
- 2 Unknown concrete structure
- 3 Cast iron gateposts and 'flag pole'
- 4 South and western elevations
- 5 North elevation

The structure sits within a small fenced enclosure. A tall flag pole is situated just to the north east of the building (formed from a sailing ship's mast). At the entrance to the enclosure are two cast iron gate posts which appear to be Victorian. No building is shown as standing in this position from a study of pre-war historic maps, apart from the present hide, which suggests the posts may have come from elsewhere.

Adjacent to the building is a concrete platform which may form part of a buried structure (there are voids in the concrete and possible flue or pipe protruding).

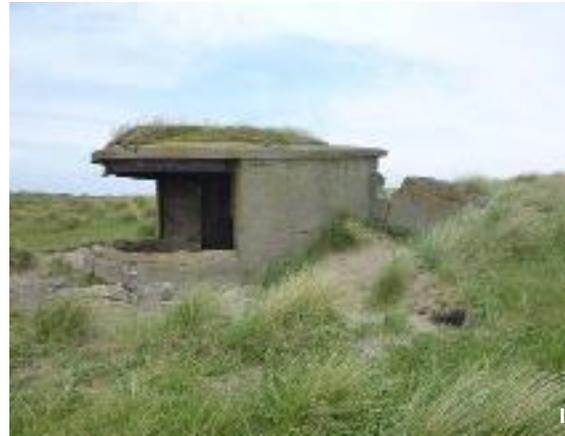
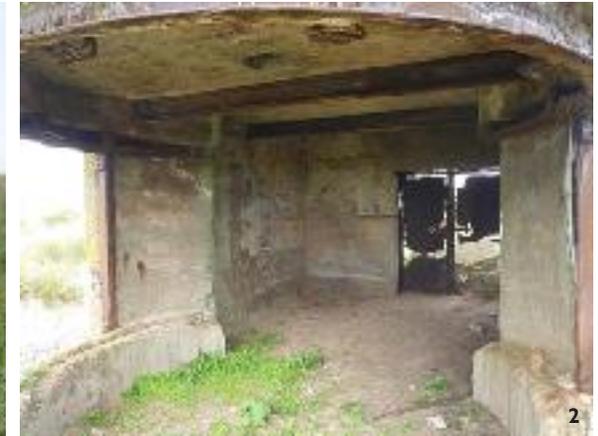
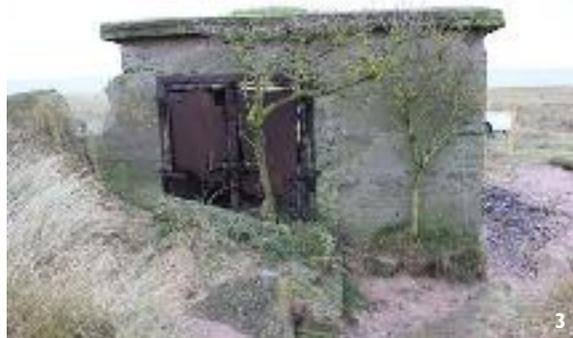
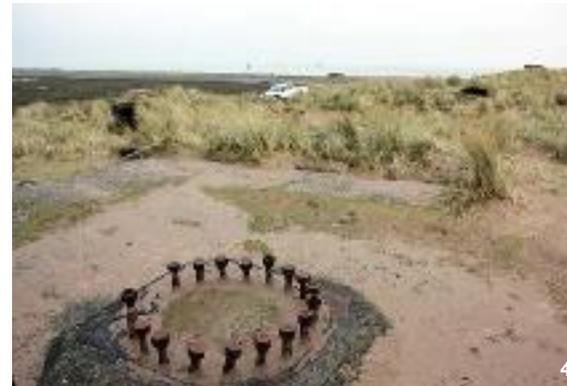
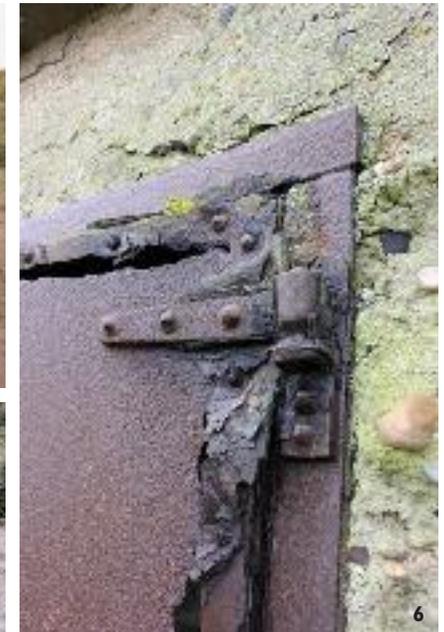
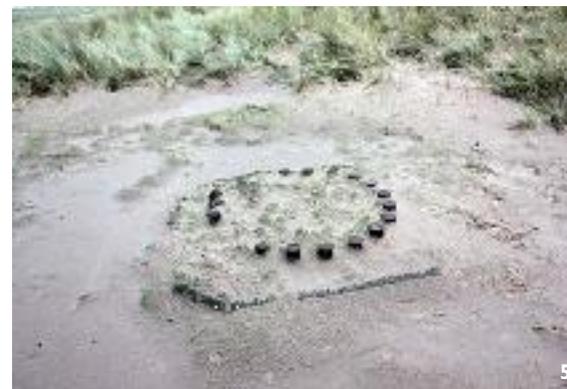
- 1 Western-most searchlight emplacement
- 2 Interior
- 3 Rear of CASL
- 4 Holdfast
- 5 Holdfast
- 6 Hinge of door

The searchlight battery at the very southern tip of Walney and consists of a pair of CASL emplacements consistent with those found on the golf course. The southernmost emplacement is unique in that it still retains its metal shutters. Between the two CASLs, within the dunes, are the concrete bases of a number of holdfasts presumably associated with the CASLs. These are also underground Nissen magazines constructed in brick and corrugated iron. To the west on the edge of the area is the base of a Spigot Mortar. This appears to be the location of Hilpsford Fort originally built in 1915.

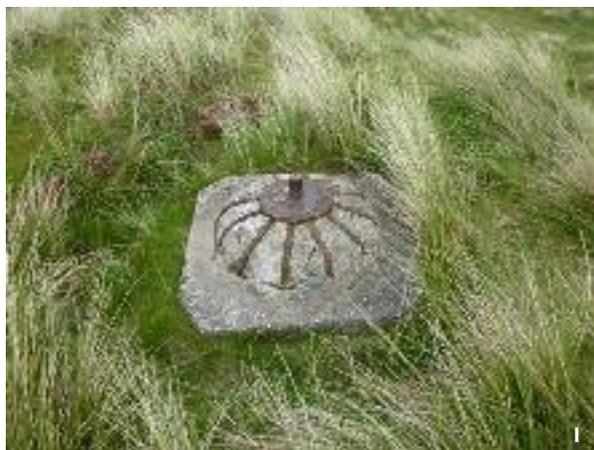
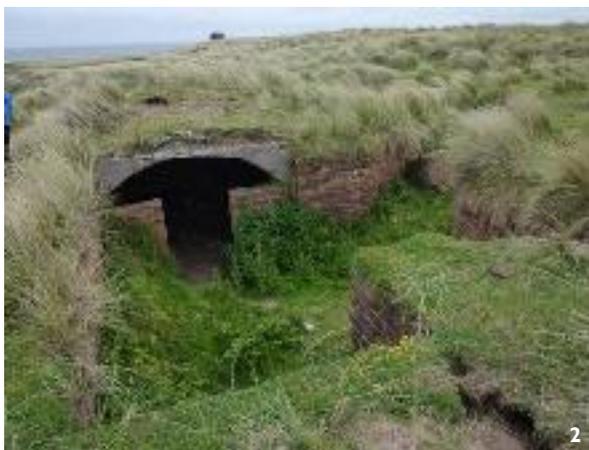
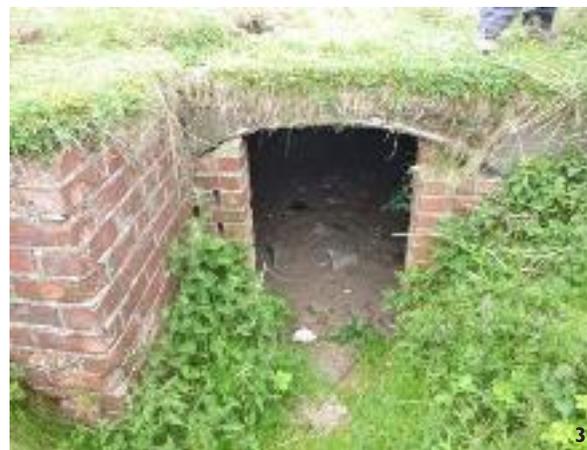
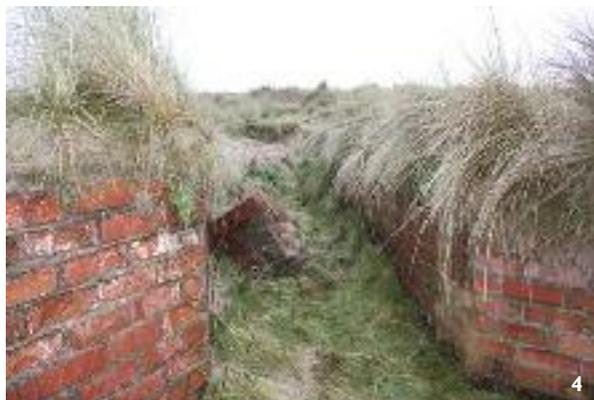
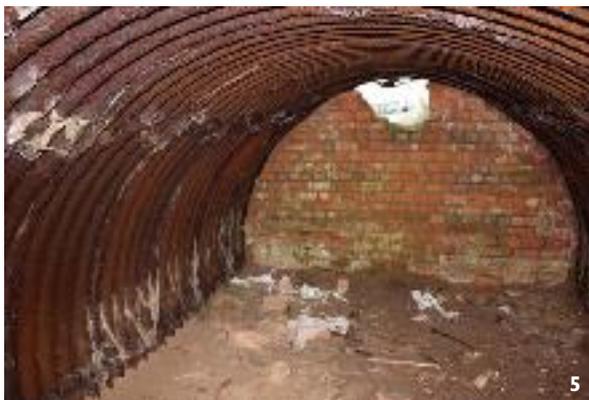
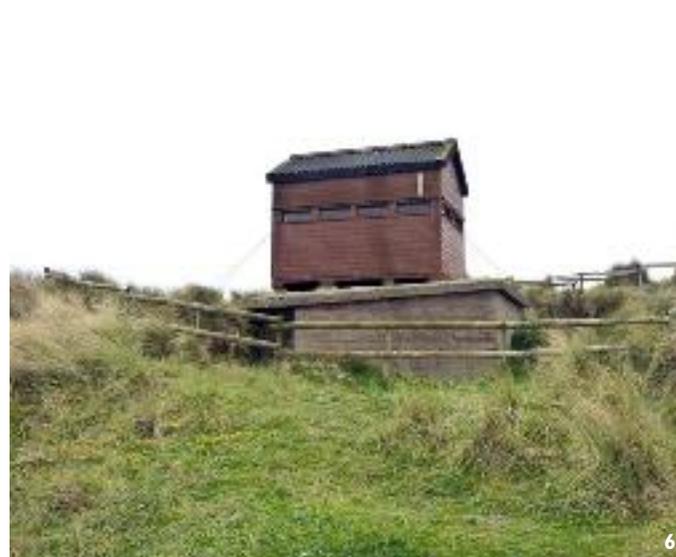
- 1 Spigot Mortar domed base and pin mounting
- 2 Structures adjacent to holdfasts
- 3 Structures adjacent to holdfasts
- 4 Structures adjacent to holdfasts
- 5 Interior
- 6 Eastern most CASL buried on a sand dune, with hide on roof

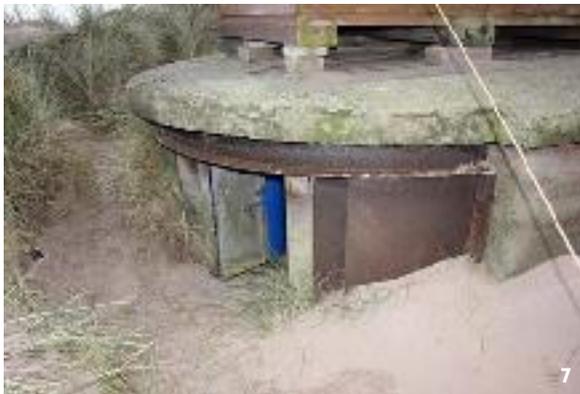
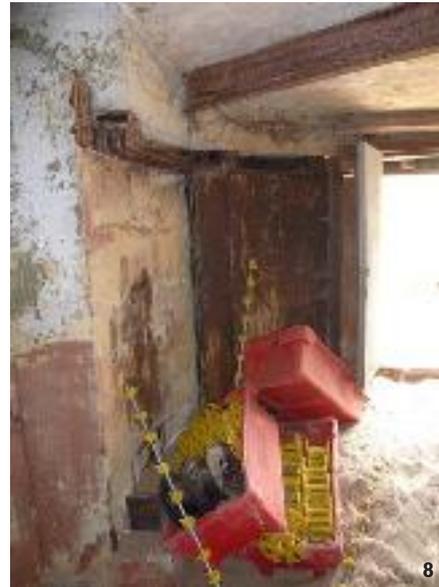
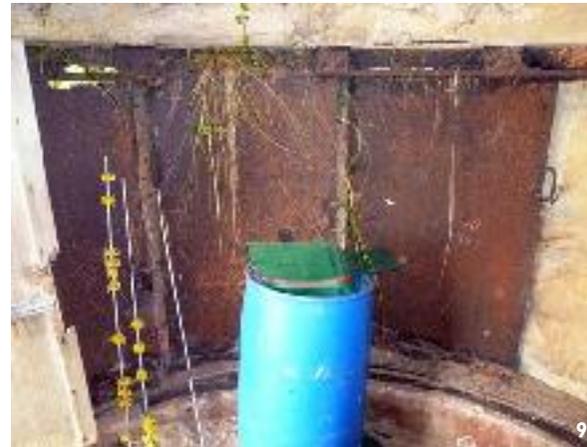
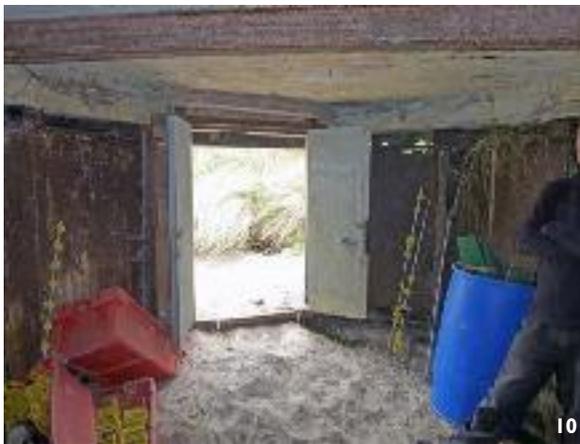
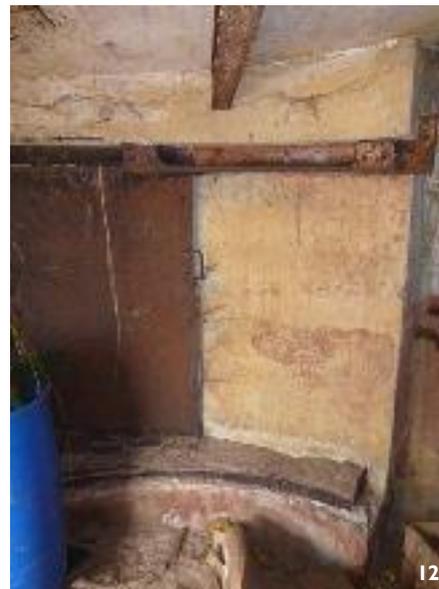
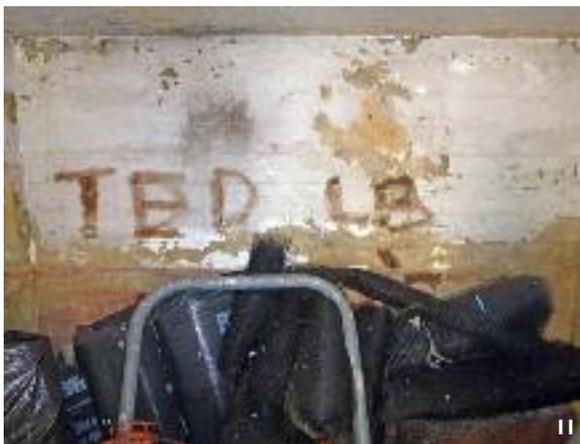
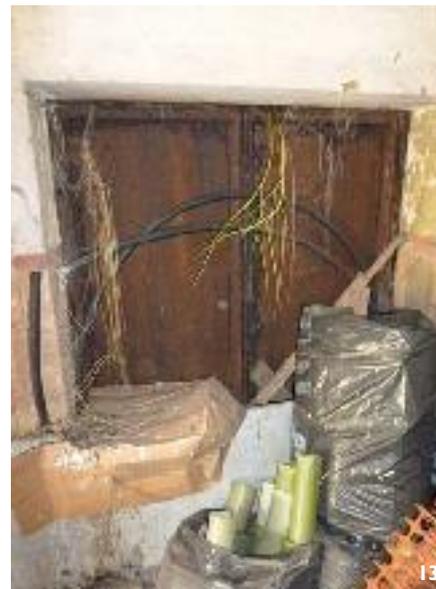
- 7 Eastern most CASL buried on a sand dune
- 8 Interior (sliding shutters)
- 9 Interior (sliding shutters)
- 10 Interior (sliding shutters)
- 11 Interior
- 12 Interior
- 13 Interior (original entrance doors)

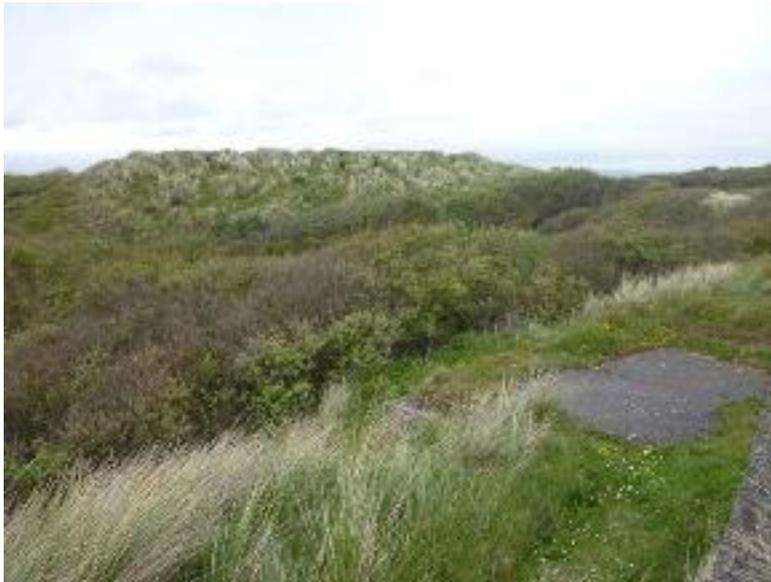
The Rifle Range features a monumental dune grass covered stop butt, which could easily be mistaken for a natural dune feature to the casual passer-by. Whether there is an underlying built structure to the stop butt was not assessed. The stop butt would have received shots after they had passed through the target and was built large enough to accommodate any ricochet.

Stop Butt viewed from the Markers Gallery

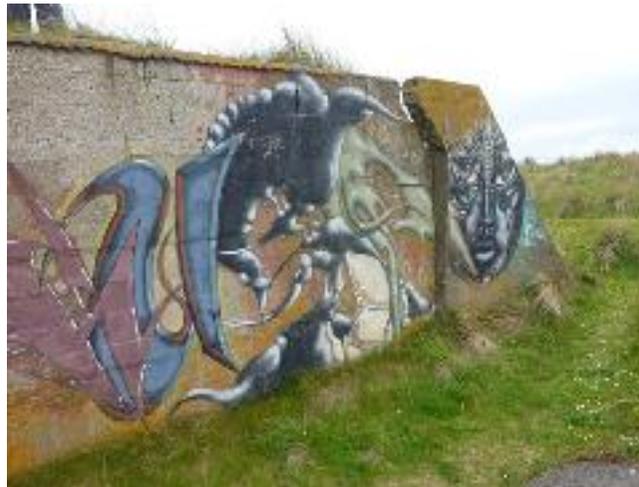
Subsiding wall front view

It is recommended that a structural assessment should be completed and the wall pinned back into the existing grass dune as required.

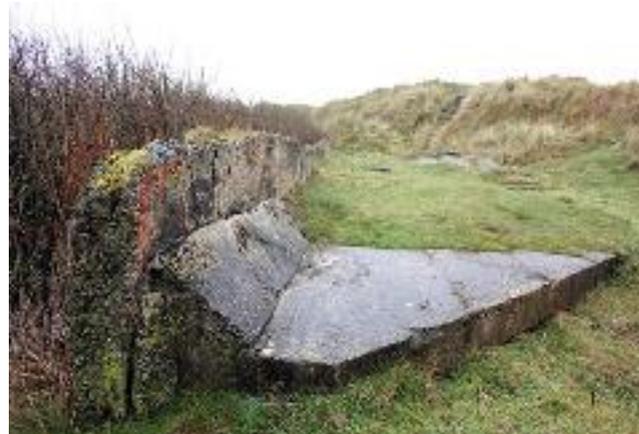
The site at present consists of little more than concrete platforms and concrete remnants set in the dunes. The concrete has decayed and exposed corroded reinforcements are present. The exposed reinforcement ends pose a potential health and safety hazard.

Concrete remnants at Air Gunner's Range

It would be beneficial to make provision for archaeological recording/investigation of this area to explore the extents of the Air Gunner's Range

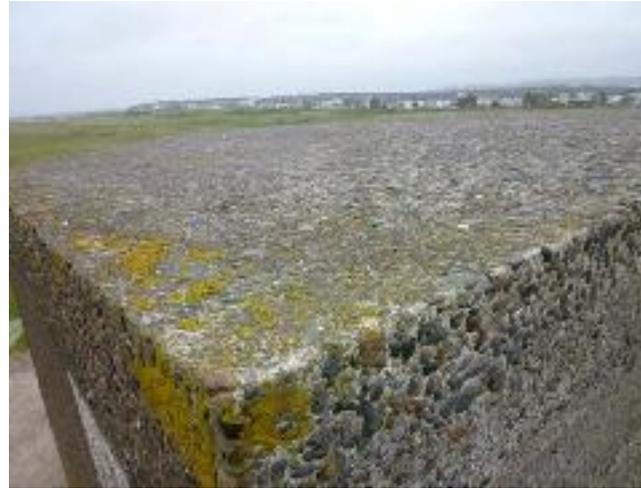
The weathering of the infills indicate that they have not been recently installed. No roof covering is present however it appears in reasonable condition.

Roof of Pill-box

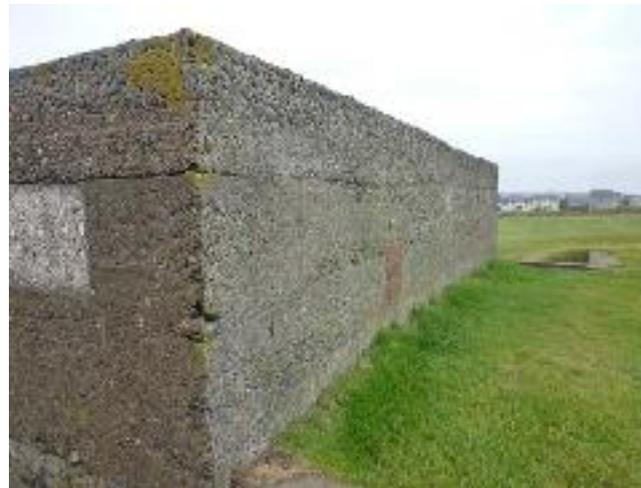
The pill-box is a simple cast in-situ concrete structure with an irregular hexagonal plan form. All apertures have been infilled with brickwork and concrete, therefore the internal condition is unknown.

Infilled Openings

It may be beneficial to remove concrete and brick in-fill to ventilate the structure and allow interior inspection. Discreet grilles may be provided for security.

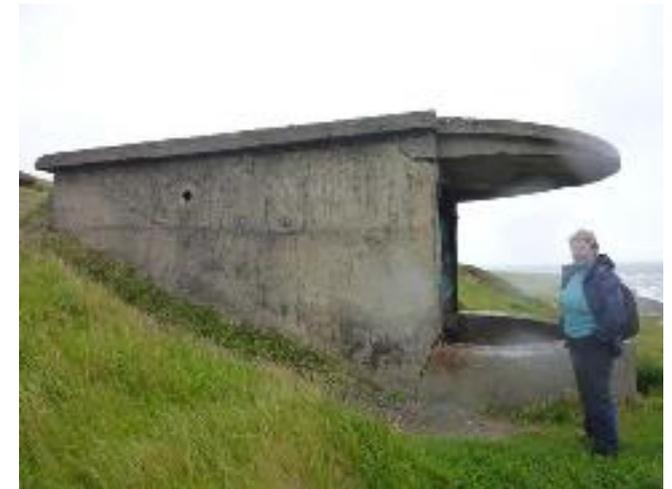
Northern Searchlight Emplacement

The northern emplacement appears structurally unsafe.

The semi-circular I-beam which originally supported the cantilevered section of the roof slab is no longer present, although its existence is evidenced by the remaining embedded steel. It is unlikely the cantilever was designed to be self-supporting. Jacking of the roof from the walls has occurred due to corrosion of the extant embedded steel.

It is advised that the corroded steel should be removed and a new I-beam fabricated and installed to support the roof.

The cracking caused by the jacking of the roof should be repaired on completion of the I-beam replacement.

It is imperative that the structure is fenced off, temporarily supported and relevant signage installed as soon as possible, pending a full structural appraisal and consideration of recommendations presented for remedial works..

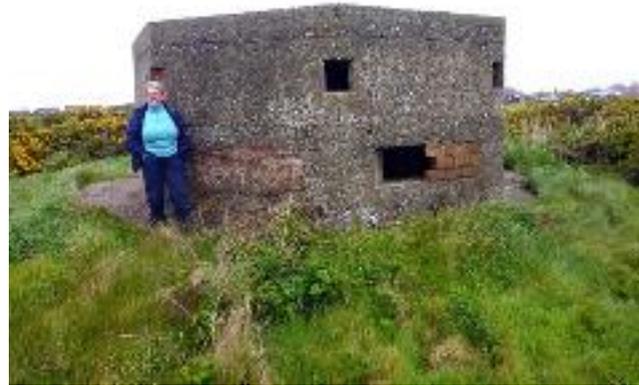
Exterior of pill-box

This pill-box is of the same type as that at Site D. Although some of the apertures have been bricked up, one of the embrasures provides a view to the interior where a ricochet wall can be noted. The pill-box is generally in good condition, with the exception of an area of cracking near the open embrasure relating to corroding reinforcements.

It is recommended that any corrosion should be treated or provided with cathodic protection and concrete repairs undertaken, following structural assessment.

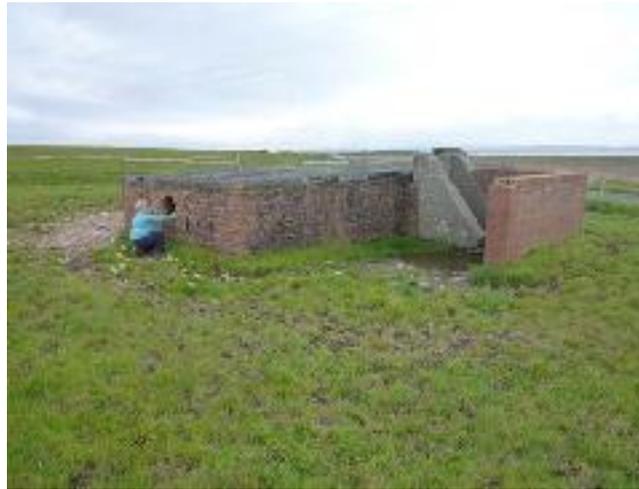
The pill-box has in fact been identified as a decoy control building. The single storey building is constructed with English bond brickwork and a flat cast in-situ concrete roof slab. The internal floor level is approximately 1.5metres below the adjacent ground and is accessed by a projecting in-situ cast concrete stair. The stair wall has been extended more recently with English bond brickwork.

Decoy control building

Structurally the building is stable, however there is severe spalling to the brickwork, most likely due to the high water table and rubbing of livestock who shelter around the building.

It is recommended that the structure is recorded and its potential decay is monitored. Provisions should also be made to provide access restrictions and signage to the entrance to minimise potential hazards for passers-by and livestock.

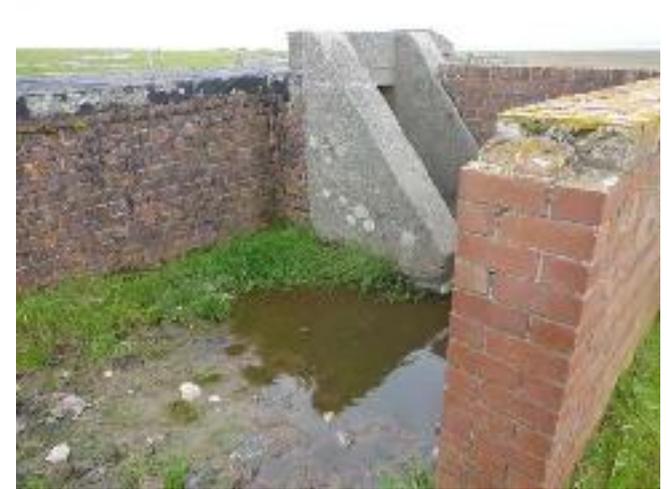
Entrance

There is a single round aperture to the west elevation, a loop-hole facing south-east and an opening in the concrete roof deck which appears to have housed a metal shutter.
