Walney Island

PHASE 2 CONSERVATION STATEMENT

Issue 3

June 2016

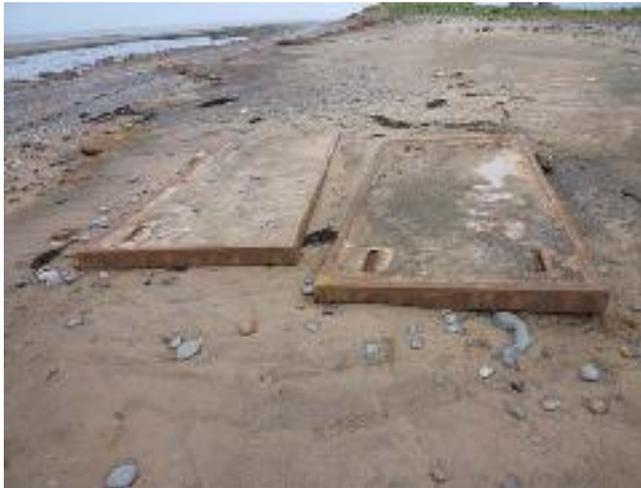
Slabs

A number of loose rectangular concrete slabs cast in metal trays are located on the beach to the south of Walney Island. These may either be holdfasts or remnants of temporary pontoons. The slabs are in fair condition.

It is recommended that the slabs are recorded and consideration given to relocating them.

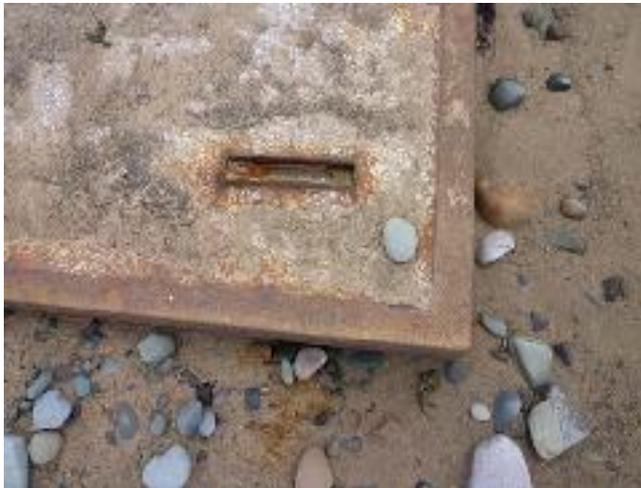
Iron fixings in the corners of the slabs

The fixings set into the corners of the slabs have some minor corrosion and have seized up due to presence of salts and sand. In due course the tray will continue to corrode and ultimately fail albeit they are in fair condition at present.

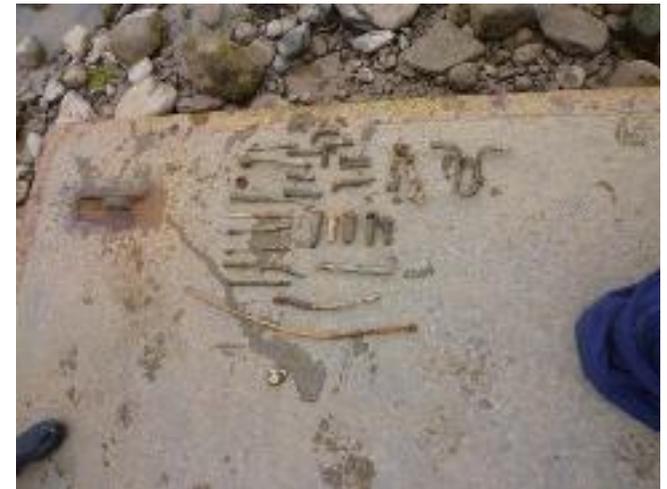
Discarded fixings found in the vicinity

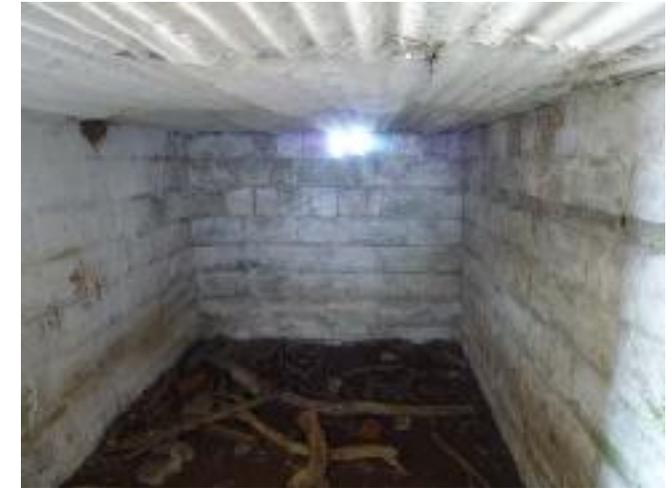
The flat roof is cast in concrete in a single slab, however the interior soffit demonstrates that both timber and corrugated sheet formwork were utilised, with very little quality control. The concrete block partitions do not appear to have significant foundations.

Interior ribbed soffit

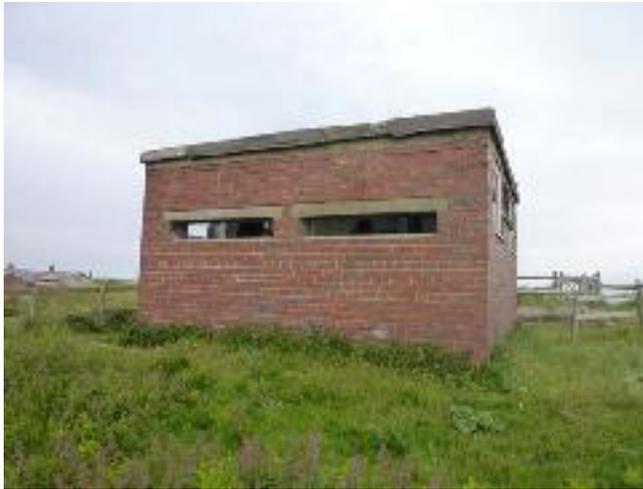
Long horizontal openings.

The makeshift concrete block entrance steps pose a trip hazard and it is recommended that they are renewed.

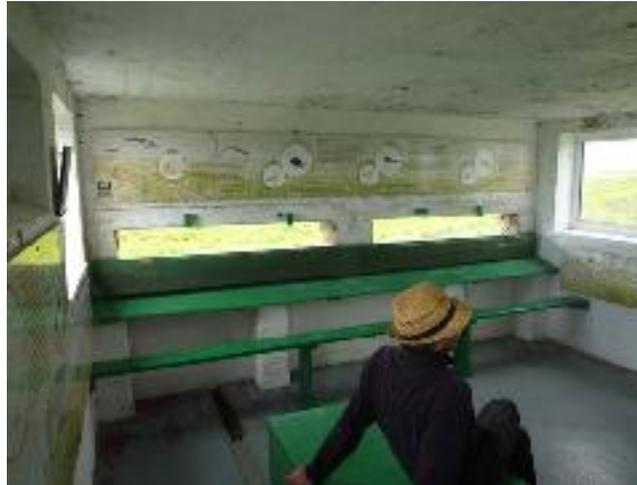
The interior consists of a single room with painted brick walls and painted concrete floor and soffit. Interpretation boards are provided, and provided with some interpretation. There is evidence of damp to the soffit due to the failure of the asphalt externally.

Salt contamination appears to be prevalent at low level around the walls, with micro biological growth at floor and wall junction.

Interior opening

The interior would benefit from redecoration, which could take place following external repairs.

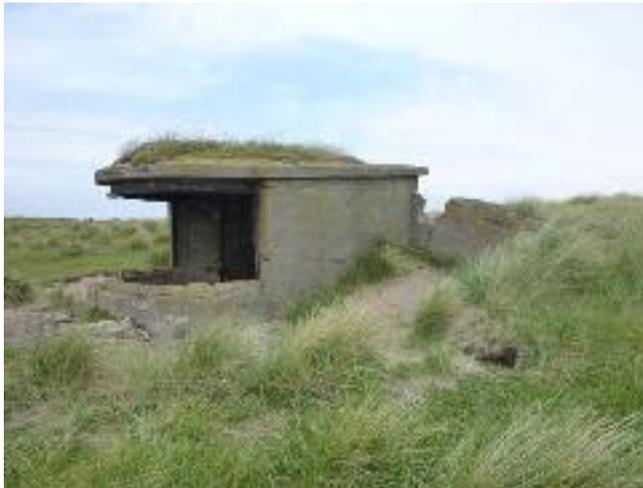
Northern Emplacement

The Northern emplacement is suffering from significant structural degradation.

The semi-circular I-beam which supports the cantilever roof is suffering from serious corrosion and unfit for purpose. Horizontal cracking is present along the roof slab eaves. It is likely that due to corrosion of the embedded reinforcement the slab has separated into two layers. The internal I-beams are in better condition with most corrosion occurring to the upper flanges.

In the short term, it is recommended that temporary supports are installed and access to the site restricted.

The corroded I-beams internally should be assessed and cleaned back and treated or replaced as required.

The semi-circular cantilever I-beam should be replaced with new to match existing.

Reinforcement to the roof slab should be treated or provided with cathodic protection and concrete repairs undertaken.

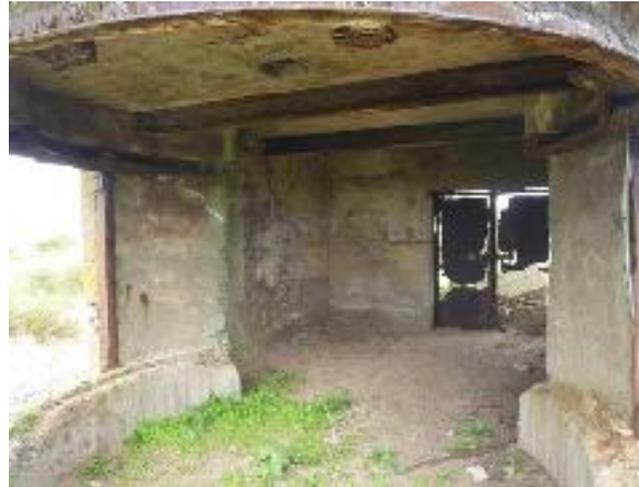
Internally, the structure appears to be in good condition with less evidence of the cracking which is apparent externally. There are isolated areas of concrete cover loss exposing the embedded steel reinforcement.

Interior

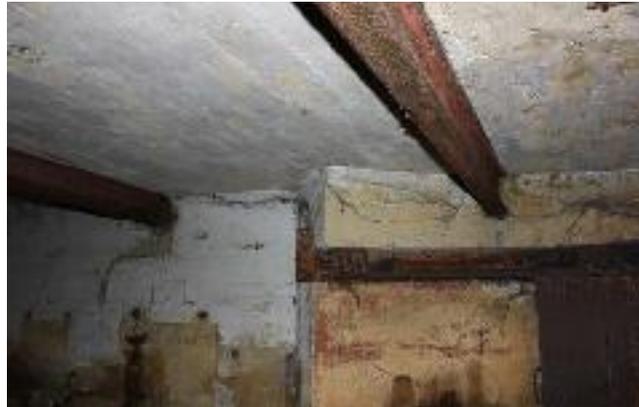
Formwork marks on the soffit

Overall, this is the emplacement in the best condition and the only one which has original shutters. Its retained condition is possibly due to its semi-burial within the sand dunes.
