Walney Island

PHASE I CONSERVATION STATEMENT

Issue 4

October 2015

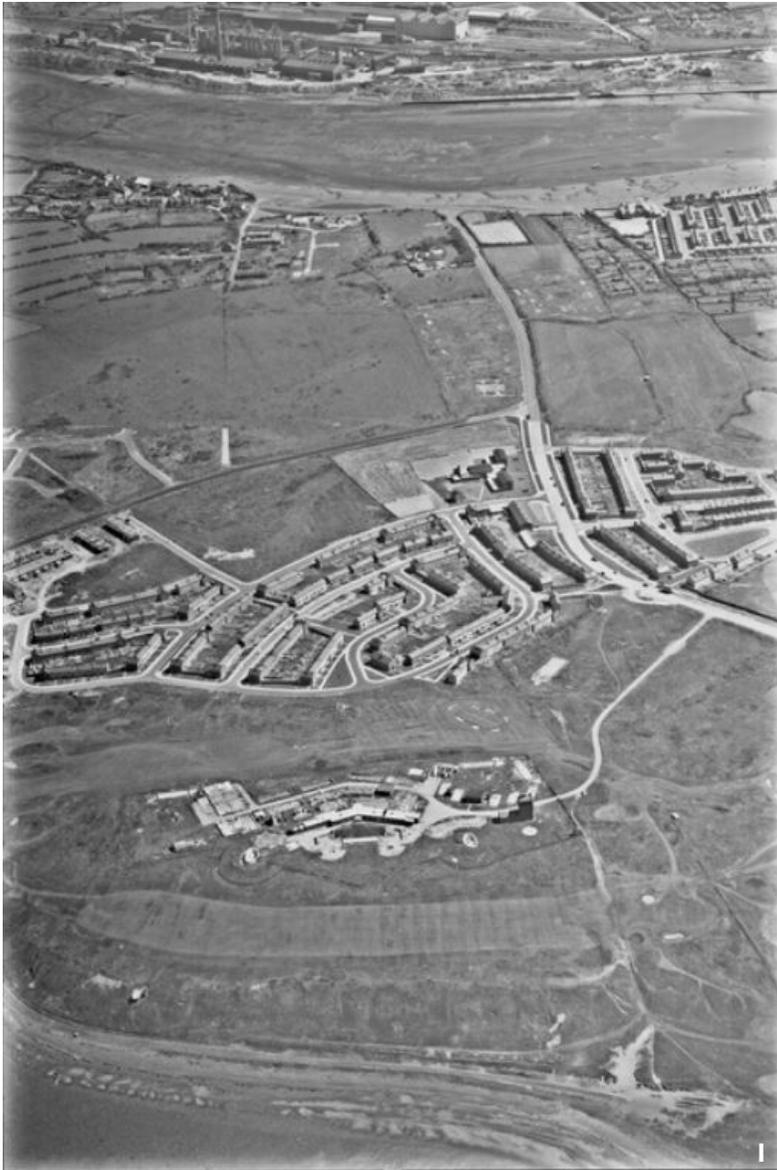
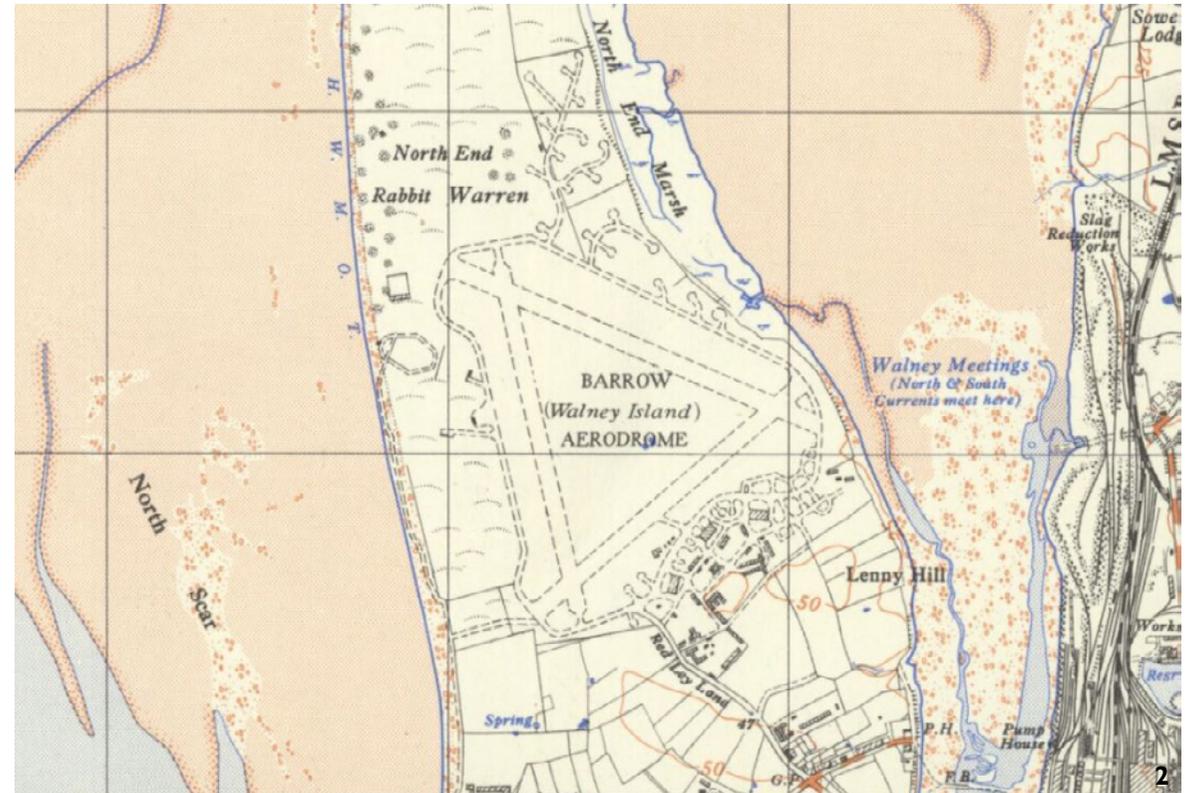
- 1 Aerial photo of Walney Island, 26 July 1963 from RCAHMS National Collection of Aerial Photography
- 2 Walney 1952 OS and South Walney 1952 OS
